Project Goals

John Greenwalt Lee

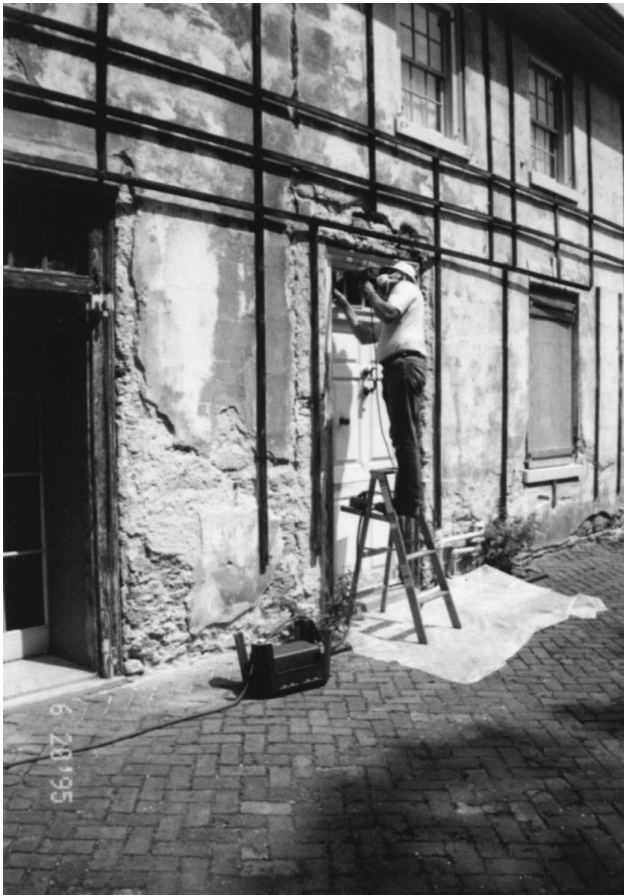
Removal of cement patches.

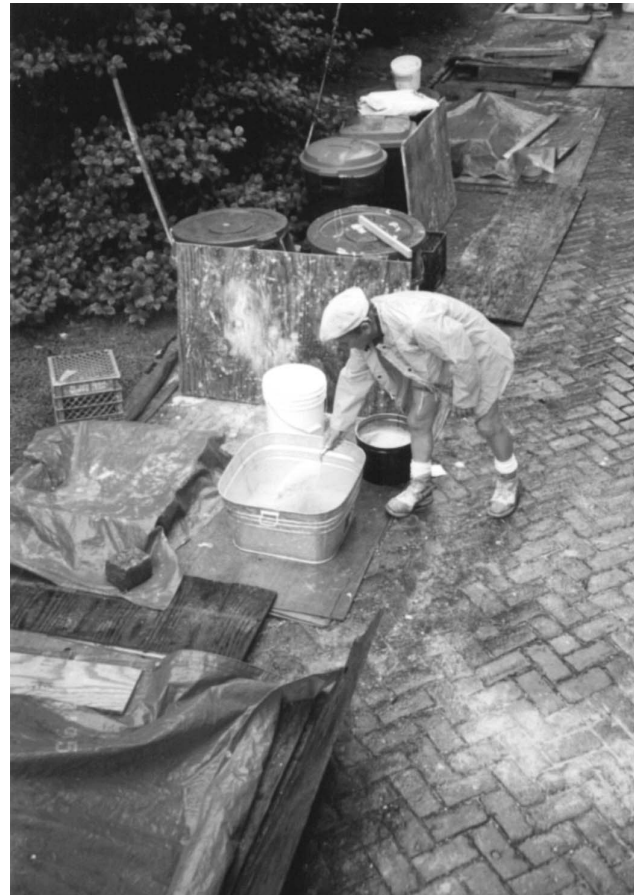
Mixing stucco.

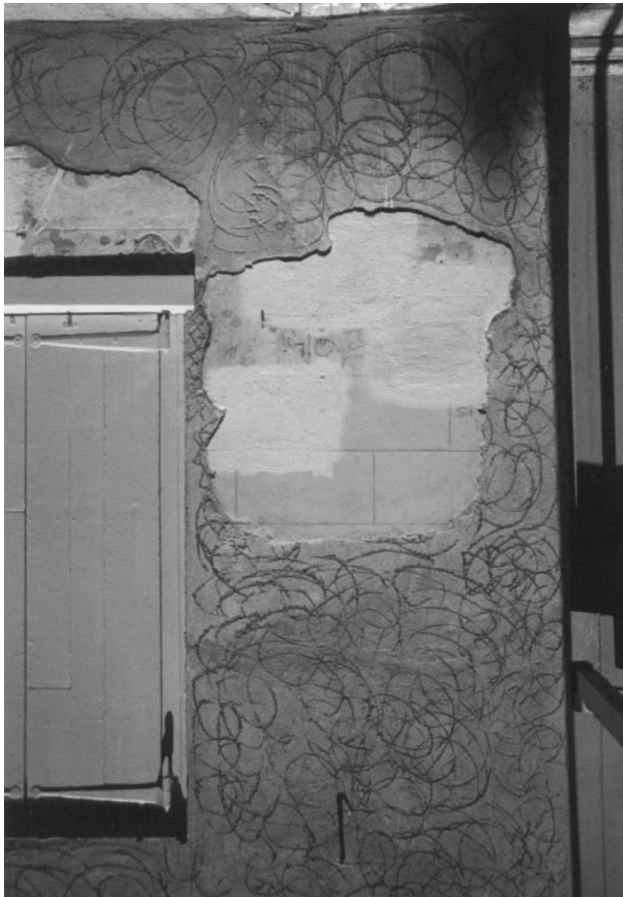
Building up stucco layers.

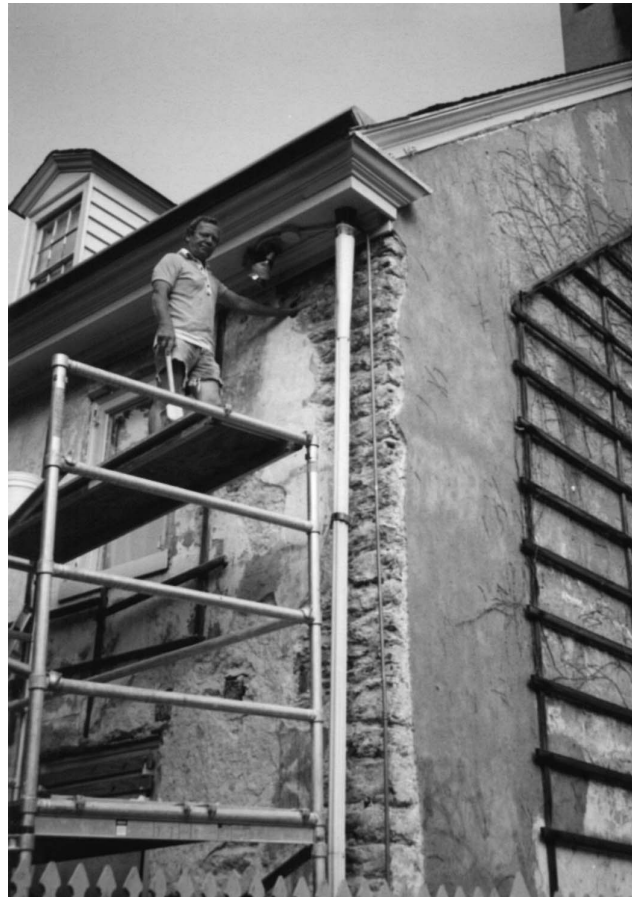
Joe Forrest cleaning masonry before stucco was applied.
