Stabilization and Treatment of Exterior Wooden Trim— Windows and Shutters

Treatment Record

Window 105

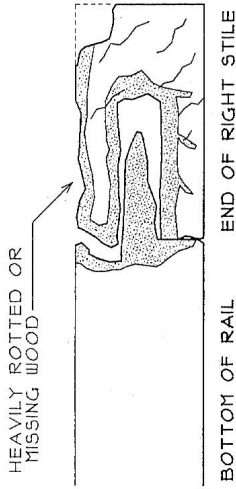
SURFACE APPLICATION OF EPOXY RESIN CONSOLIDANT NOT SUFFICIENT TO CORRECT PROBLEMS.

BEST APPROACH IS TO TAP THE FRAME APART, STAND THE ROTTEN ENDS OF RAILS, STILES, AND MUNTINS IN A CONTAINER OF EPOXY RESIN CONSOLIDANT.

THERE SHOULD BE ENOUGH RESIN TO COVER AT LEAST 1/2 TO 2/3 OF THE ROTTED AREA. ALLOW THE RESIN TO SATURATE THE ROTTEN WOOD AND CLIMB UPWARDS UNTIL THE ENTIRE DAMAGED AREA IS LOADED WITH RESIN. FOR SOME PIECES OF WOOD IT MAY BE NECESSARY TO DRILL A STAGGERED SERIES OF HOLES ACROSS THE GRAIN (MORE ABOUT THIS IN THE NEXT SECTION).

WHEN FULLY SATURATED, REMOVE, WIPE OFF EXCESS RESIN, AND ALLOW TO DRY.
