Conservators Assessment: Masonry and Exterior Paint

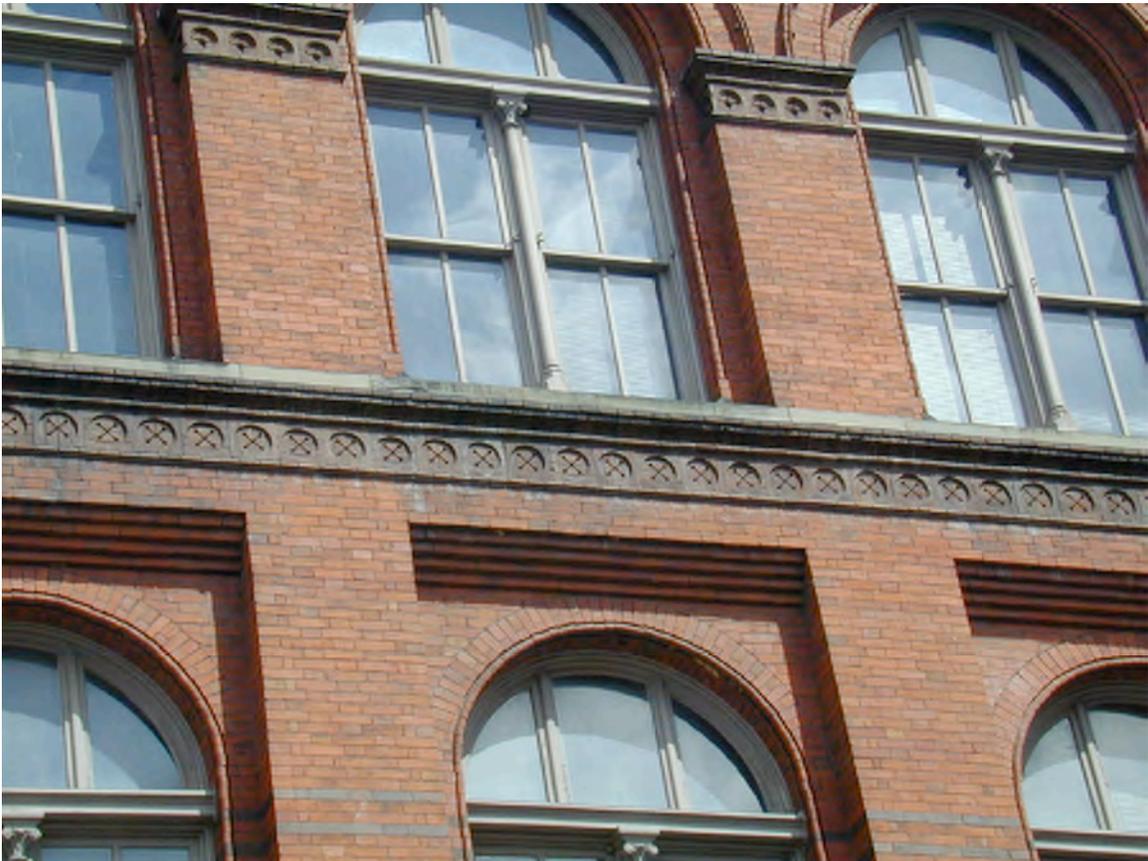
Stone copings under the gutters have been subjected to significant water intrusion that during cold weather has assisted frost-jacking damage. These stones need to be relaid in proper alignment. To add to the longevity of the solution and create a better maintenance solution, we recommend a gutter liner that covers the entire upper face of the stone and creates a drip edge to keep water off of the stone surface.

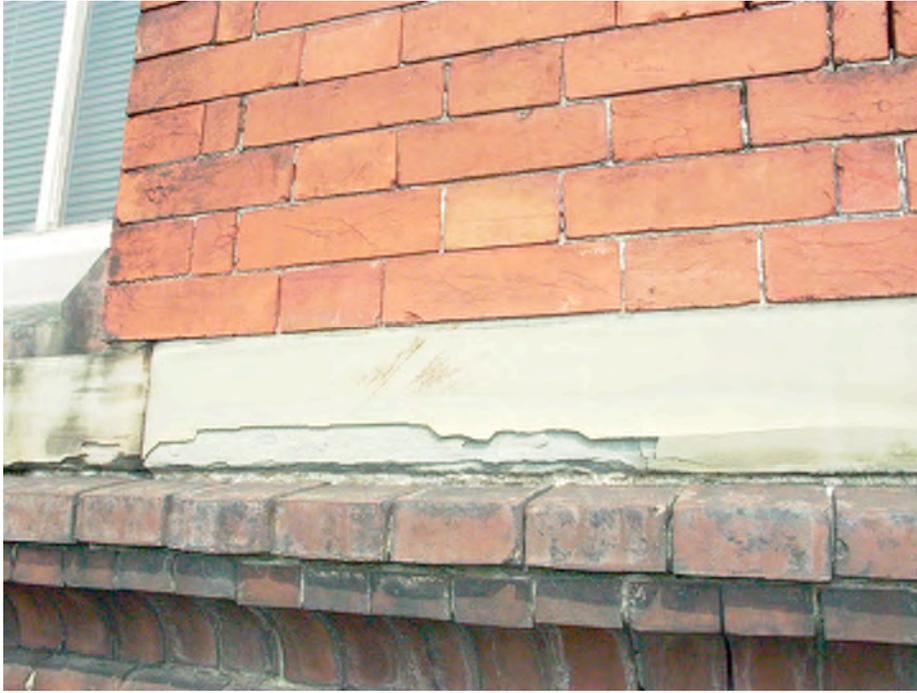
Beyond the immediate delaminations at the surface or areas where the stone has been placed under extreme stress, the sandstone in general appears to be quite sound – with the exception of that form under the granite at the “moat” level. It would be useful to locate any correspondence regarding the later building additions where the sandstone began to be replaced. Was this replacement due to early deterioration or was it only a simplification of the construction palette? Considering the amounts of coal being burned during the decades after construction, rapid deterioration early would have been more likely and the rate may now have simply slowed due to decreases in pollution levels.

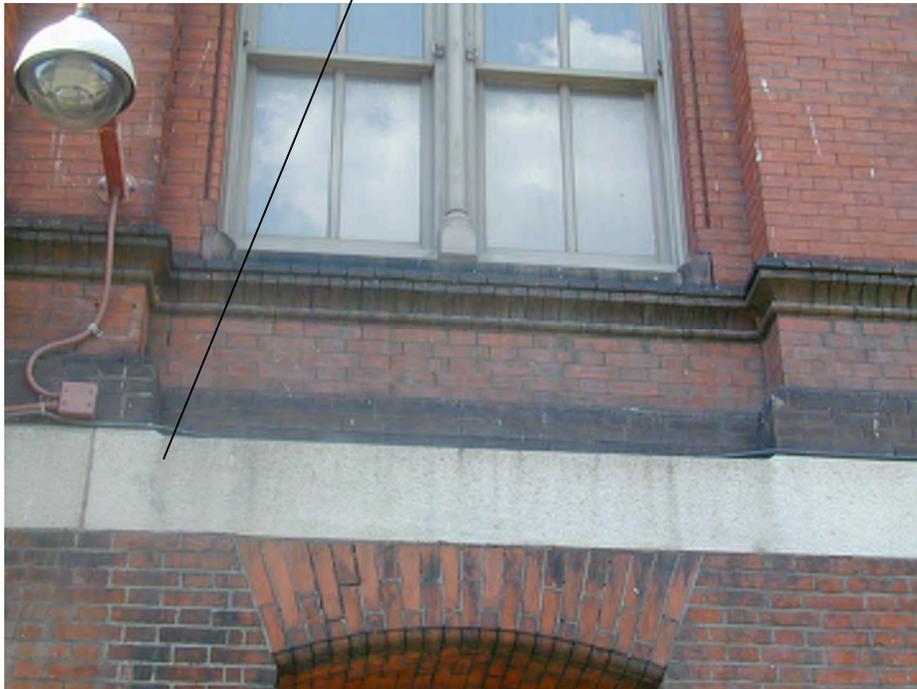
Stone failure due to stress fracture is most often seen in the granite elements that are very long compared to their thickness. This is particularly seen at window sills where the jambs are under a considerable load and the window area has almost none. The other stones seen as window sills show less breakage, likely because they will accommodate deformation better than the brittle granite. Where stone is stress fractured grout repairs would be appropriate.

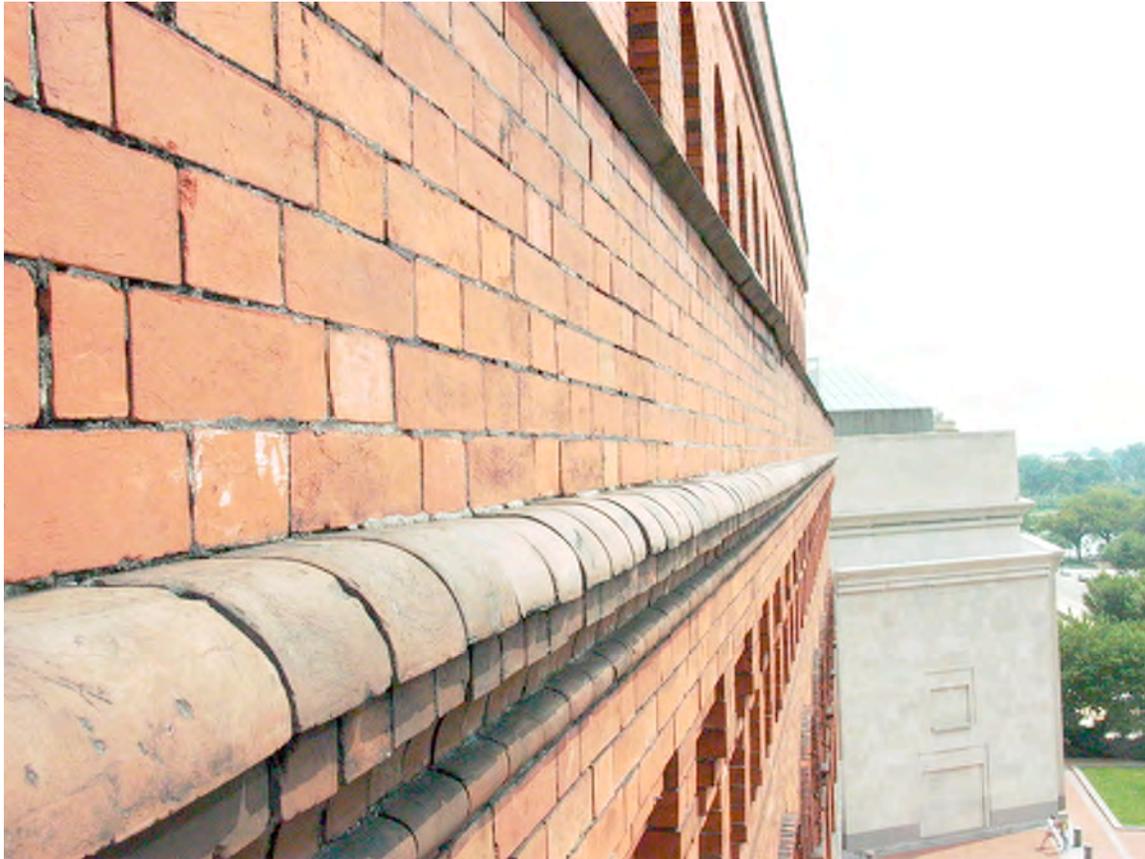
At each projecting belt course the mortar formulation is weak already as on the rest of the building. But these areas are also subject to far more weathering as water is continually washing down and wearing away the vertical joints. Skyward-facing mortar joints should be a regular maintenance issue that is addressed at least every couple of decades.

All stone and terracotta outcroppings or projections would do well to be capped in metal. Copper would profoundly stain. Lead-coated copper would not conform to the irregular masonry tops. Lead however is able both to fully conform to all irregularities in the surface below and has enough integral weight that additional attachment methods apart from letting the top edge into a mortar joint and setting with lead wedges would be unnecessary.

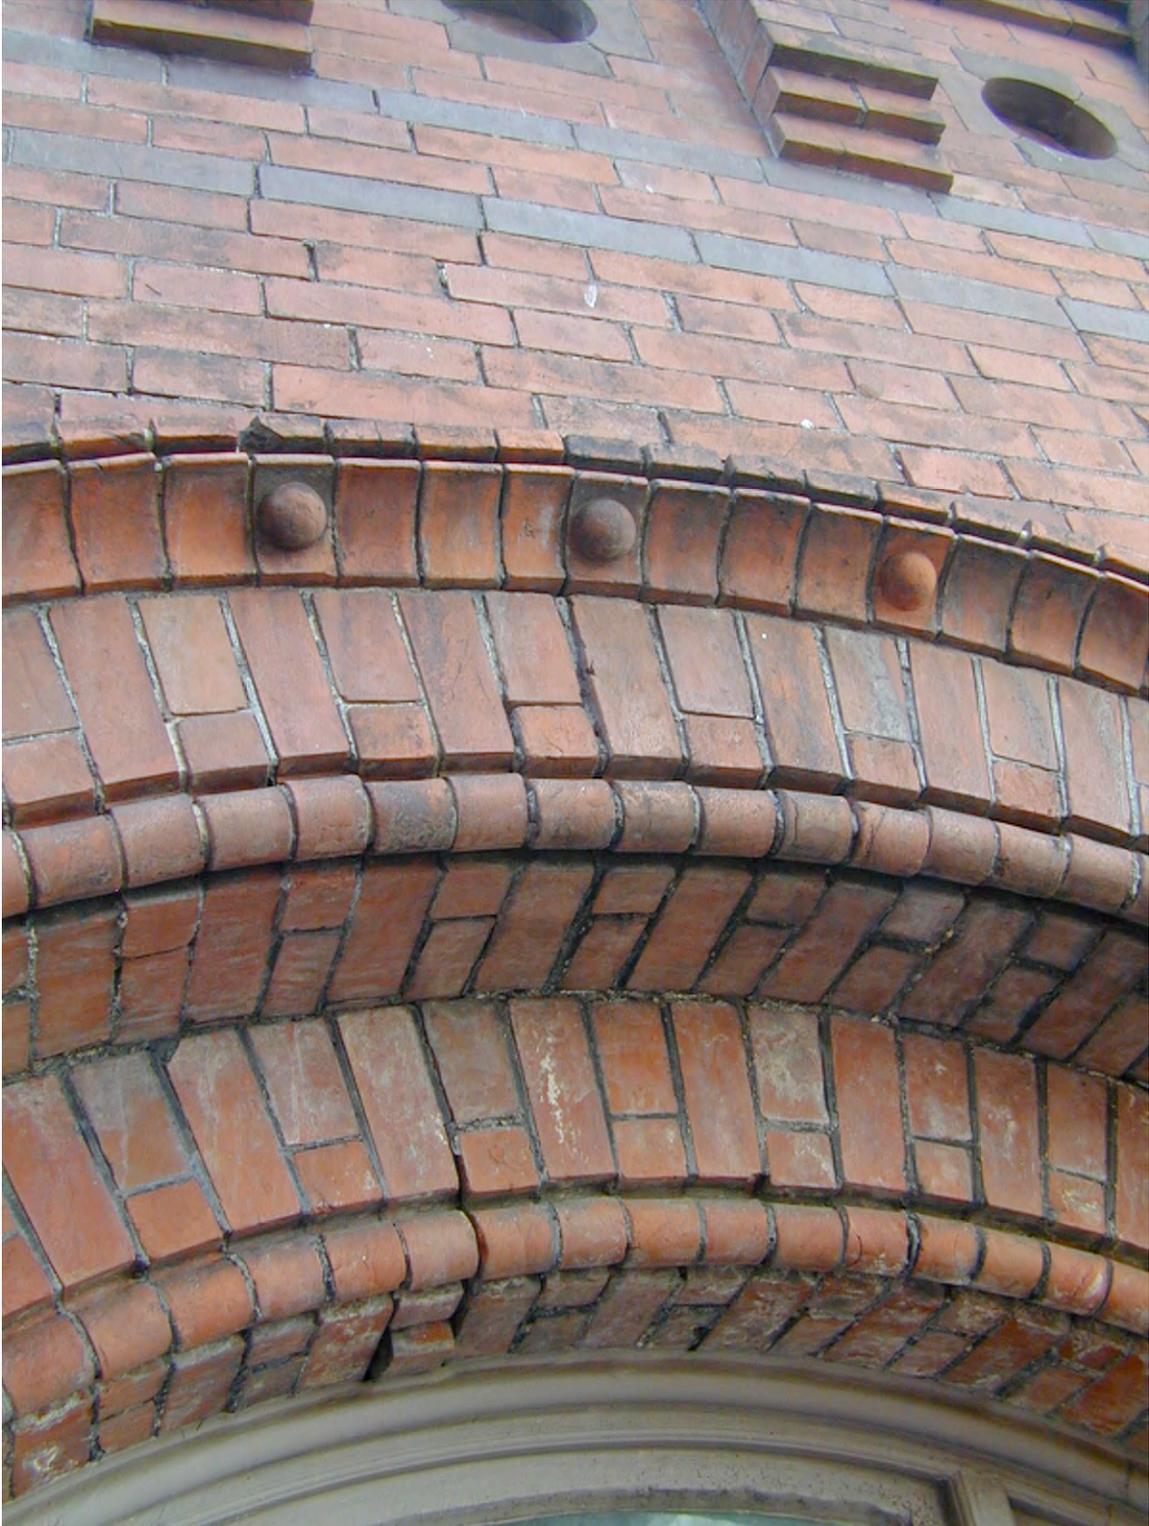
The terra cotta – shaped brick and decorative ceramic units are not manufactured to the same quality standards that we would expect today. The existence of large numbers of warped pieces create the appearance of their being way out of position once the surrounding mortar fails. There appear to be many areas of misalignment at first glance which are in fact due to irregularity of the masonry units and not deflections. Therefore expecting a total uniformity of appearance after repair is inappropriate.

This is not to say that there are not a few bricks that have slipped in these arches, but most of the irregularity is due to the misshapen units themselves that created unsolvable condition for the masons.

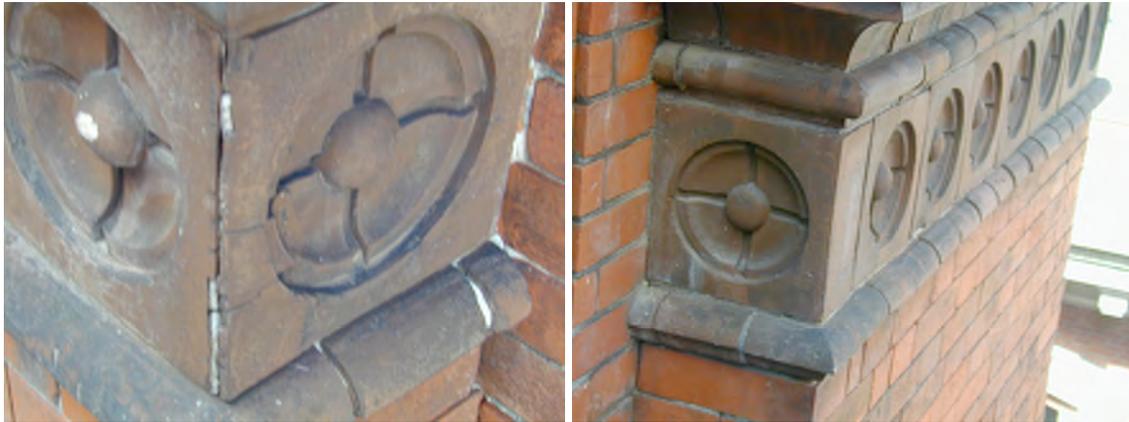
On the small terra cotta pilaster band that returns into window, the corners are mitered. This creates very thin and therefore very weak corners. These corners occur at the windows and not at the building corners where the pieces have full thickness edges.

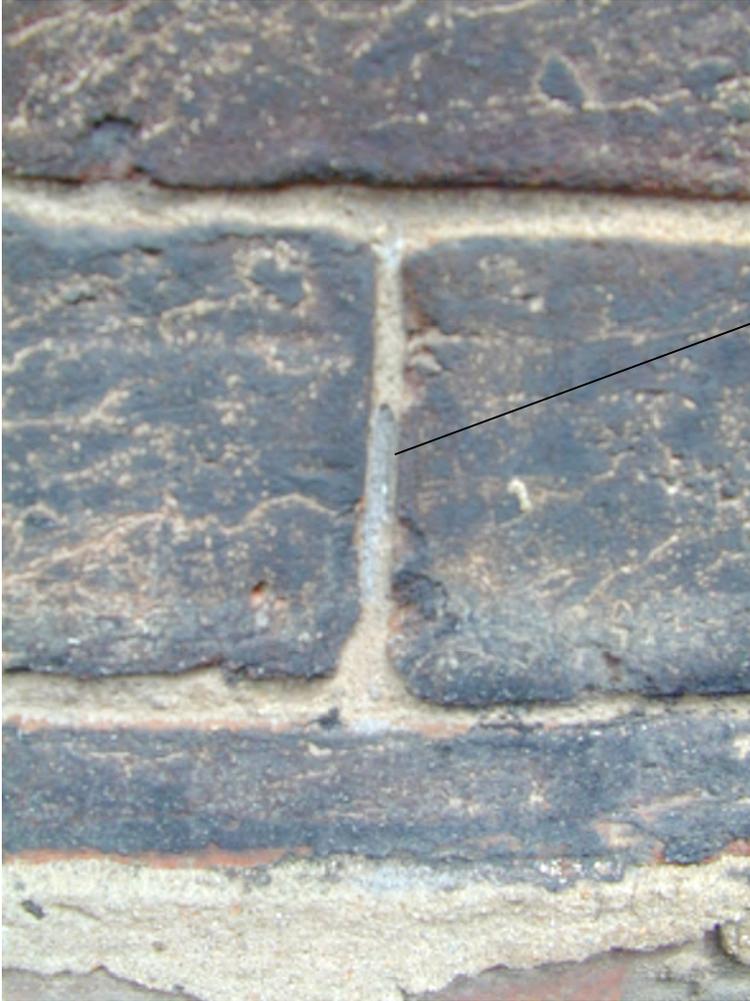
Weathering of the mortar, and specifically dissolution of the binder from heavy acid rain in past eras of heavier sulfur pollution, have lead to white calcite deposition on the front of some joints. Scratching the surface quickly uncovers the original black mortar used to construct the building.

Scratching the white surface crust of an original joint reveals the dark bedding mortar below.

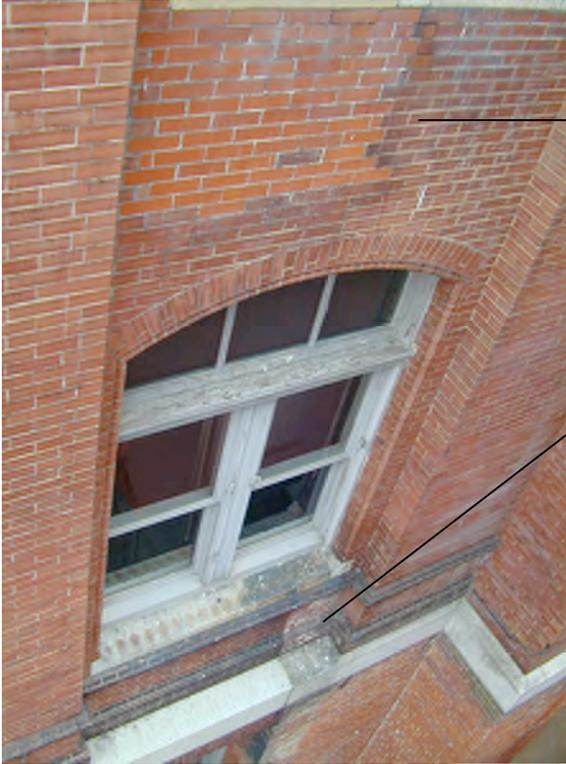
From the outlines of earlier structures on the building façade and the location of infill masonry, it appears that this structure once had a maze of fire escapes that were later removed. The infill areas are unattractively executed and often contribute to deterioration on the building whether through vertical alignment from window sill down through multiple courses of the same joint or from material interactions with the concrete sills at windows (once doors) that are leaching unreacted lime into the surrounding materials below. It would be wise to correct the materials and methods of construction at these locations as part of this project.

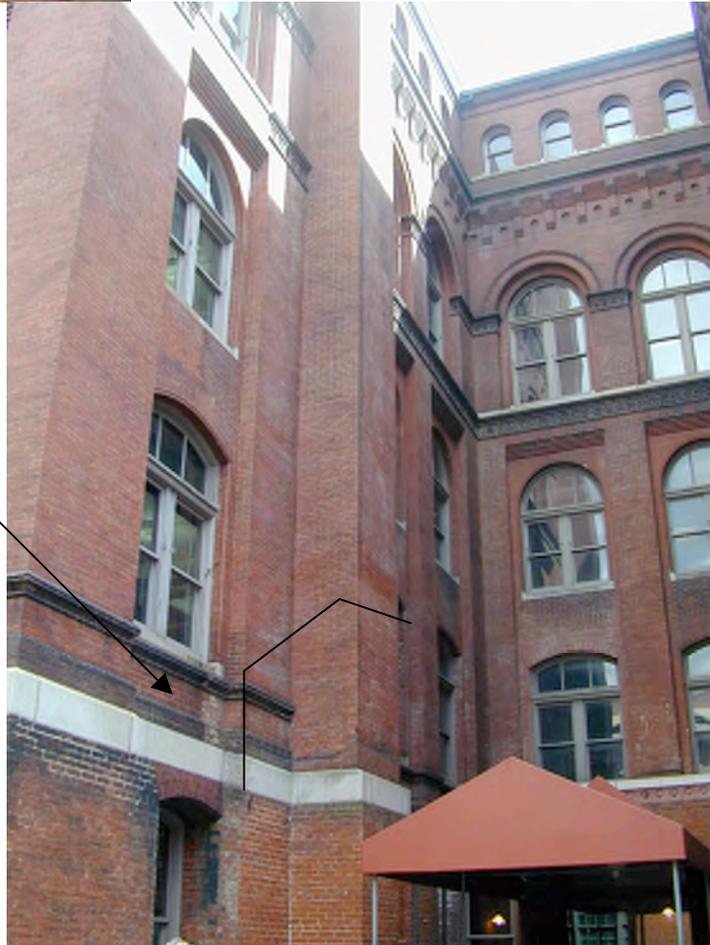
Alterations related to removal of earlier fire escapes (*outlined*).

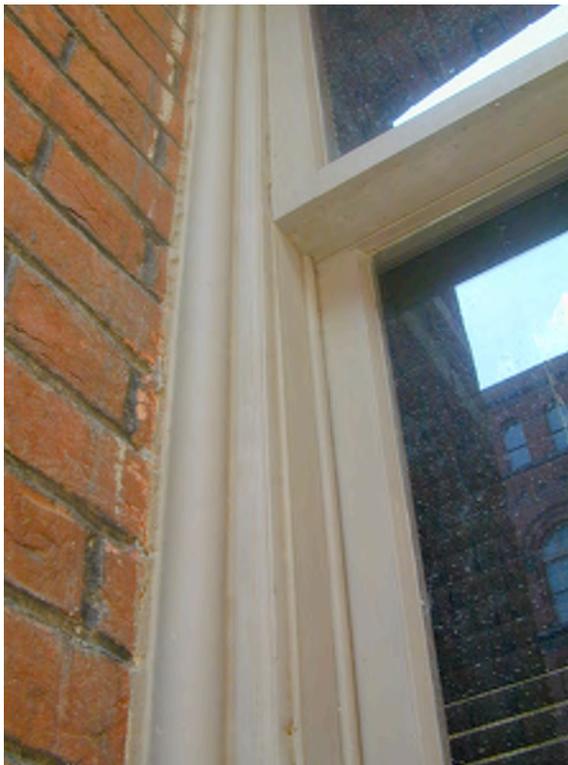
The lower windows are new – this includes all of the sash and nearly all of the wooden trim below the transom.

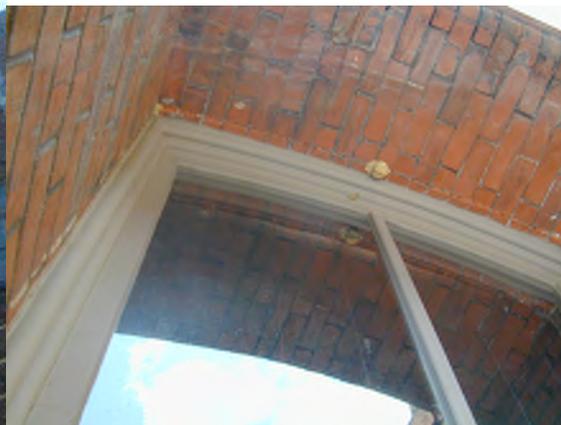
Earlier window locations found in the form of paint ghosts highlight the changes at these windows, i.e. window replacement.

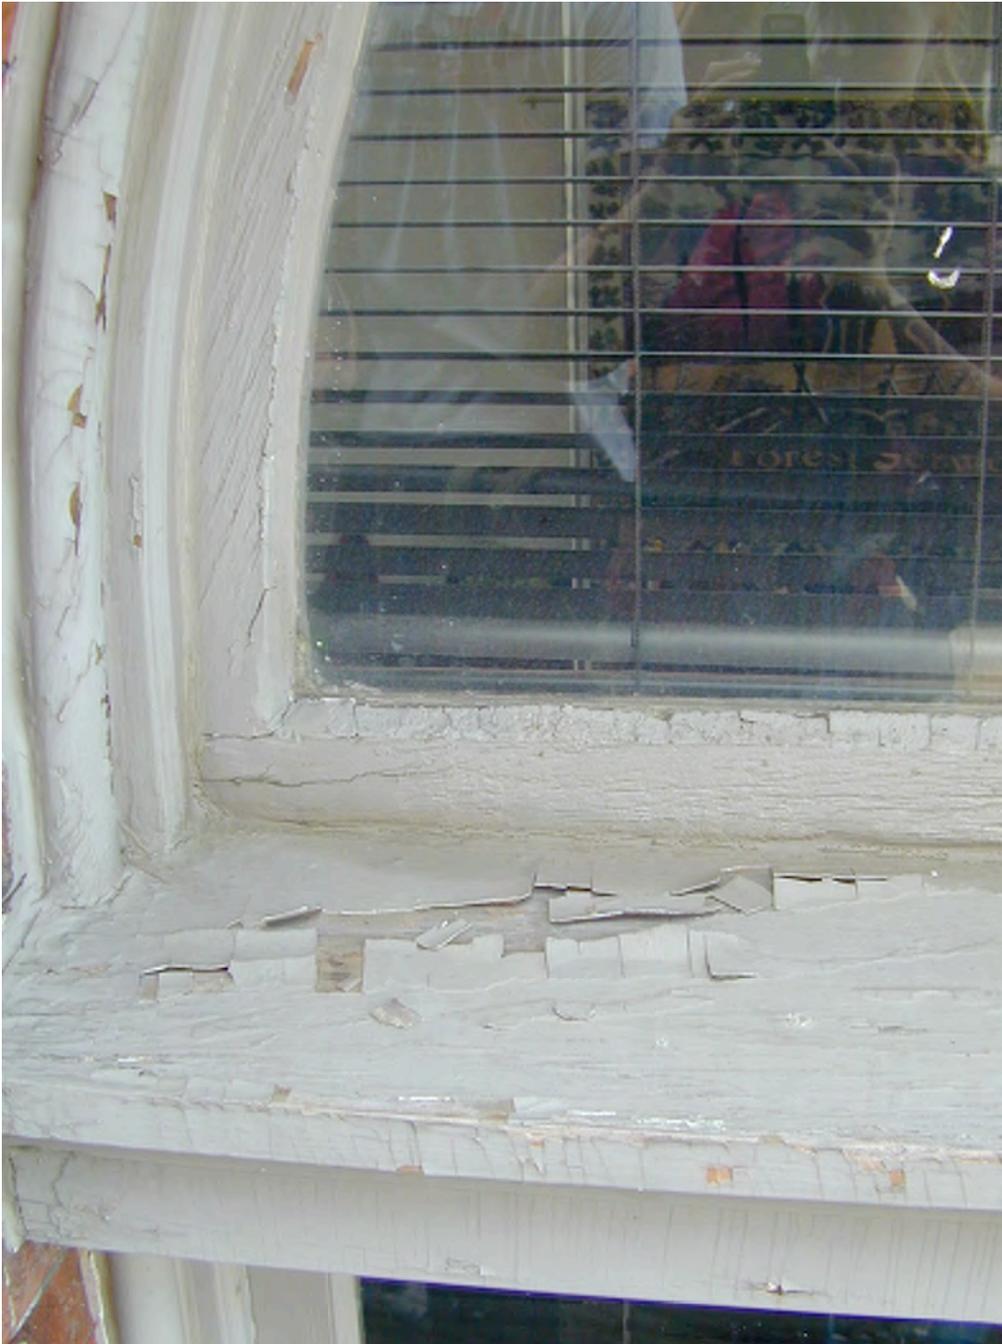
The transom areas appear to be sound in nearly all instances, aside from nearly wholesale paint failure from lack of maintenance. Removal of this lead paint should be carried out using one of the new n-Methyl-2-pyrrolidinone paint strippers with a lead chelator. These strippers remove all traces of the lead while being comparatively safe for the application crew and they do not add any chemicals that would be detrimental to the masonry, unlike methylene chloride or alkaline strippers that are rarely neutralized adequately. Significant failure of window glazing in the transom areas will also require careful replacement.

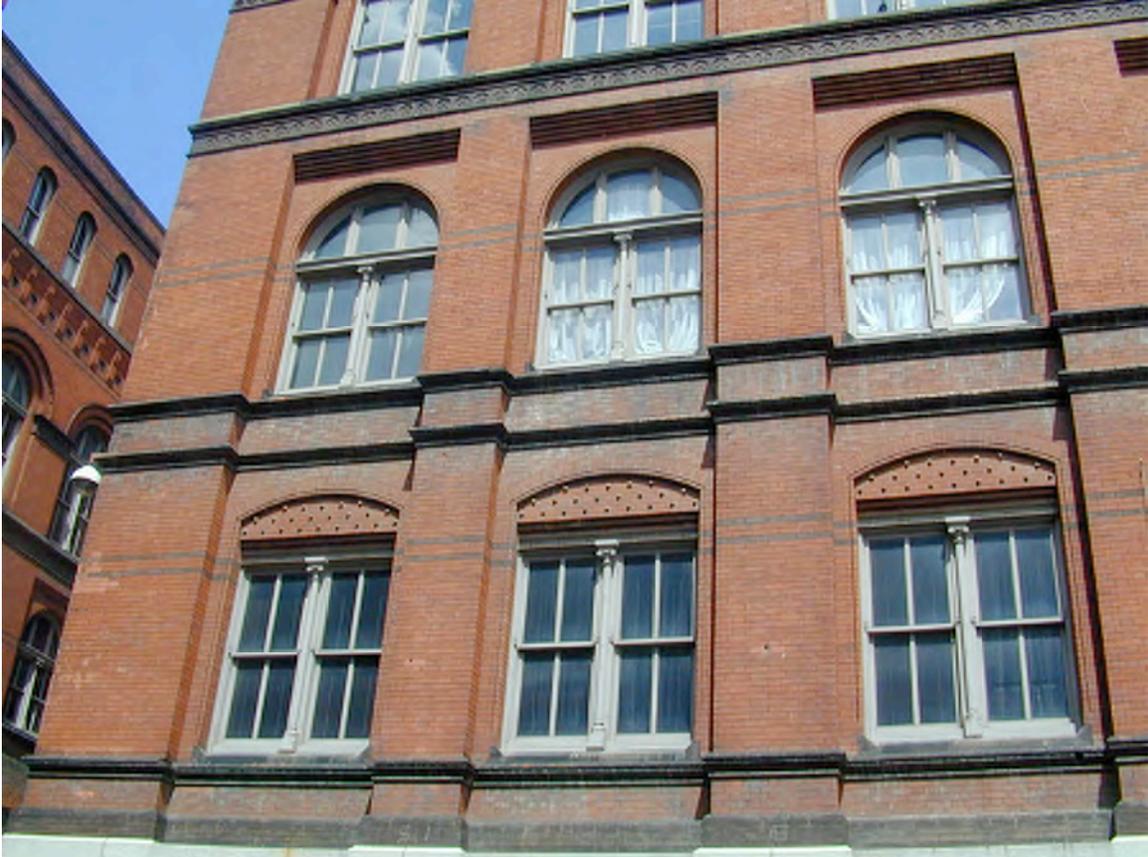
In general the arches have vertical joints that have washed out. It appears that the discolorations in the window recesses are from carbon black dark stains and a lime haze is visible on the undersides due to deterioration of the mortar as water has been washing through. In thinking about how to clean these areas, it should be noted that surface soiling is normally washed away by the rain. It is only in these areas below building projections that are heavily protected from this rainwater washing that the staining is particularly heavy.

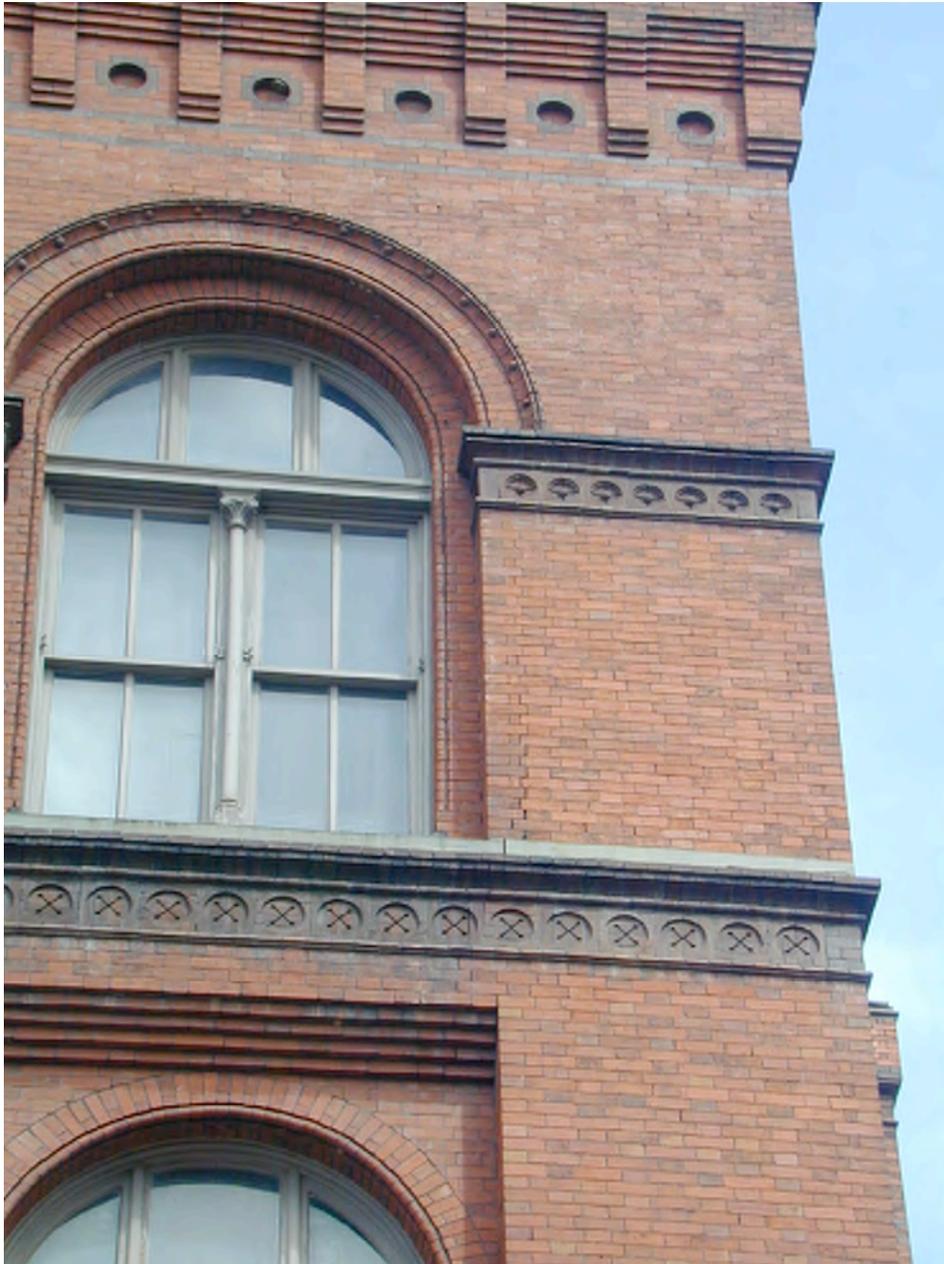
With interior concrete slab floors and the building heated, the slabs are in their warm condition while the skin of the building is trying to contract during the winter. Building corners therefore tend to exhibit the most stresses due to this competing expansion and contraction. Corners can not move in against the slab while the rest of the skin is trying to pull in. The damage is cumulative so the greatest force is at the corners, but the break area is generally focused into the nearest weak point – in this case that means that moving in from the building corners to the nearest weak point the brick window edges show

cracking that is more severe moving toward the exterior building corners and to a lesser degree at interior corners. Queen closers at the window edges do allow the cracks to generally follow the mortar joints without pushing on through the bricks themselves.

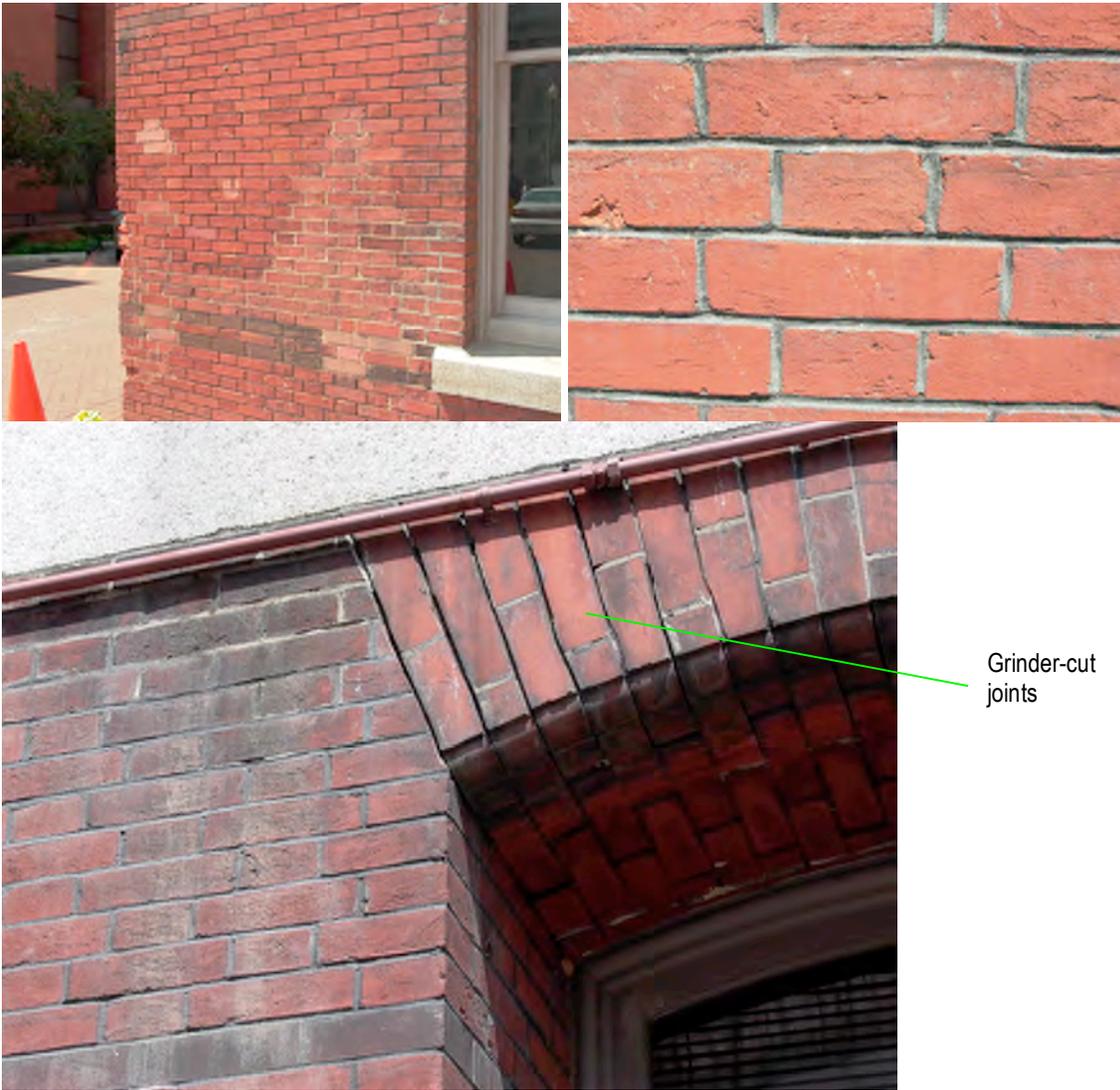
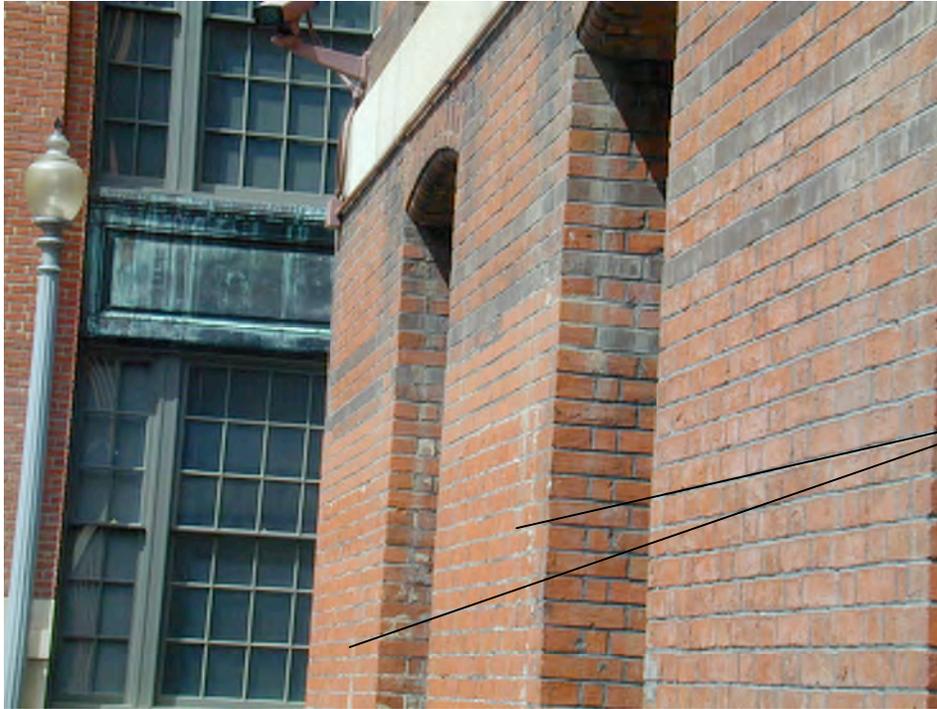
The appearance of most of the ground floor brickwork is considerably different from the rest of the building because of inappropriate repairs and cleaning methods used in the past. Attempts to remove paint from the surface with unnecessarily high water pressure has significantly increased the surface area and texture of the brick faces in some areas. Removal of fire escapes and gate hinges have left areas with damage due to differential stress and differential weathering of areas that were once protected. Much of the ground floor has also been repointed after brutal grinder cleaning of the joints that has both enlarged the width of the joints and made the coursing appear more irregular, even sloppy, especially with the use of concave jointing tools. And these lower areas of repair were generally repointed with a white mortar, as opposed to using the black mortar of the original construction. This may be due to a perfunctory assessment of the original, but deteriorated mortar where many of the lower joints have a white surface coating from redeposition of calcite where the mortar had been dissolved under acid rainwater.

High
pressure
washing
damage

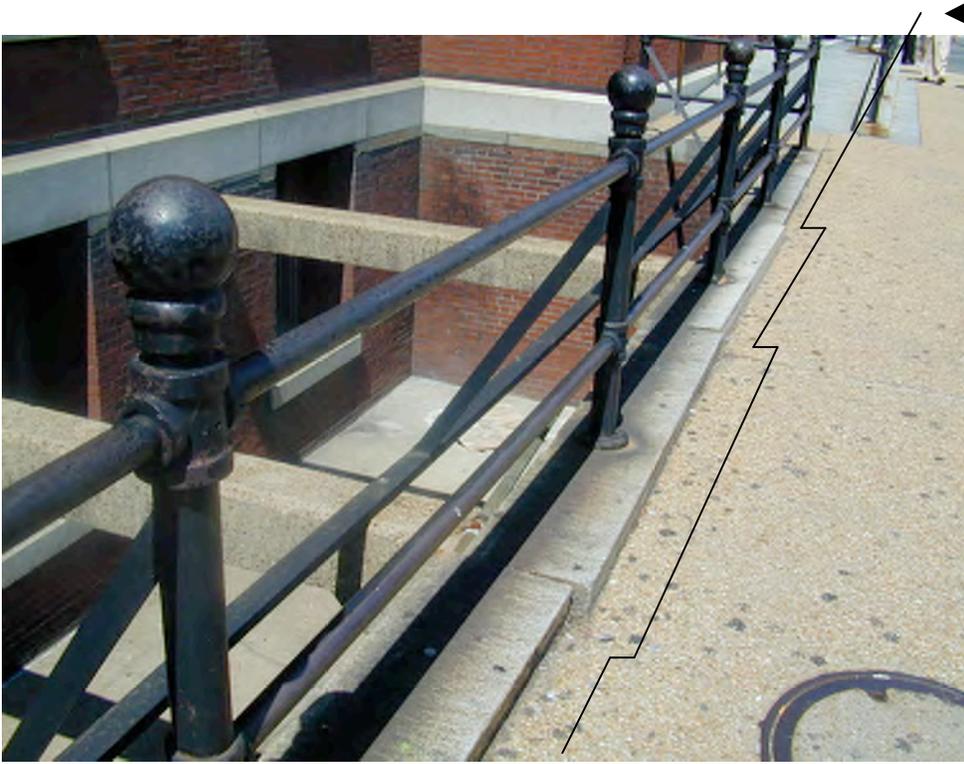
The retaining walls of the light well “moats” are experiencing a differential horizontal displacement, apparently from the fill load behind. This would imply that the walls are too light. This could be remedied by excavating behind the wall and installing an engineered cast in place concrete retaining wall to which the existing brick walls can be attached as “veneer.” The existing walls can be re-aligned before attachment to the structural retaining wall behind and the cracks and voids grouted. We have re-aligned walls in several projects, one relatively local was for the International Masonry Institute. This is not difficult or on the scale of moving the Cape Hatteras Lighthouse and is very cost effective when compared with replacement.

Buttressing
concrete insets
worsened
misalignment
stresses on
moat retaining
walls - both
stone and brick
