PRELIMINARY ASSESSMENTS: Masonry, Plaster and Finishes Failure

Report of the John Greenwalt Lee Company
Produced for Maryland Department of General Services

PRELIMINARY MASONRY and FINISHES FAILURE ASSESSMENTS: Old Senate Chamber, Old Treasury Building & Shaw House

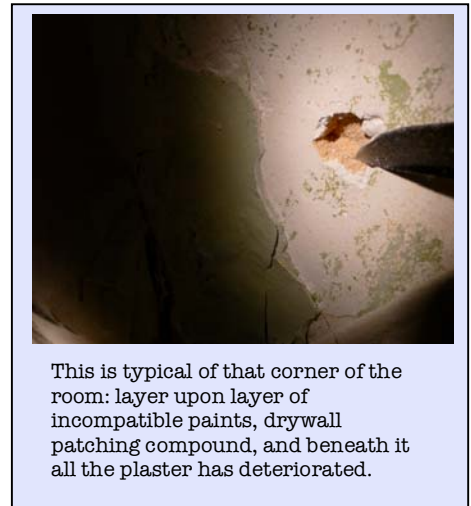
This is typical of that corner of the room: layer upon layer of incompatible paints, drywall patching compound, and beneath it all the plaster has deteriorated.

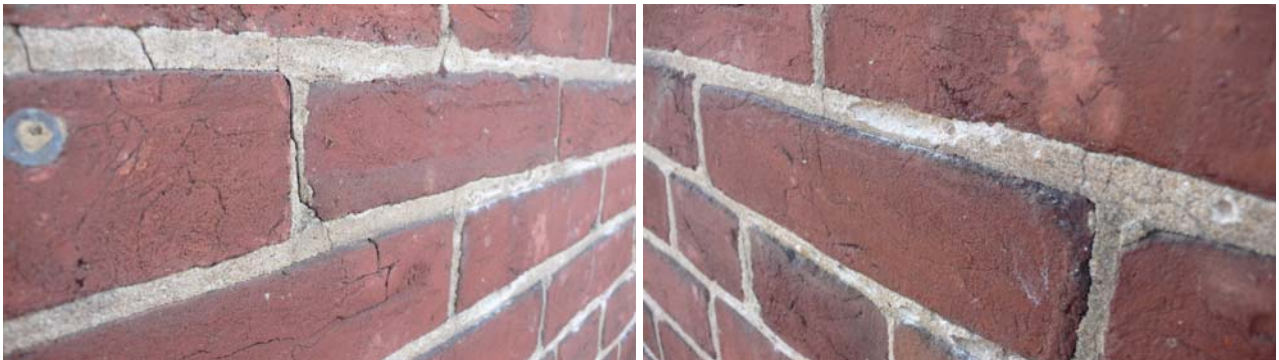
Thin portland pointing that is exfoliating off due to the failure of the lime mortar beneath it. Undoubtedly the lime mortar was sound when the portland was put over it. Now the portland is trapping water and contributing to deterioration. Large number of cracks in the portland, through and around joints, allows for the entrance of water.

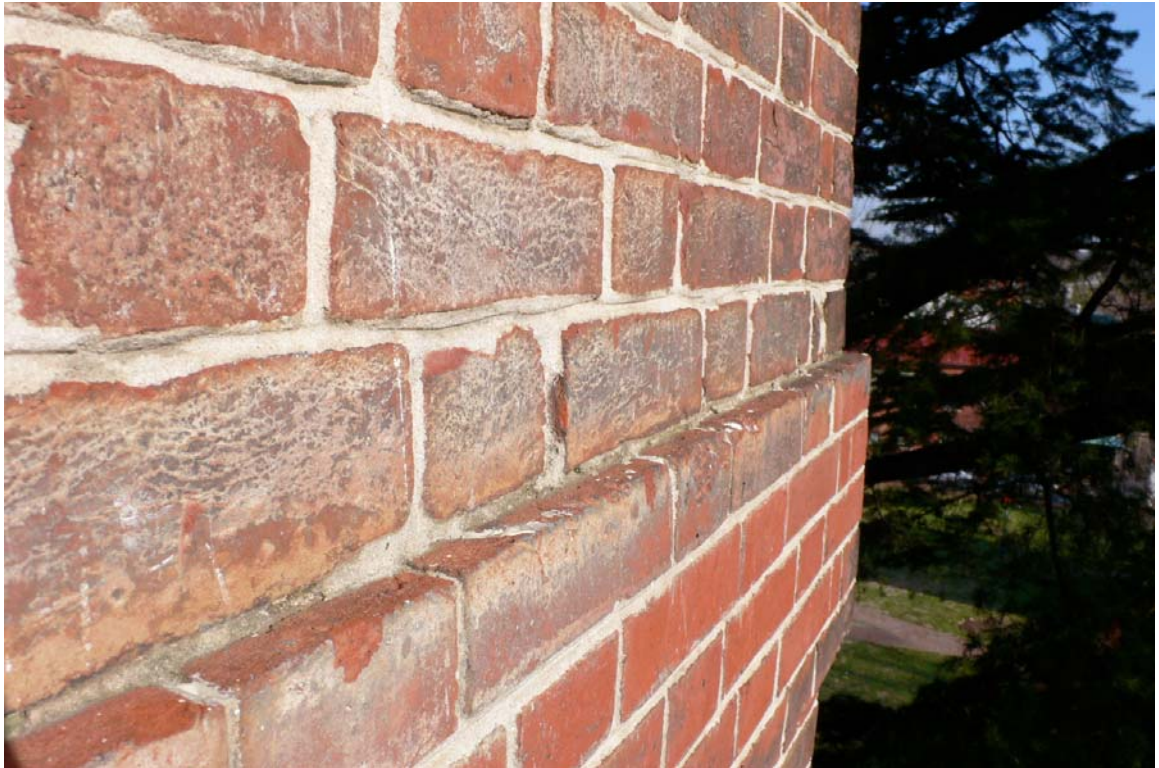
This is the belt course. The portland pointing that had been there is missing in areas. The lime mortar that is revealed is not in great shape, but is also not leaking liquid water directly into the building. Directly to the left of this photograph is where the caulking had been applied. The caulking needs to be removed. If anything, it is trapping water in the wall. There is no place for any caulking in mortar joints on historic brickwork.

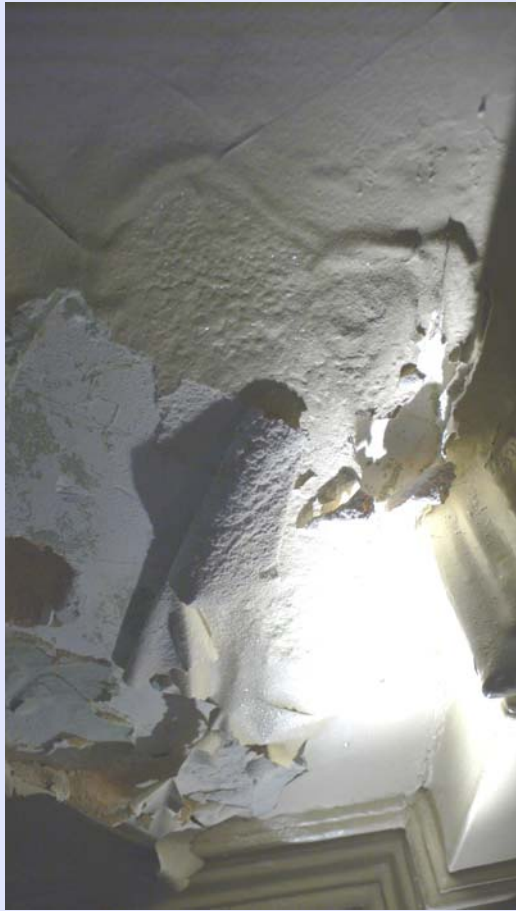
Liquid water condensed on the surface of the plaster in the corner of the Old Senate Chamber and running down the wall.

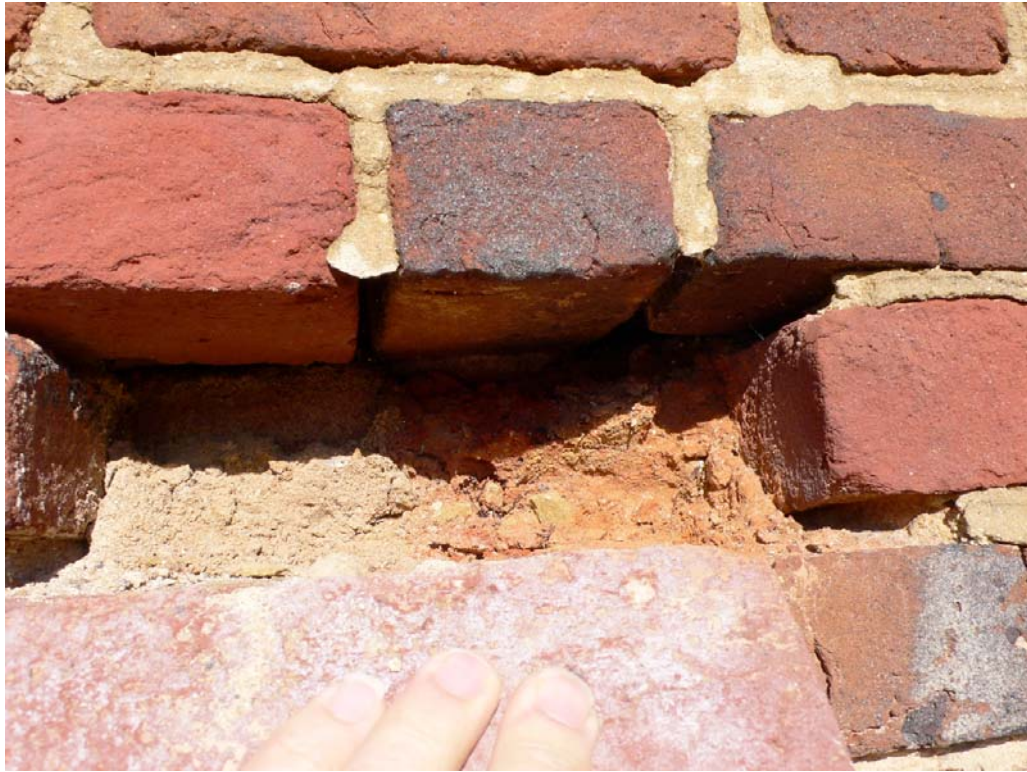
Some of the portland repointing is very superficial, but the damage it created is still extensive. The internal mortar is now only sand and much of the brickwork is only supported on the outer 1/2" leaving an unstable condition.

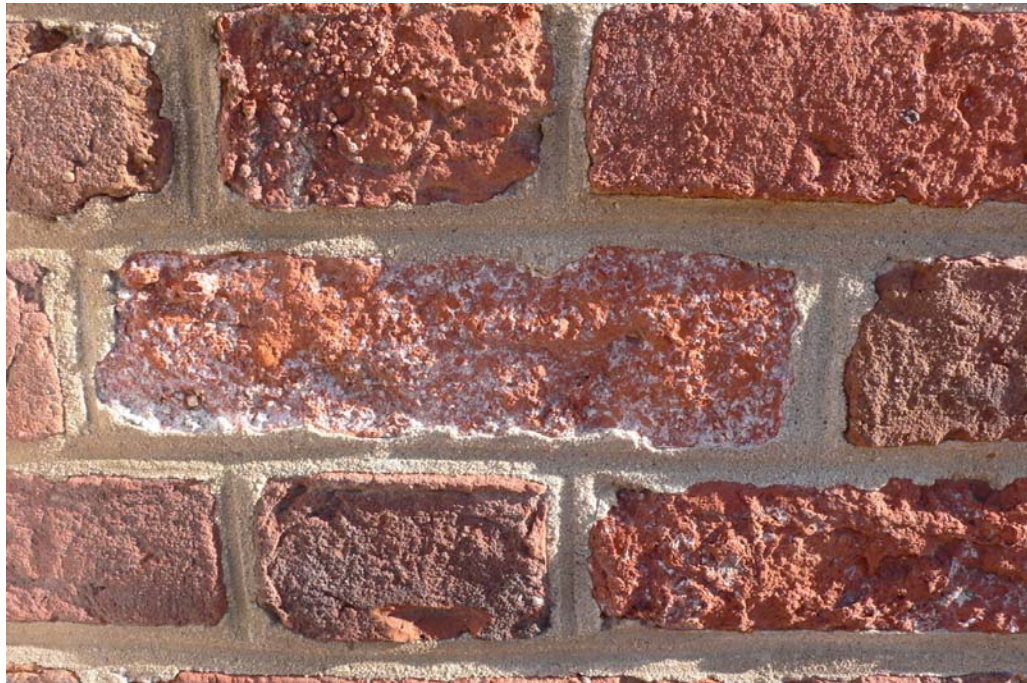
Small-pored and underfired bricks are the first to collapse from a buildup of salt (white deposits throughout the brick faces and edges of the mortar). Because of its density, the portland cement holds water within the bricks and by reducing the evaporative surface of the wall, forces all drying to occur through the bricks, drawing the salt into their porous matrix where it expands and begins to push the bricks apart.

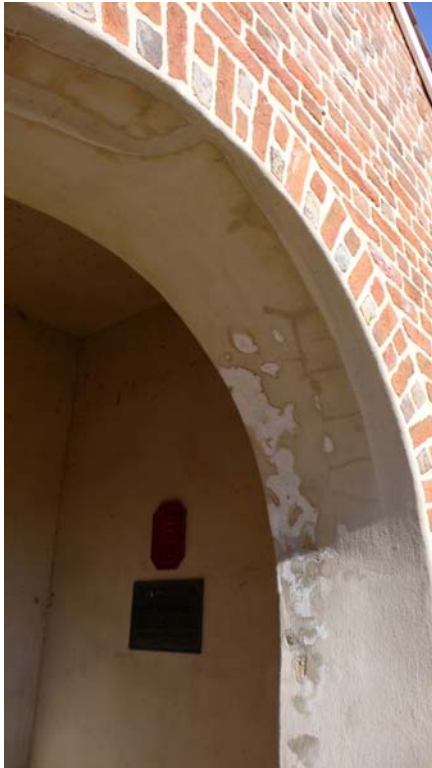
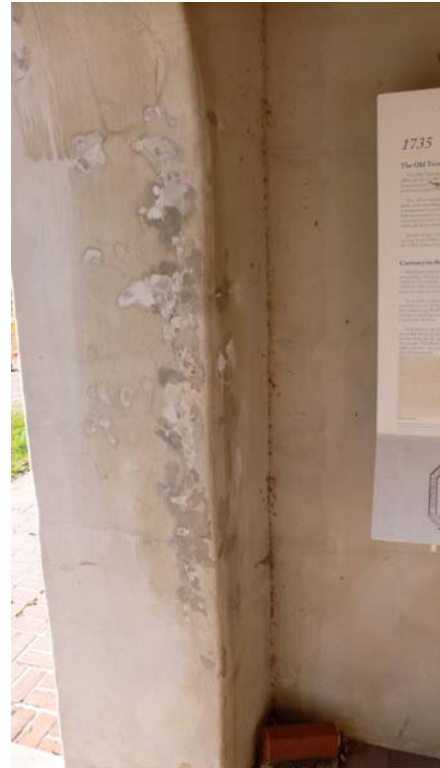
Water trapped behind portland parging can only find evaporation slowly through cracks and out through brickwork above. The salts are heavy around the cracks in this doorway parging. Although they release it slowly, the high surface tension of small cracks leads to increased water uptake during rain.

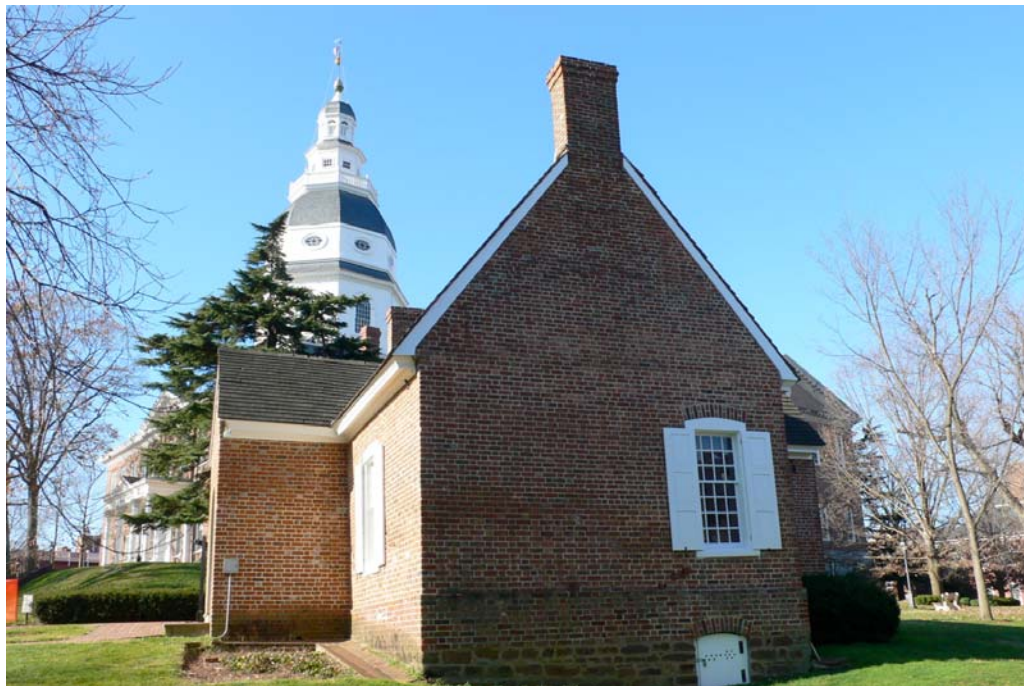
Again bands of failure and discoloration around the building indicate increasingly higher repairs followed by a steady rise in the water level as the water searches for an evaporative surface.

Very dark bands near grade indicate biological growth from a constantly wet environment.

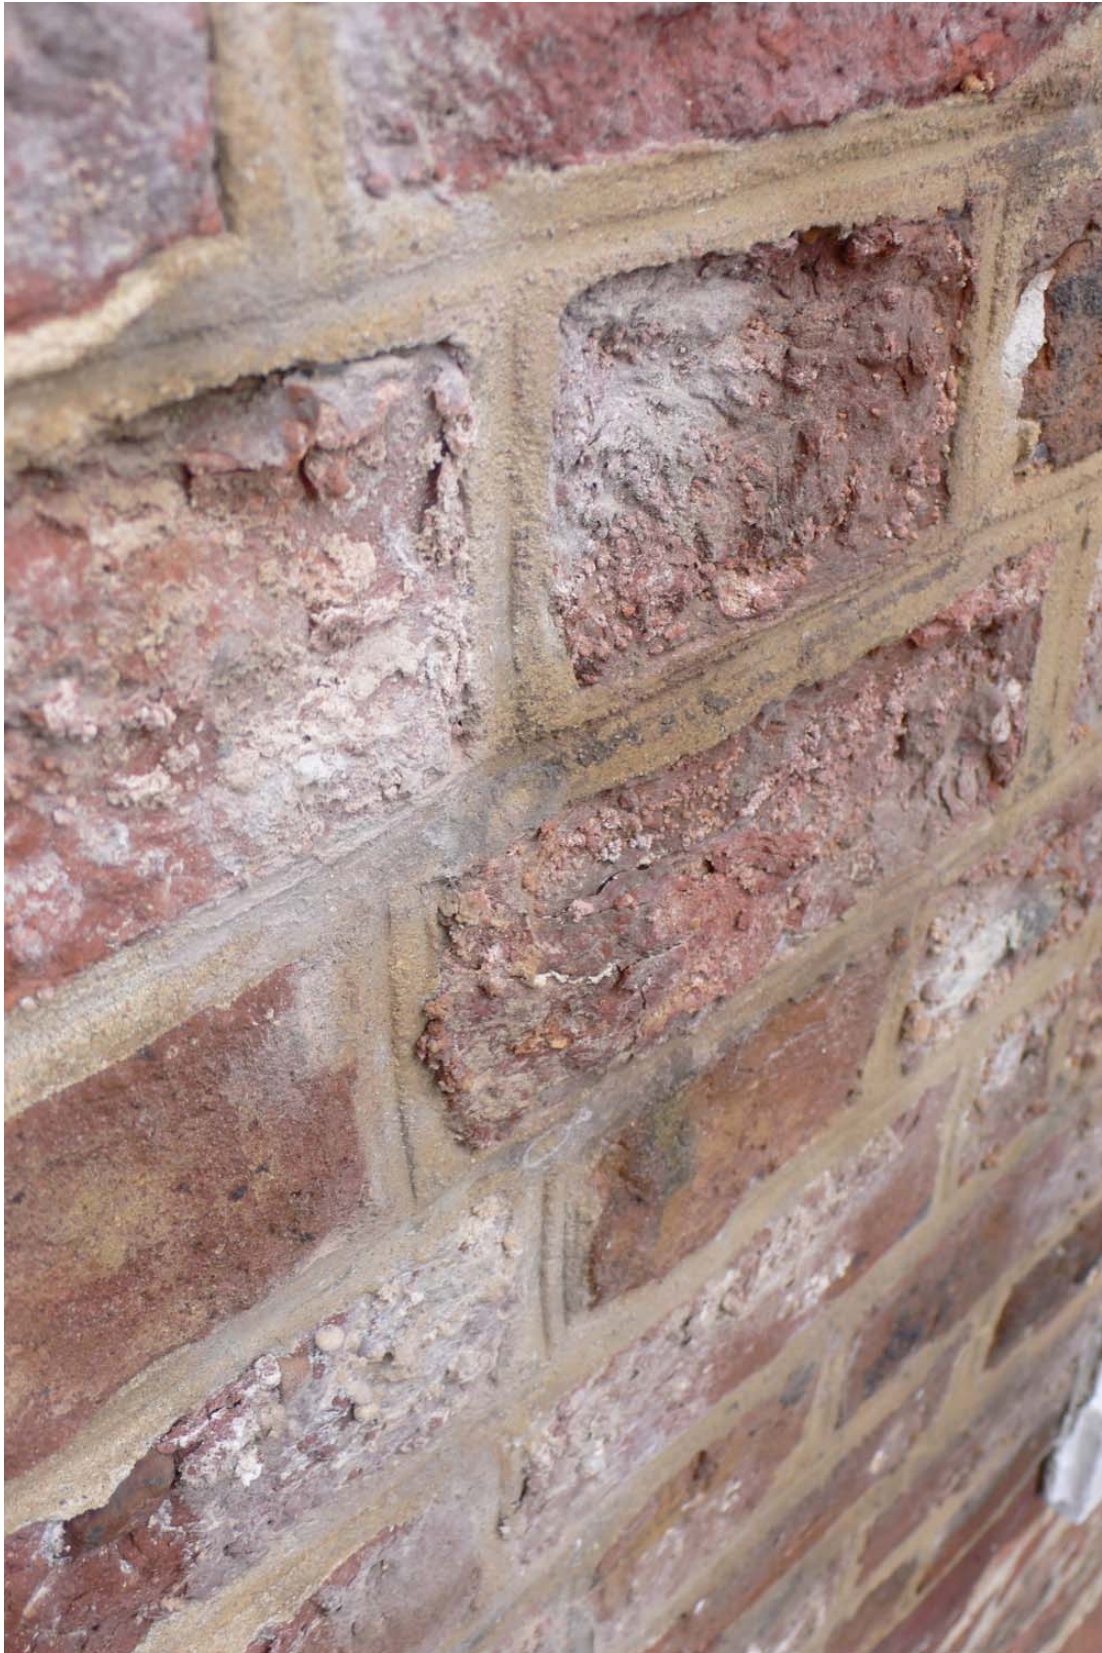
Again salt at the surface and brick faces beginning to exfoliate behind the 1950s portland pointing.

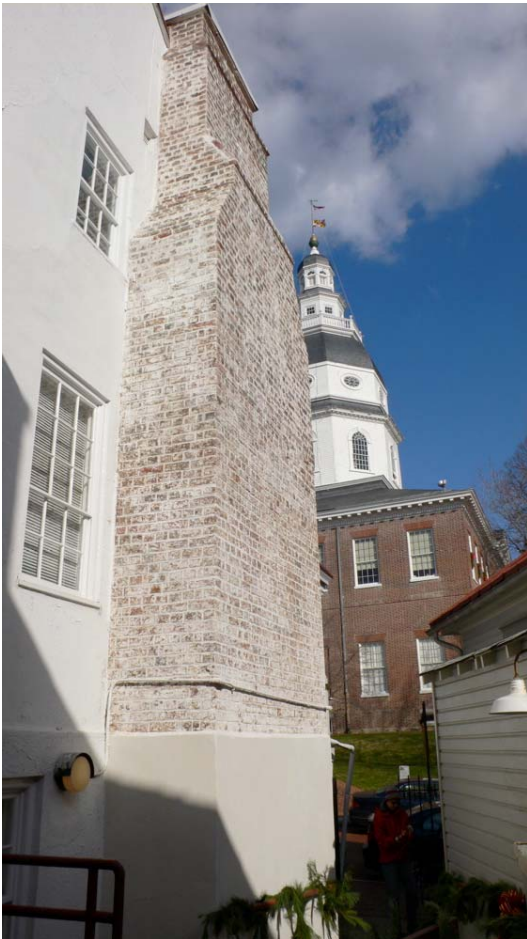
The uncovered chimney shows that a repointing campaign was carried out while the chimney was painted: the masons ground out the joints as best they could see them under paint (sometimes cutting the bricks, but generally relieving the original joints somewhere between the top of the joint and the bottom of the joint) and then pointed with a hard white portland cement. Why this was done is unclear since most of the shelly lime mortar remaining on either side of these white lines in the joint appear sound in most cases. However, it is likely that this was done as part of an aggressive, but ill-conceived attempt to control water problems lower down on the building. That repair campaign included the installation of heavy portland parging on the walls. Instead of restricting water access, this parging has led to more extensive water problems. The Shaw House is sited so that the end of the building with interior water problems (SE) is a repository for a considerable amount of water flowing from the sidewalk on State Circle. This water settles into a depression at the base of the Shaw House chimney that is bordered by the surrounding buildings. This swimming pool effect causes enough problems, but is also exacerbated by the deicing salts that flow in with the water.

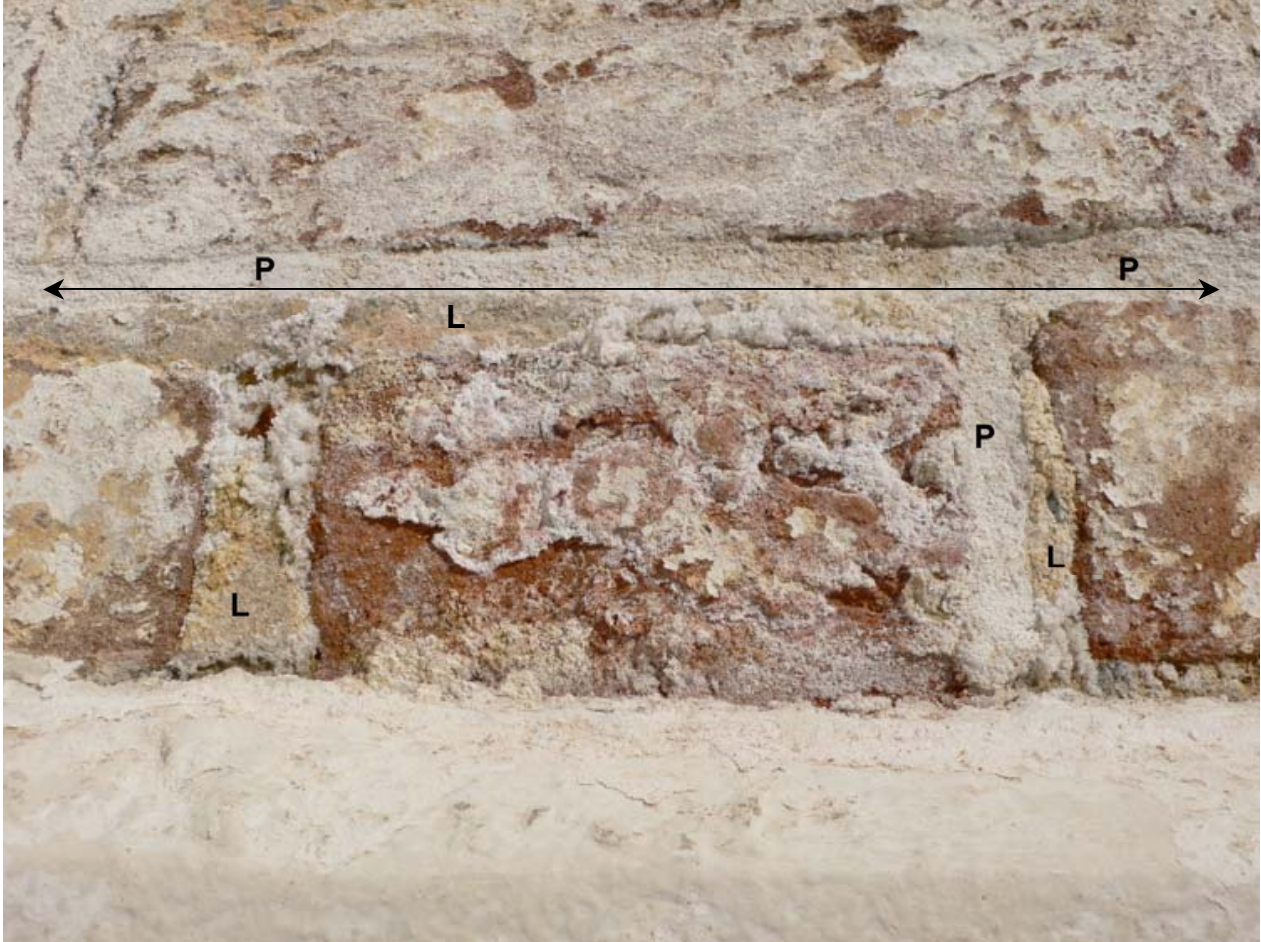
White portland mortar (P) inserted into grinder-cut joints in the original lime mortar (L) that occurred while the building was painted lead to an unusual appearance with paint now removed. Water can now begin to evaporate to the exterior for the first time in many years. In this band just above the impervious portland parging,, salt crystals are now beginning to grow out through the brick faces and the remaining porous lime mortar.

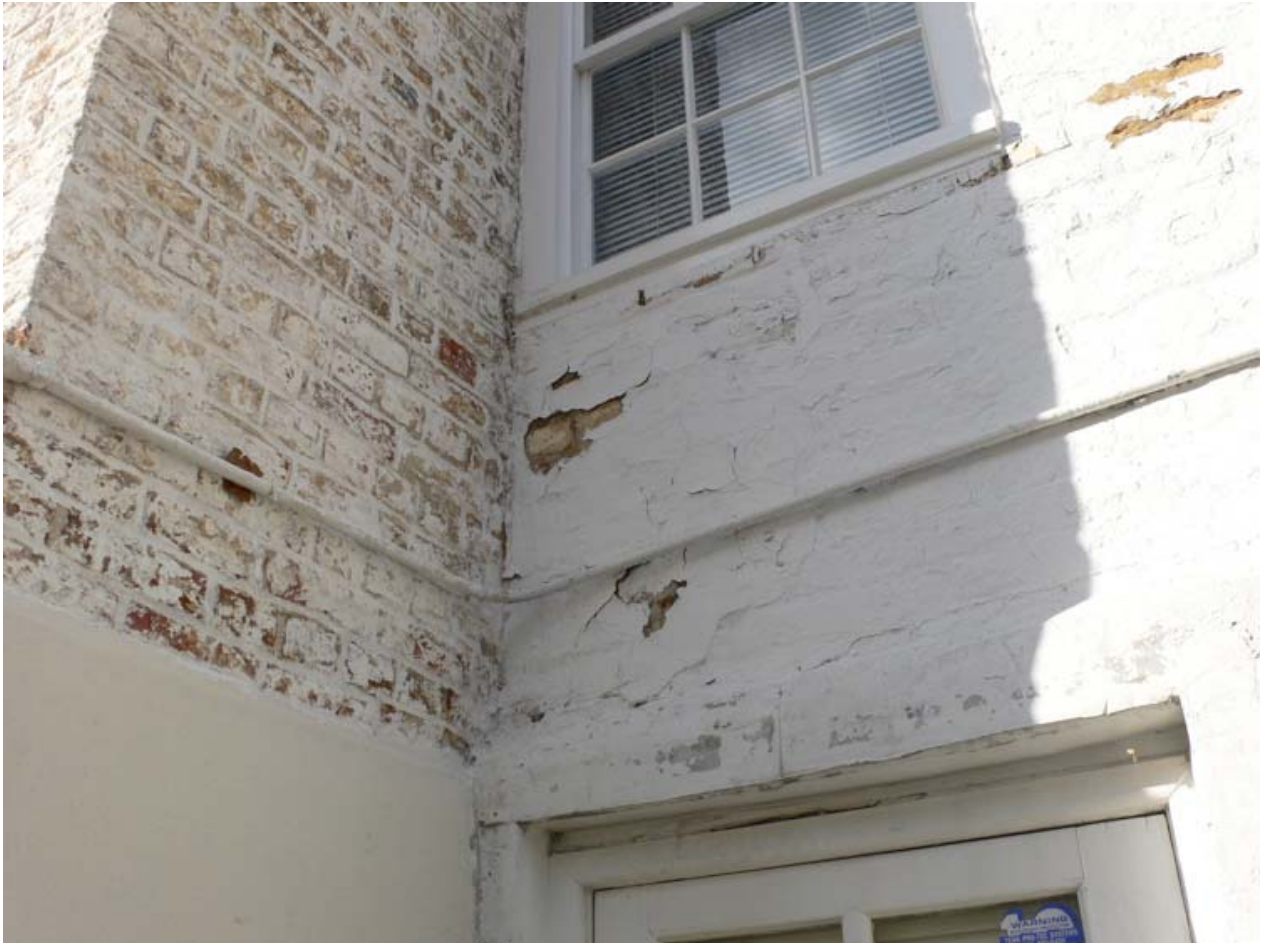
Salts have been growing even under the existing paint as can be seen by these blisters below the window. Salts damage underfired or smaller pored bricks the most. Two examples of the face damage that occurs to these bricks can be seen to the right of the windowsill.

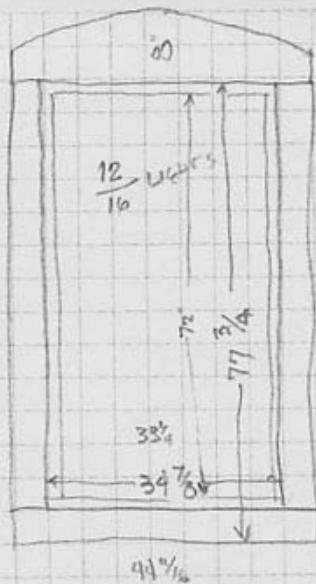
TYPE A

CHOPPED OPENING
 NOT REBUILT W/ CLOSERS
 BROKEN BRICKS @ JAMB

REPLACED SILL SASH LOOKS OLDER THAN TYPE B
 MAY BE JUST THE PROPER PRO-
 PORTIONS OF THE LIGHTS - VERIFY

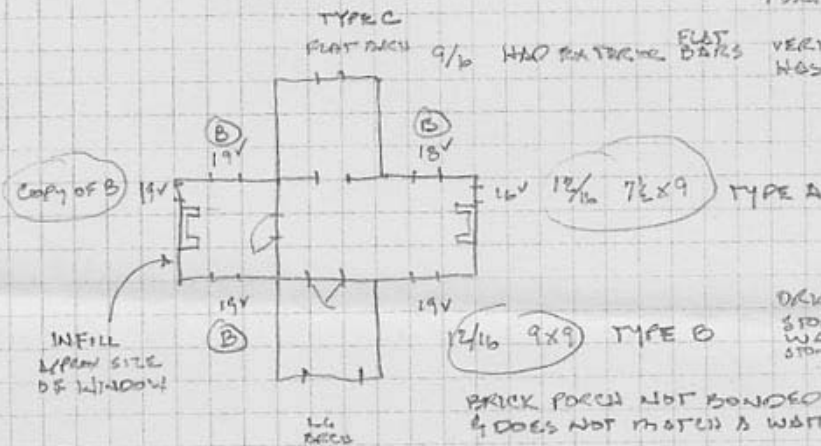
TYPE C
 FLAT ARCH 9 1/16 HAD ENTIRE FLAT BRICKS VERIFY SASH
 HAS OLD GLASS

ONLY T SPACED BLDG HAS
 STONE FOUNDATION WITH BRICK
 WATER TABLE 9 COURSES ABOVE THE
 STONE - MOST OF STONE NOW ERODED
