Interim Report on Archival and Architectural Evidence
Old Senate Chamber at the Maryland State House

09/17/2008 *(updated on 11/24/2008)*

Report by the John Greenwalt Lee Company

**Produced for Maryland Department of General Services, Alvin C. Collins, Secretary
Contract Number BA-491-070-203**

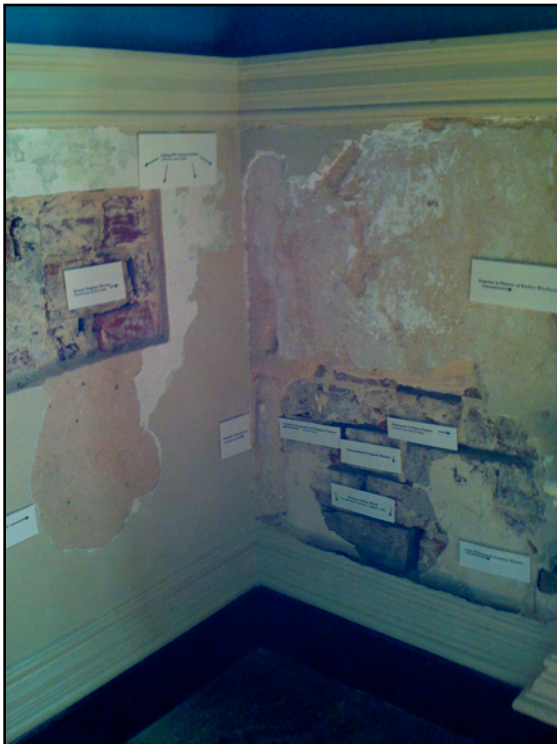
In November 2006, we were asked to look at the Old Senate Chamber to provide a second opinion on how water was getting into the room. There were many areas of peeling paint and salt erupting through the plaster with the area behind the speaker's desk in the Northeast corner showing the heaviest deterioration. Previous studies had suggested various alternate sources of the water, but within ten minutes we pinpointed condensation. Combined with incompatible modern paint coatings on the surface, water condensing on the cooler surfaces of the walls in the Old Senate Chamber was causing the deterioration of the plaster and finishes. Beneath the surface the wall was dry.

← The initial reveal in the NE corner behind the president's desk with labels.

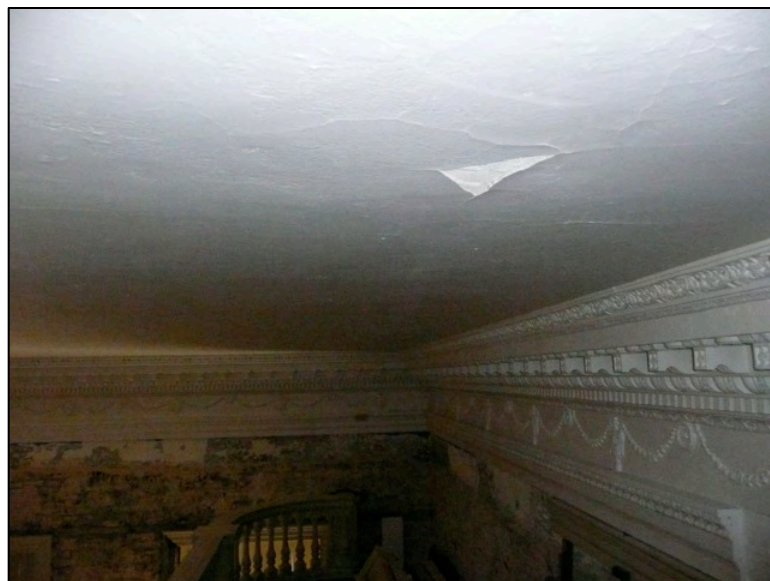
1905 ceiling plaster looks fine from the floor, however it is experiencing the same failure symptoms as the wall plaster – just not yet as pronounced. Recommend replacement as with the wall plaster as it will need to be replaced within the next decade with considerable mess and damage to lower work. Removal may assist current re-piping project

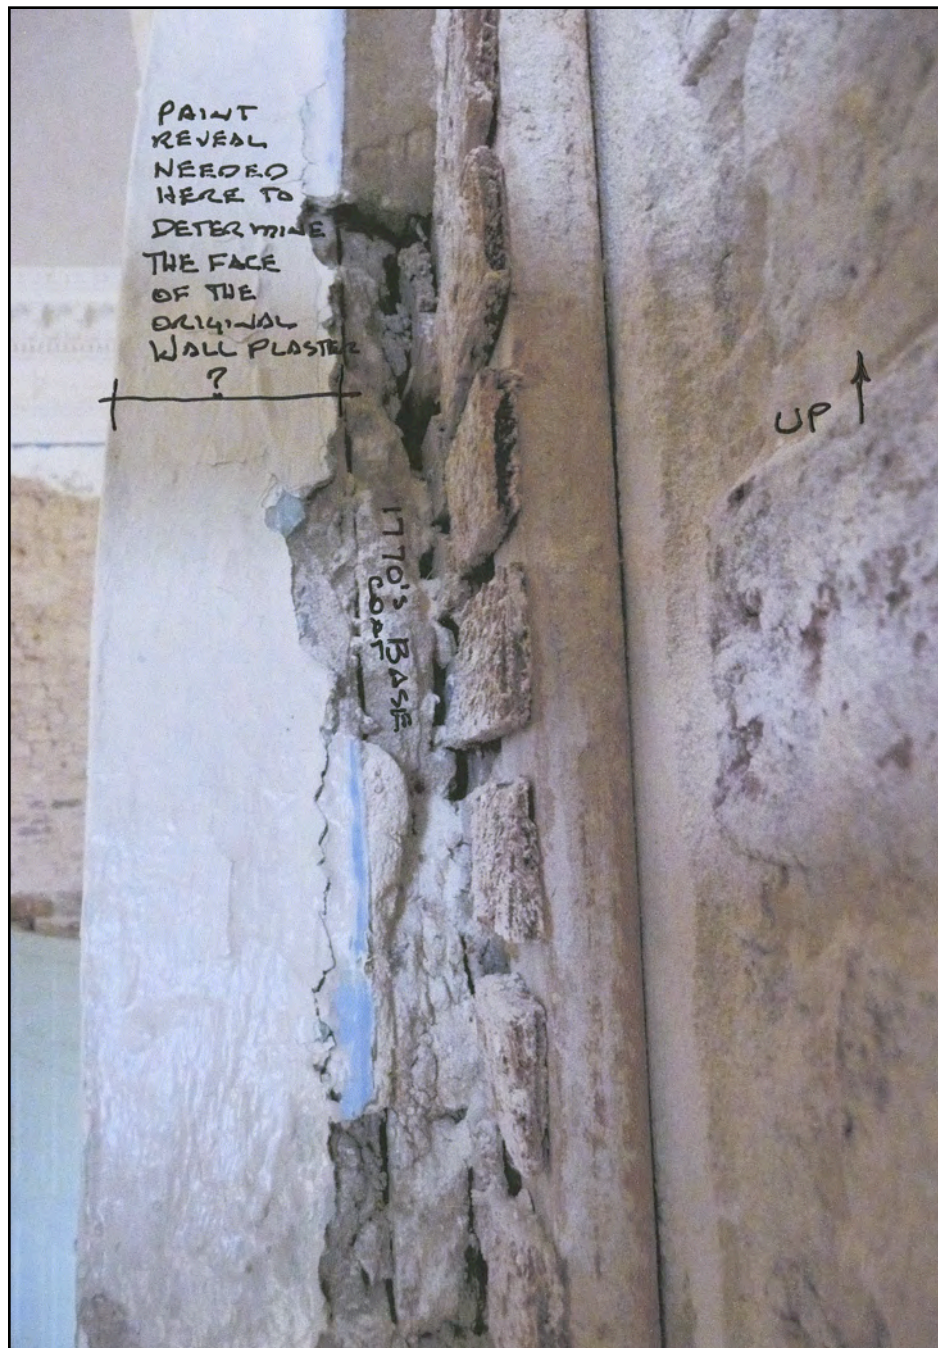
Annotation: The color chosen for painting the walls in 1905 was based on finding a color within the niche that matched Trumbull's painting. Current paint microscopy does not indicate this was the earliest color in the niche, but rather part of a later paint scheme.

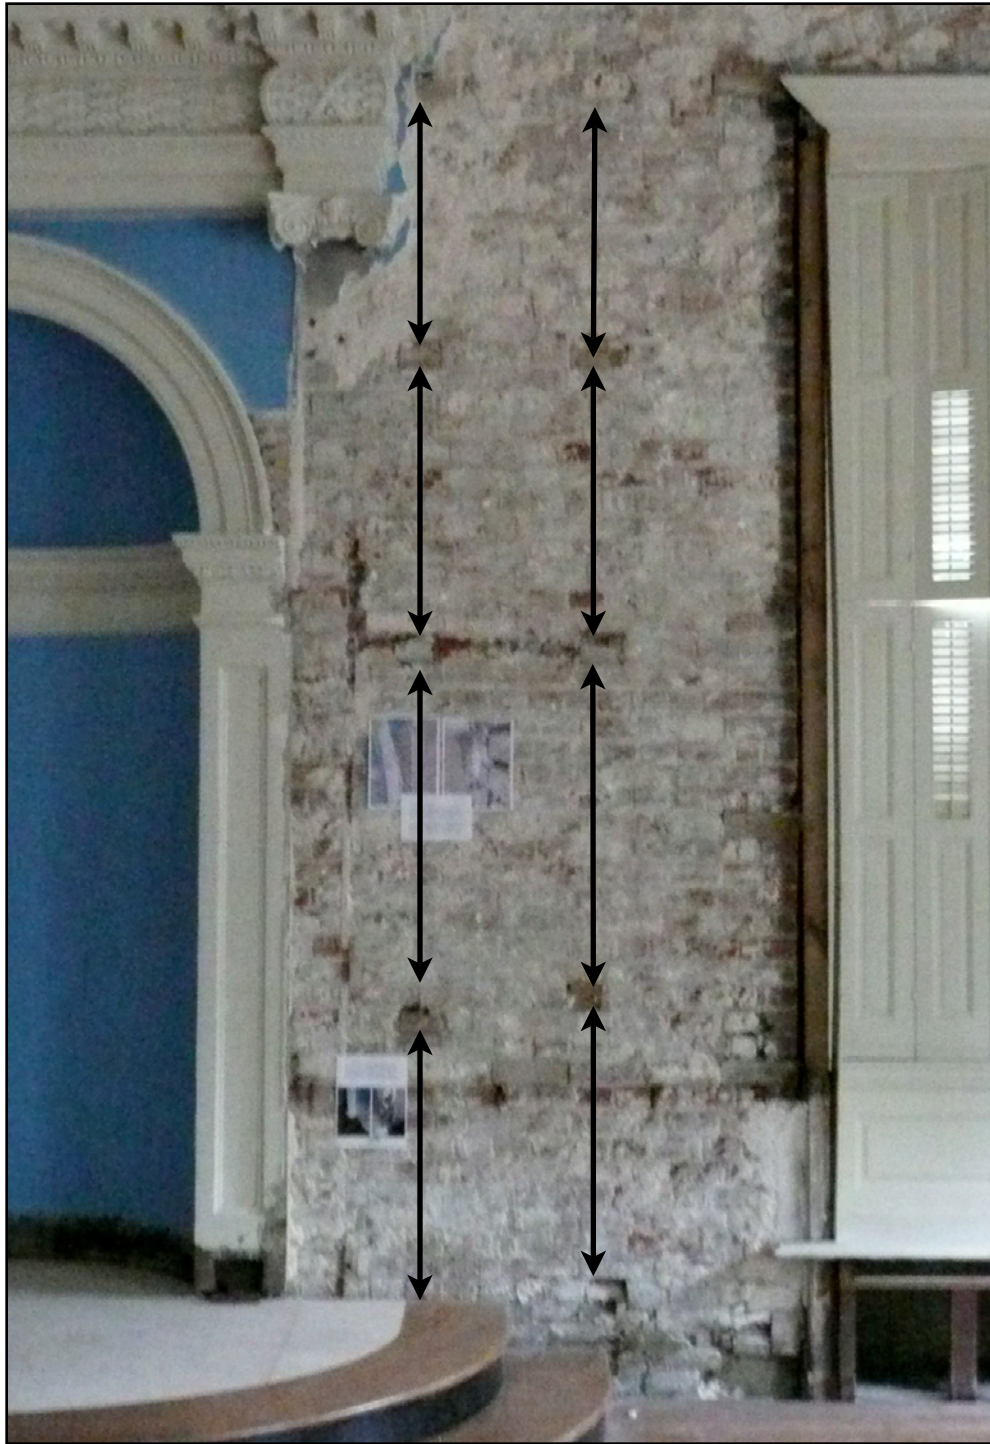
Looking up at the intersection between the 1878 plaster in the spandrel over the niche with adjacent 1905 plaster directly on the brick. This area of the niche provides good examples of each of the types and qualities of plaster used during each era of alteration. The high-quality lime plaster used in the construction of the niche remains as a guide for the type of plaster that should be replicated for any future plastering in the room.

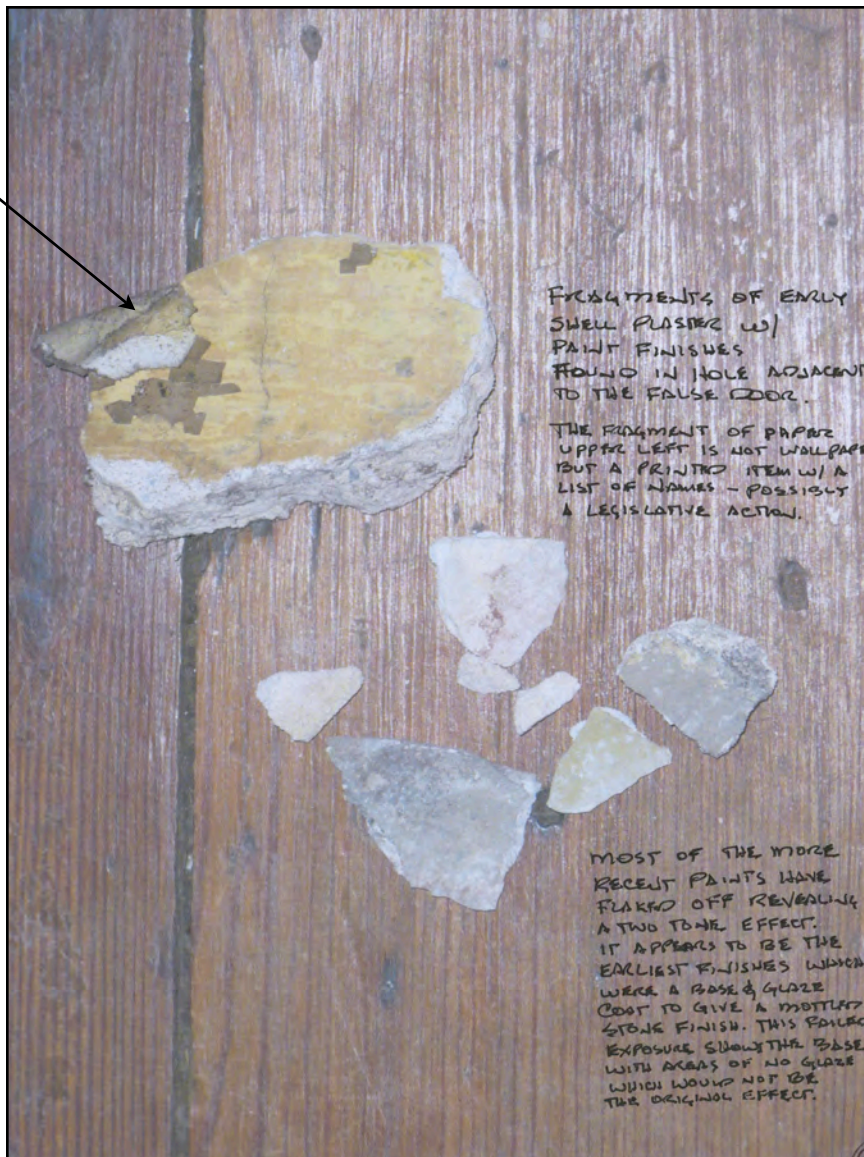
On the interior walls once the 1905 plaster was removed, numerous locations have bits of what appears to be original base coat with sizable chunks of shell flecks remaining. These obviously do not occur on the exterior furred out walls.

Fragments of early shell plaster with finishes were found in a hole at floor height to the right of the false door.

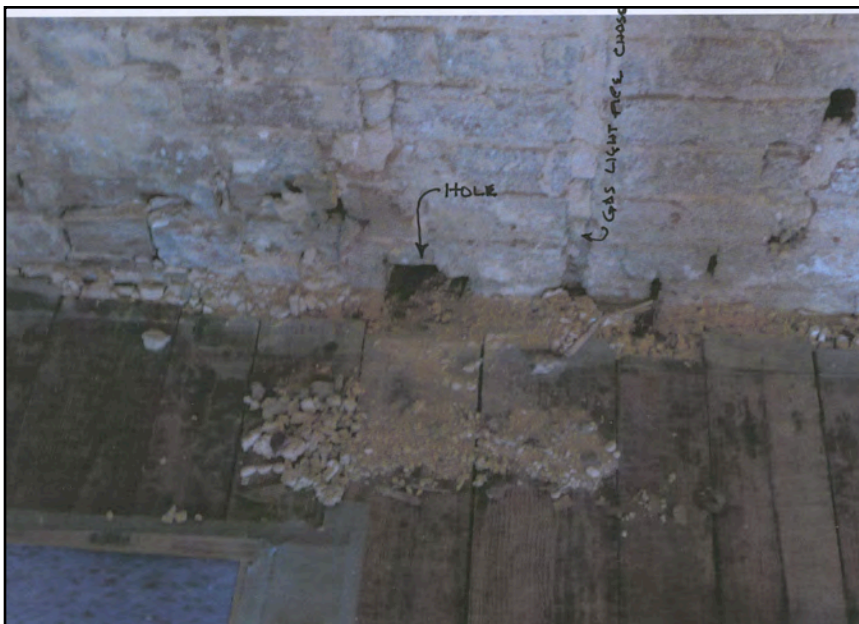
Detail of the location where 2" piece of early wall plaster was found.

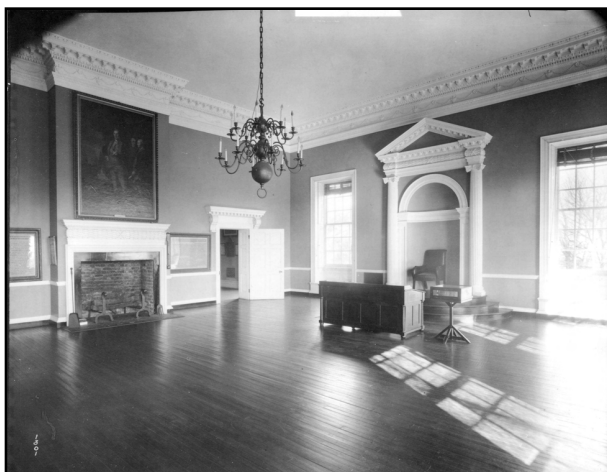
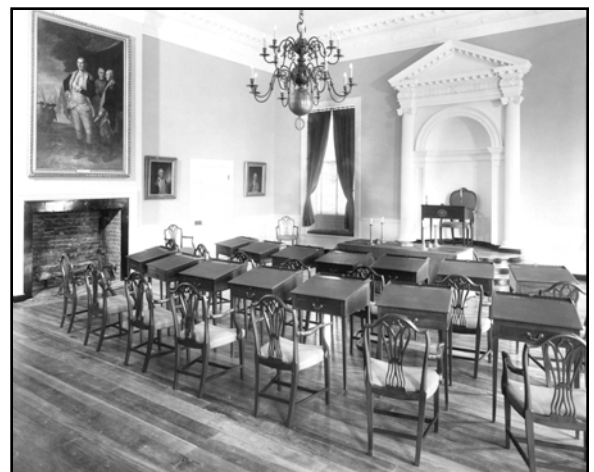
Infill plaster from the 1940s above the false door indicates removal of the 1905 overdoor. Because the design of the 1905 overdoor was not balanced by wider trim (or pilasters) below, it appeared top-heavy and so was removed in the 1940s as part of a reinterpretation of the restoration.

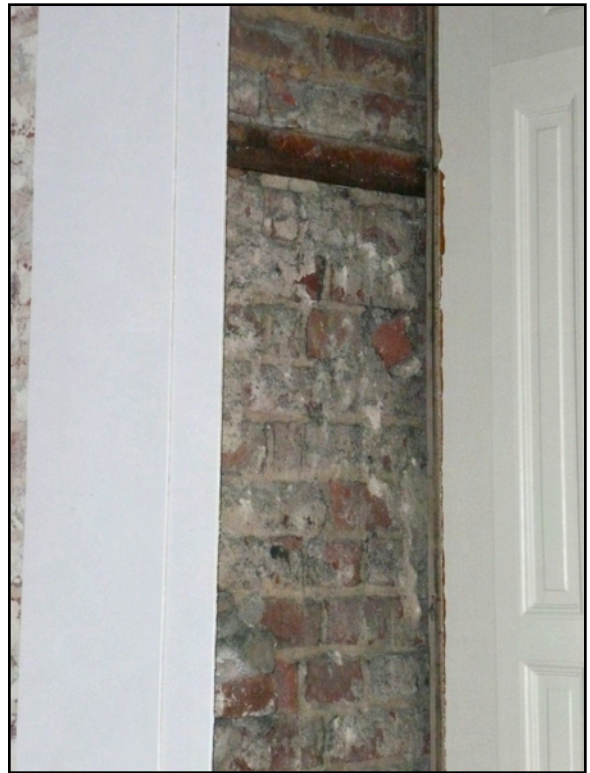
Fragments of early shell plaster remain in the lower half of the shutter pockets, but the brick above has never been plastered. No plastering would be required for wood paneled sides to the window. However the back of shutter pockets are often thinly plastered directly on the brick with the rest of the void receiving the folds of a closed shutter. One possible implication of this physical evidence is that the lower sash were covered by shutters that pocketed into the plastered recess while the upper sash were unshuttered. This may be related to the 1792 Shaw work order.

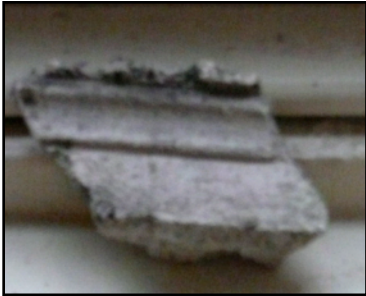
This fragment of plaster found in the space beneath the window recess closed up in 1905 where the gallery wainscot intersects the fourth window. It appears to be mortar that was dropped during plastering of the room onto a window muntin where it cured before being swept away.

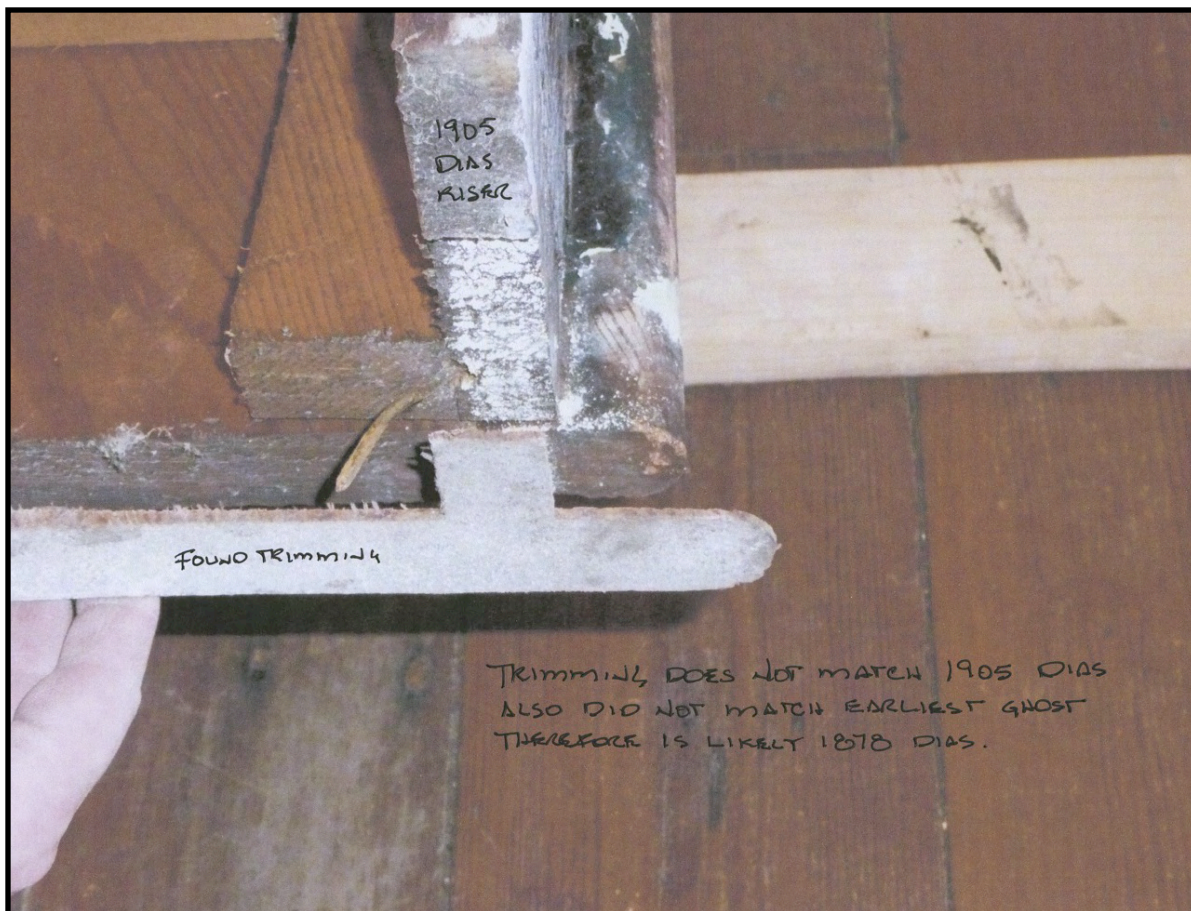
Trimming from the end of a dais tread and partial riser that was found under the existing 1905 dais when pulled out from the wall. Showing a longer nosing than the existing dais treads, it is probably from 1878.

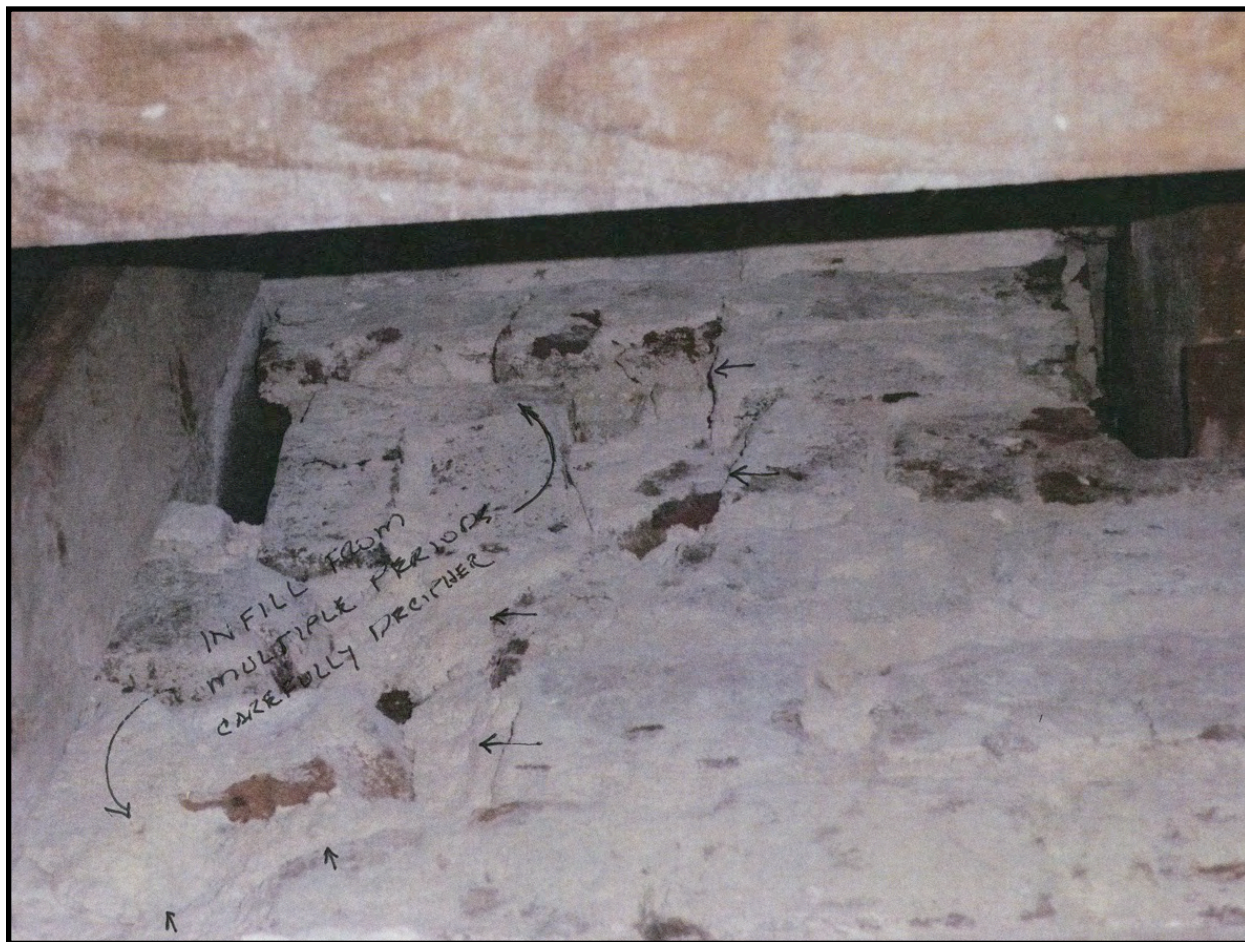
There is a patch of early masonry infill that may be related to the original door to the hall on the back wall approximately aligned with the right-hand column flanking the vestibule.

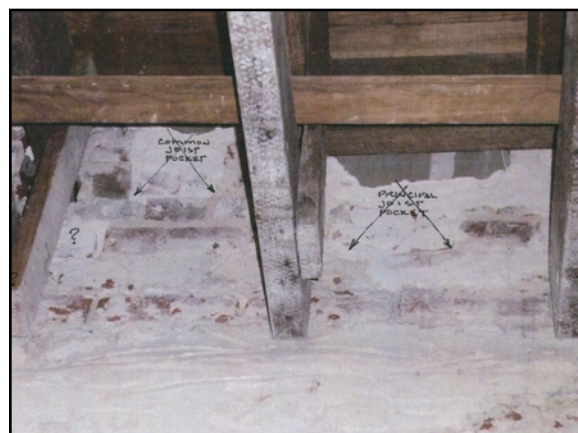
Yet unidentified alterations/patches at the far left end under the gallery at the wall intersection.
