The Wyck Architectural Conservation Project: An Overview of the Program

History

John M. Groff

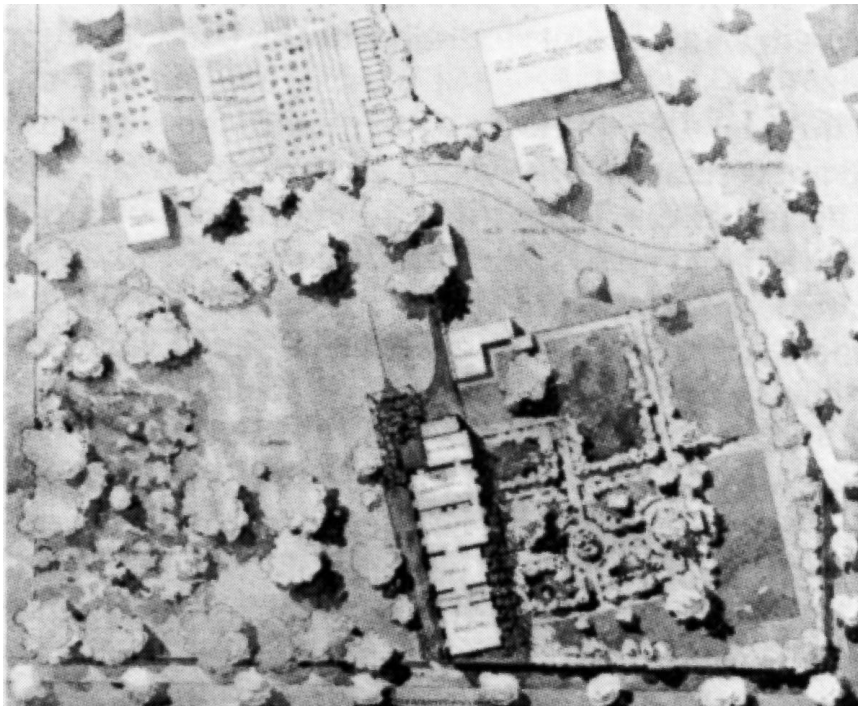
A plan for the house and gardens of Wyck, 1902, from House and Garden.

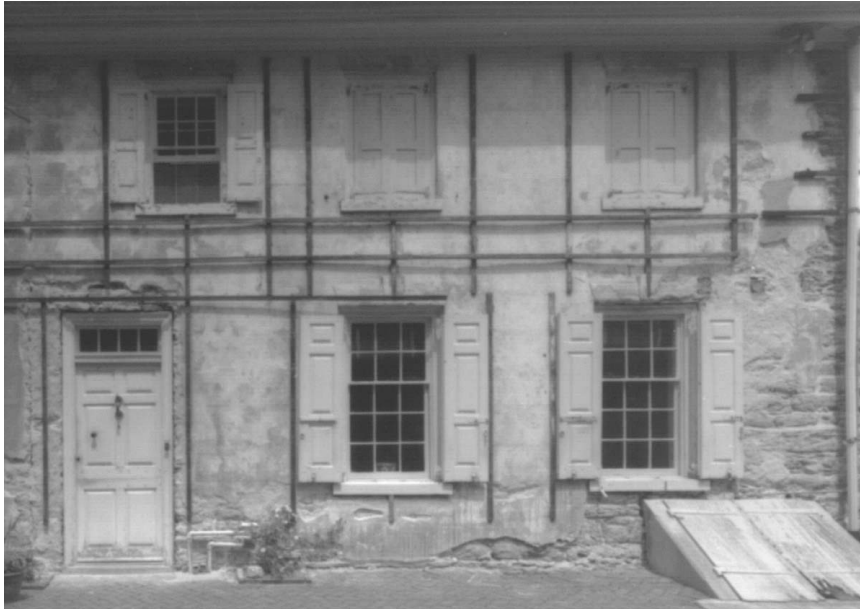
Wyck front facade after removal of cement patches.

After the introduction of Portland cement as the new panacea in the late nineteenth century, local masons began to include it in the patching mix used at Wyck. From the early 1900's right through extensive stucco repair in 1974, Portland cement in high proportions was an ingredient in the stucco repairs. During the preparation phase of the Wyck project, specifications were developed for the removal of the hard, impermeable cement patches and the mixing of replicated stucco to in-fill these areas where necessary. (For more details on stucco repair, see chapters 5 to 7.)

facades of the house after the cement patches were removed. These images can be placed side by side to create an overall view of the complete facade. Unusual discoveries in construction details or anomalies were sketched, described, photographed and analyzed by preservation architect Charles Phillips for this report and for incorporation into Wyck's Historic Structure File.
