Stabilization and Treatment of Exterior Wooden Trim— Windows and Shutters

Treatment Record

Window 105

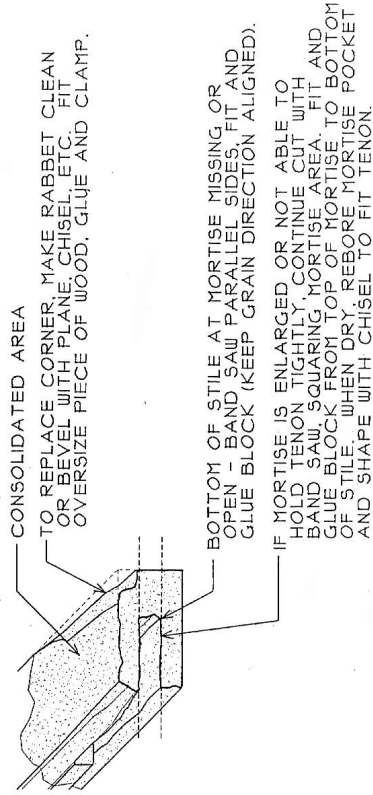
AFTER EPOXY RESIN CONSOLIDANT CURES

THERE SHOULD BE ENOUGH RESIN TO COVER AT LEAST 1/2 TO 2/3 OF THE ROTTED AREA. ALLOW THE RESIN TO SATURATE THE ROTTEN WOOD AND CLIMB UPWARDS UNTIL THE ENTIRE DAMAGED AREA IS LOADED WITH RESIN. FOR SOME PIECES OF WOOD IT MAY BE NECESSARY TO DRILL A STAGGERED SERIES OF HOLES ACROSS THE GRAIN (MORE ABOUT THIS IN THE NEXT SECTION).

WHEN FULLY SATURATED, REMOVE, WIPE OFF EXCESS RESIN, AND ALLOW TO DRY.
