PRELIMINARY ASSESSMENTS: Masonry, Plaster and Finishes Failure

Report of the John Greenwalt Lee Company
Produced for Maryland Department of General Services

PRELIMINARY MASONRY and FINISHES FAILURE ASSESSMENTS: Old Senate Chamber, Old Treasury Building & Shaw House

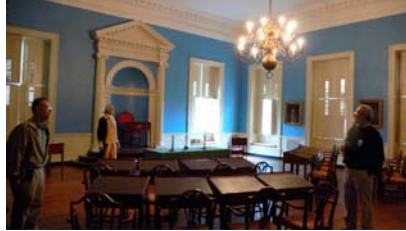
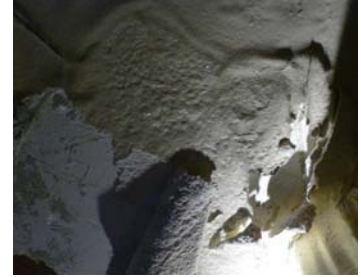
Old Senate Chamber

Inadequate humidification & temperature control

Water-soluble paints at plaster surface water-soluble patching compounds mobilized by humidity

Recent latex paint traps water and weakens adhesion of earlier paints

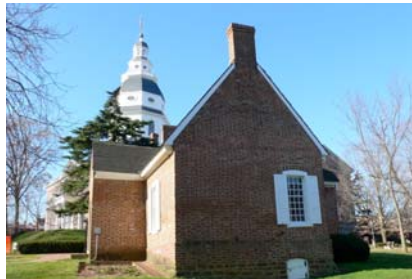
Old Treasury Building

Inappropriate portland repointing

Early lime mortars saturated and failing behind portland; bricks unsupported

Bricks sitting in wet soil; deleterious deicing salts drawn up into masonry

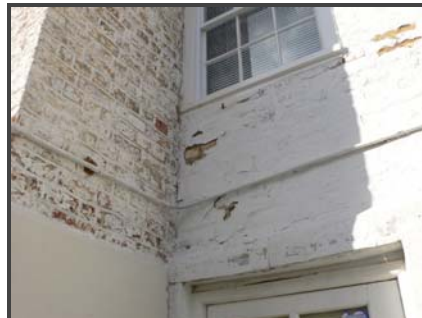
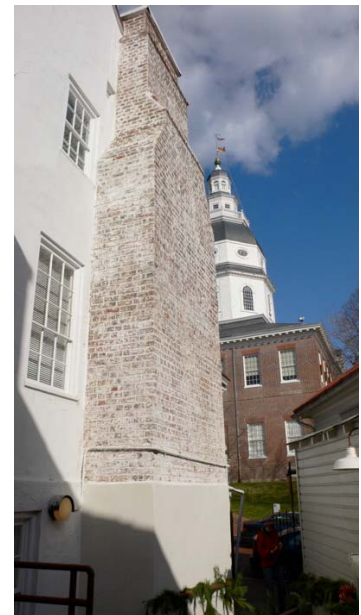
Shaw House

Exterior paints are trapping water

Portland cement parging of chimney and wall base trap water in bricks

Cement slab against base of chimney and over to adjoining building, along with slope of ground from State Circle This leads to water ponding and infiltration against East wall

Water entering the East wall moves in and up in search of an evaporative surface, leading to paint and plaster failure inside; paint blisters outside

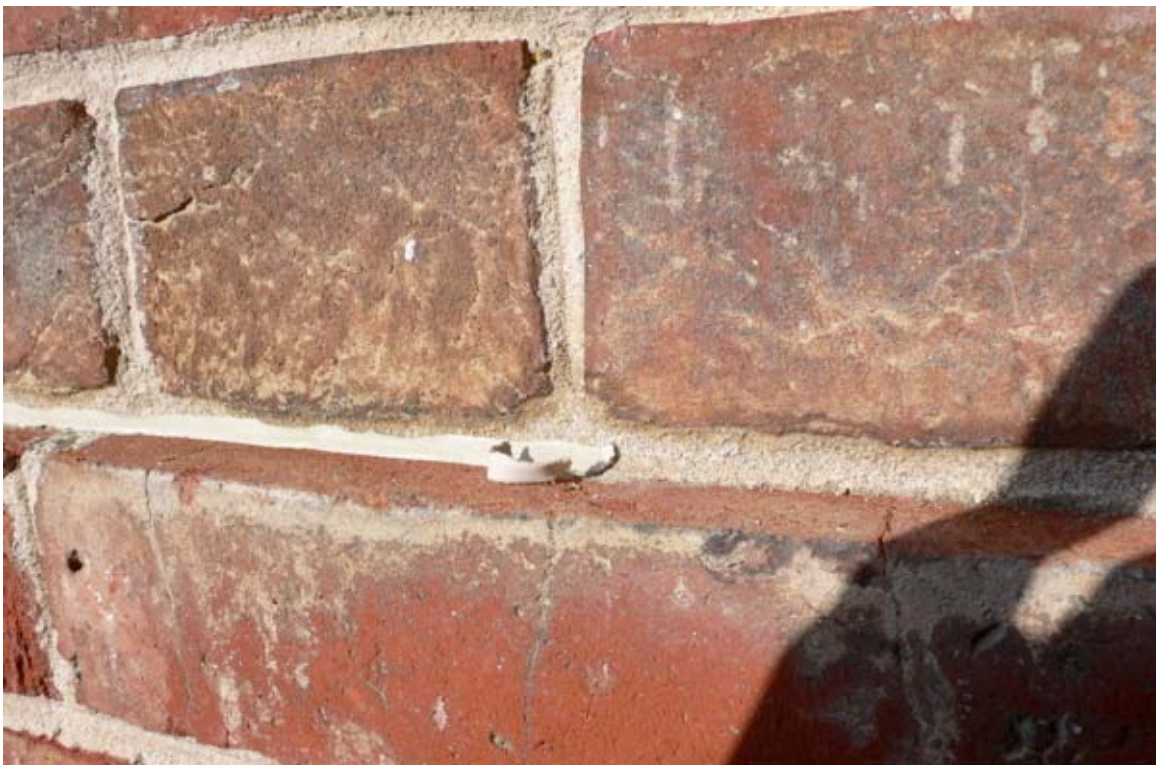
This is the belt course. The portland pointing that had been there is missing in areas. The lime mortar that is revealed is not in great shape, but is also not leaking liquid water directly into the building. Directly to the left of this photograph is where the caulking had been applied. The caulking needs to be removed. If anything, it is trapping water in the wall. There is no place for any caulking in mortar joints on historic brickwork.

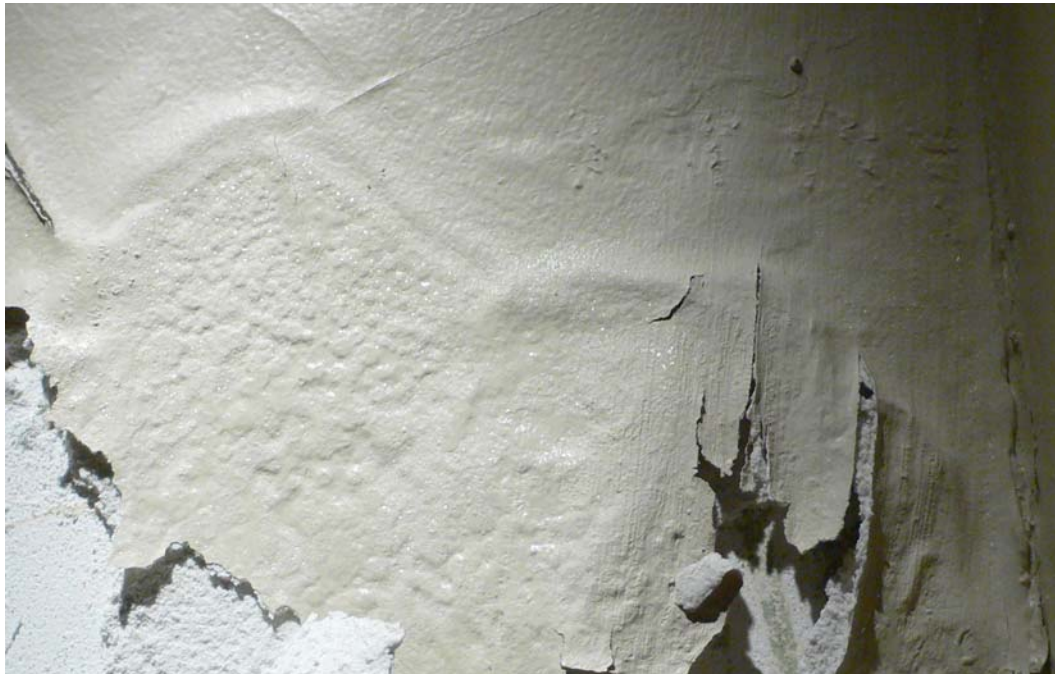
Liquid water condensed on the surface of the plaster in the corner of the Old Senate Chamber and running down the wall.

Water condenses from warm air meeting cold surfaces. When occupancy in the building is at its highest – when the legislature is in session – and condensation would be most prevalent, the NE exposure of this room also ensures the masonry receives very little warming from the sun due to its low winter apex and because the mature trees against the building shaded this corner.

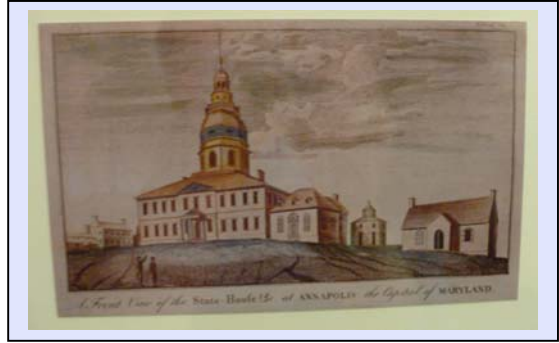
Although originally designed with stone foundations and ten courses of brick before the watertable, indicating the builders understood that brick in contact with soil should be avoided, the grade around the building has risen so that in many areas the belt course is partially below ground. Even late 18th century engravings show the grade much higher, so it may be that returning to exposed stone foundations is historically inappropriate, but a method of drying the lower walls needs to be introduced.

The extensive brick and mortar deterioration on the Treasury suggests both salt and water are being wicked up ever higher. Every attempt to stop the water from the outside using portland pointing has forced the water to the inside and higher up on the exterior.

Along with grading and drainage issues, the portland pointing must be removed and replaced with historically appropriate and materially compatible shelly lime mortar. All portland parings on the exterior and interior need to be removed. Depending on the condition of the brickwork below, the bricks can either be left as they are, or if too heavily damaged, a lime paring can replace the portland, thereby allowing evaporation. Poultices can be used to remove salts introduced both from later materials, deicing salts and possibly fertilization, but salting of the ground around the building during the winter months must be stopped promptly.

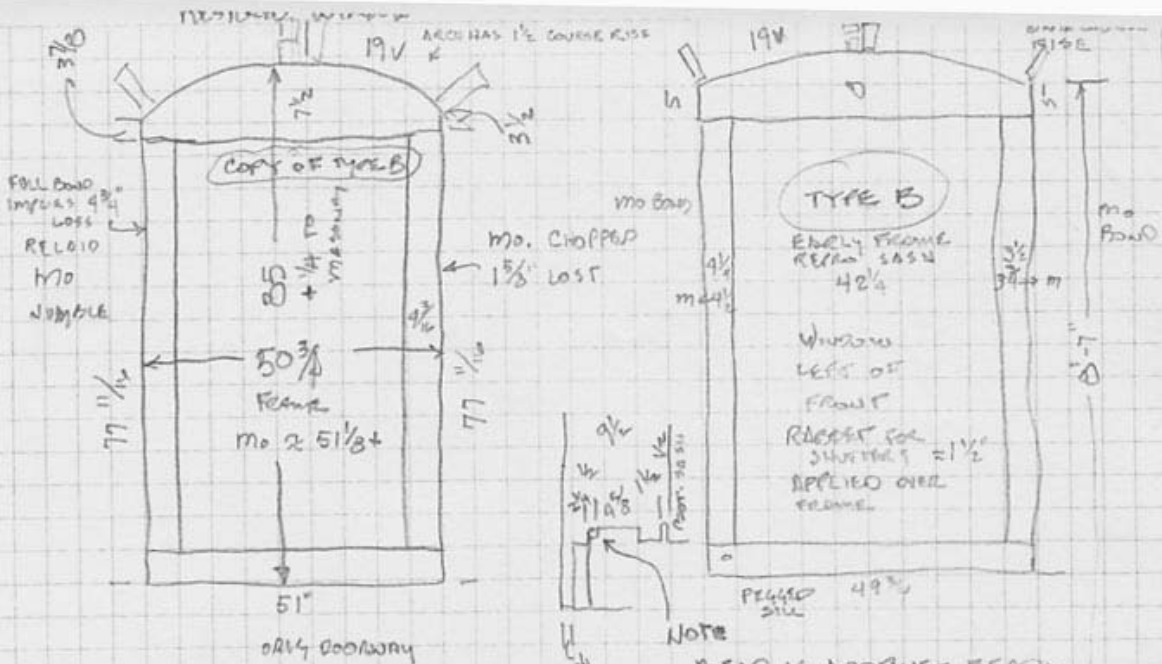
NOTE
 BEAD IS A CORNER BEAD
 IE. FURTHER IMPLIES
 ADDED SHUTTERS
 ADD SHUTTER JAMB
 TO OCCUPY RABBIT

JAMES
 BEADED IN STUCCO

EARLY
 ORIG. DOOR

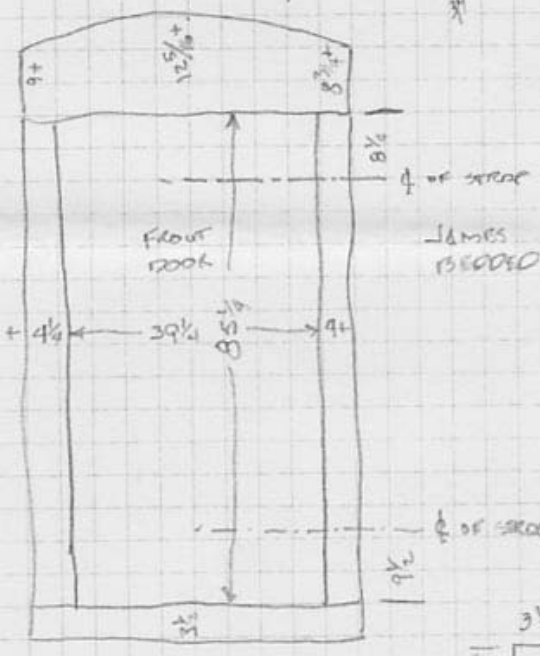
NO BEAD ON JAMBS
 REFR. FRAME
