Interim Report on Archival and Architectural Evidence
Old Senate Chamber at the Maryland State House

09/17/2008 *(updated on 11/24/2008)*

Report by the John Greenwalt Lee Company

**Produced for Maryland Department of General Services, Alvin C. Collins, Secretary
Contract Number BA-491-070-203**

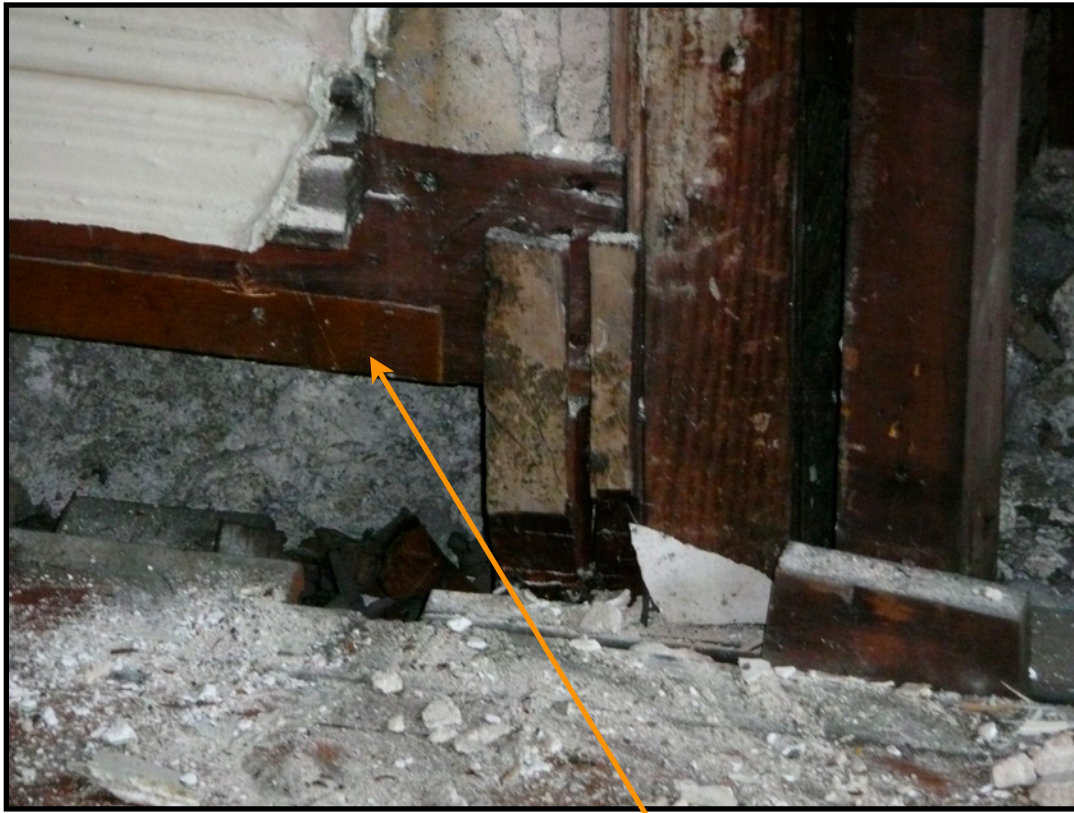
Reused board with 1878 maple graining

Annotation: Grounds for the 1905 baseboard just to the right of the dais included a reused piece of the 1878 trim, thus providing an example of the light wood with two-toned graining used throughout the building in 1878.

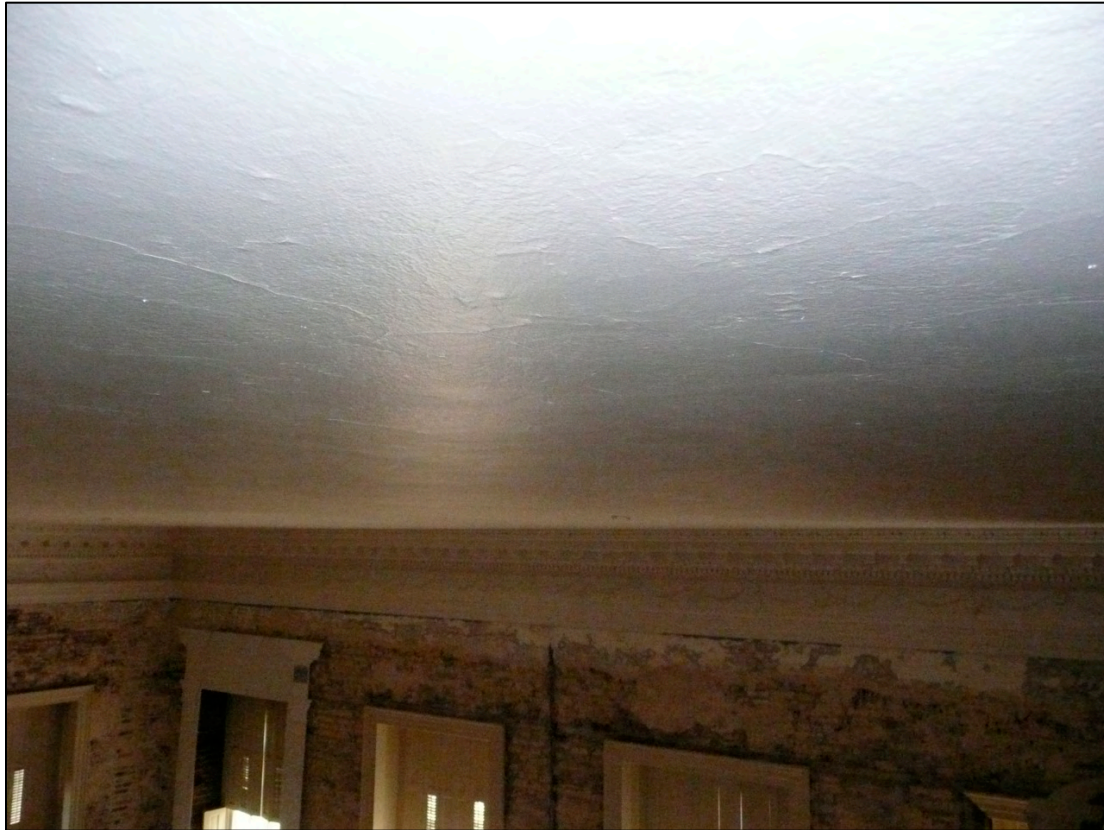
1905 ceiling plaster looks fine from the floor, however it is experiencing the same failure symptoms as the wall plaster – just not yet as pronounced. Recommend replacement as with the wall plaster as it will need to be replaced within the next decade with considerable mess and damage to lower work. Removal may assist current re-piping project

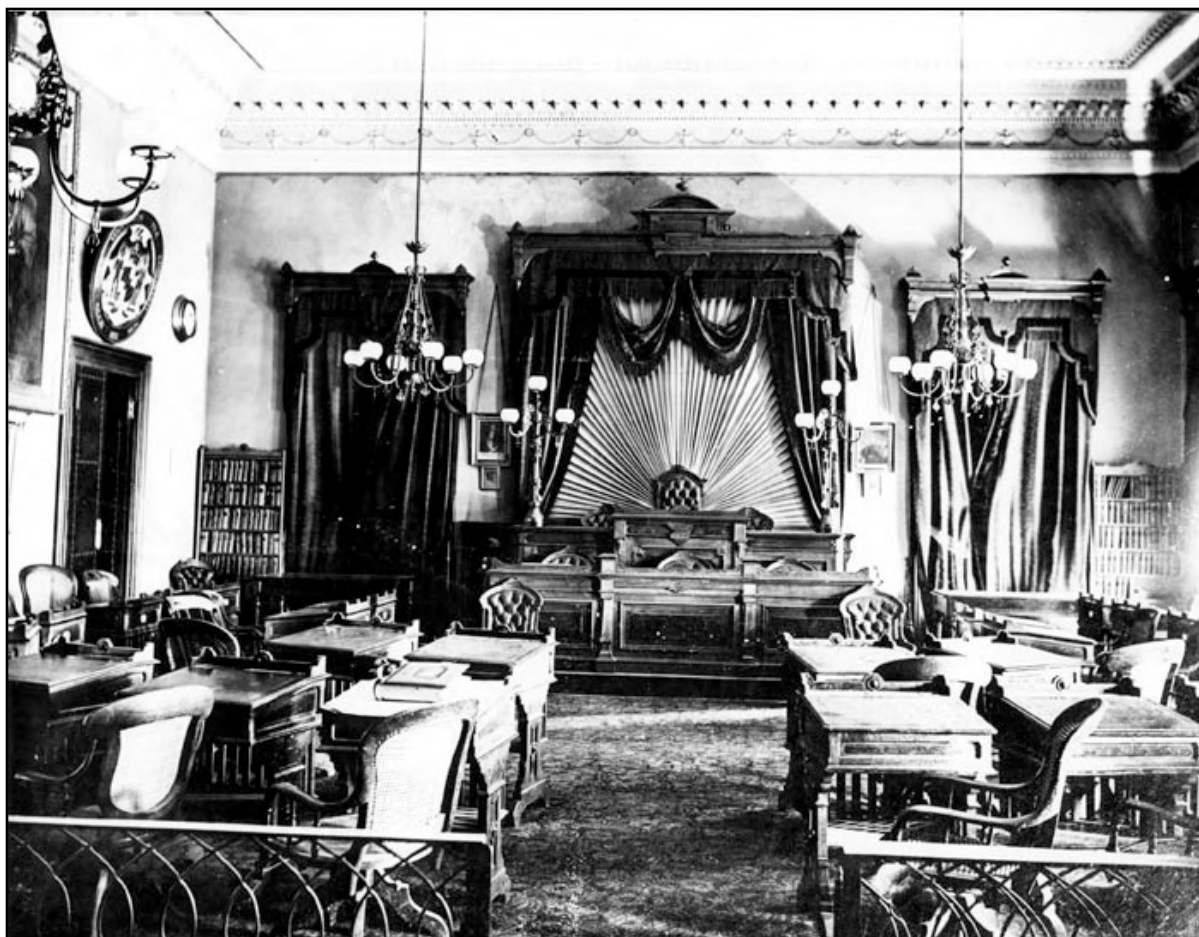
This is the cornice as recreated in 1878.

None of the individual parts match the photograph from 1868 that shows the previous cornice, although they are generically similar. There is an additional step in the plaster between the cornice and the field of the ceiling. This transition is decorated with a cast decorative band. As a quick reference, look at urns and the position and shape of the swag.

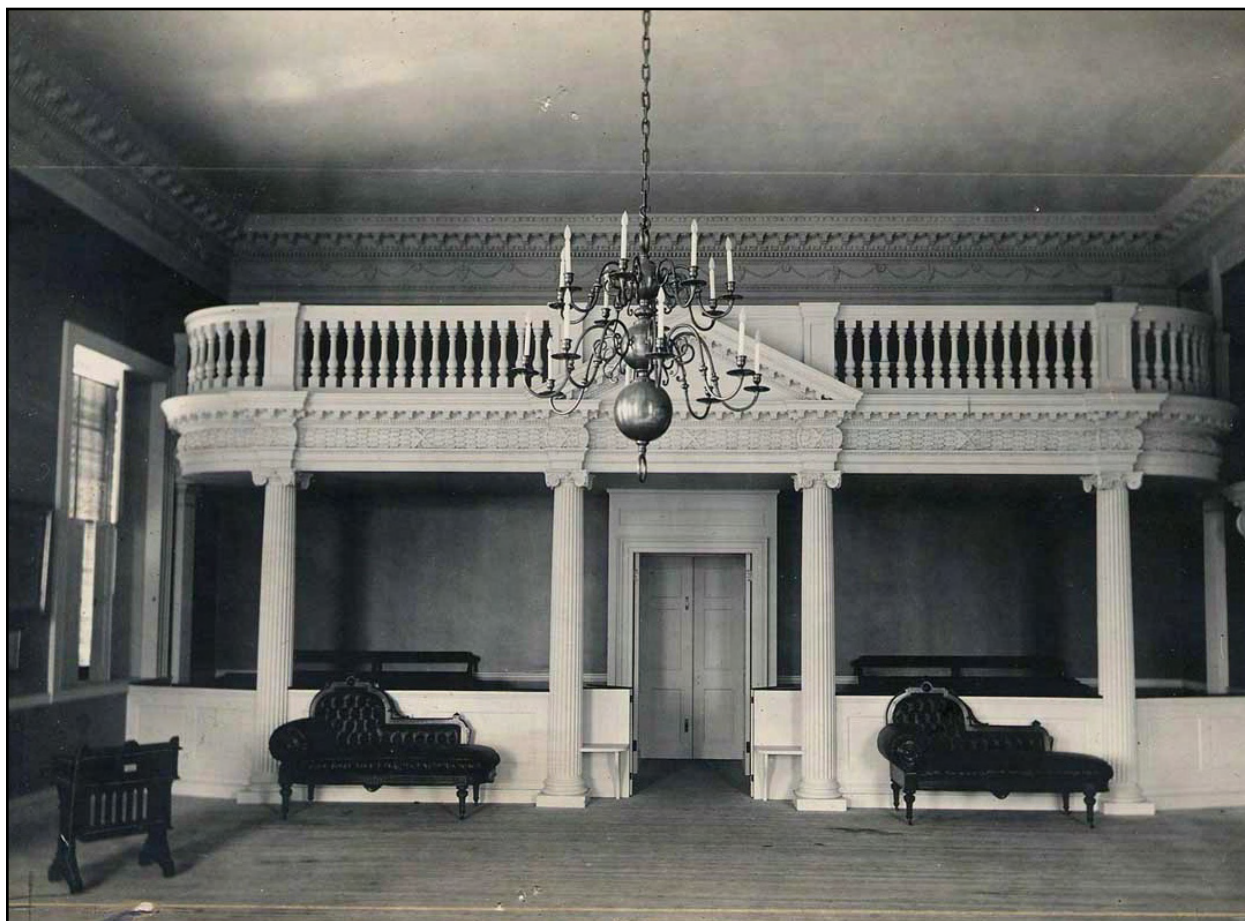
None of the obvious details match from 1826 to 1878 to 1905 despite each architect making claims of exact dimensions and castings from the previous.

J.A. Wilson notes that the 1905 ceiling is about 3" lower than the 1878. This was verified in 2008 by removing the bottom band (architrave) of the cornice and finding 1878 wall plaster running 3-1/2" up behind it.

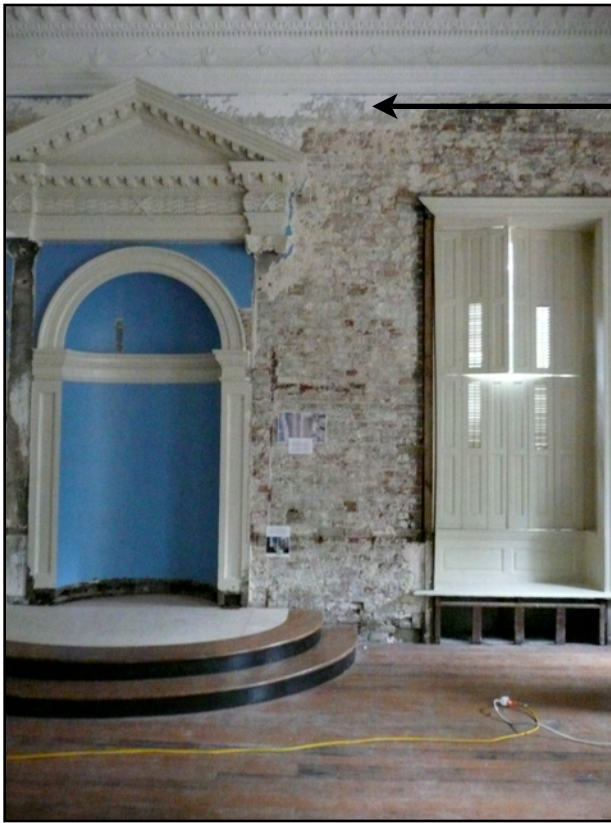
With 1905 blue wall plaster removed, note the 1878 wall plaster with intact finishes extends below and behind the 1905. The 1878 plaster is intact on the walls behind the current cornice and down about 3-1/2" onto the wall below.

According to J. Appleton Wilson, the ceiling was lowered by 3" in 1905. Why was an approximately two foot band of 1878 plaster retained around the room before re-plastering in 1905?

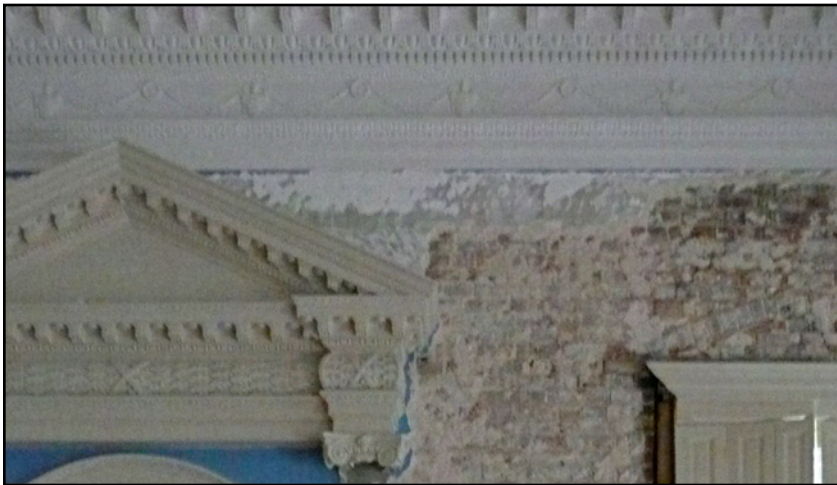
1905 rendition Nothing is centered over the niche, but a rosette is nearest. Urns are sharply conical, sitting on a narrow base. Large rosettes hover higher than urn tops, leading to an asymmetrical drape of the swags. Swags do not touch bottom of band.

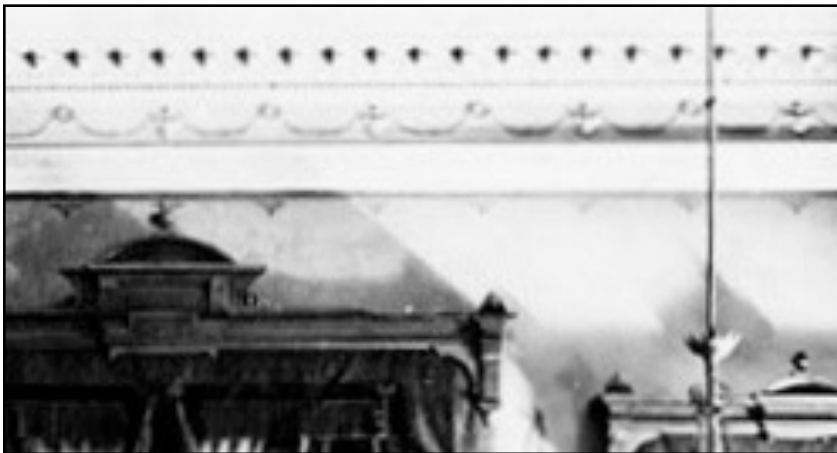
1878 cornice: An urn is centered over the niche, swags are considerably more flattened, nearly resting on the bottom of the band and rising higher on urn with a wider spacing between elements.

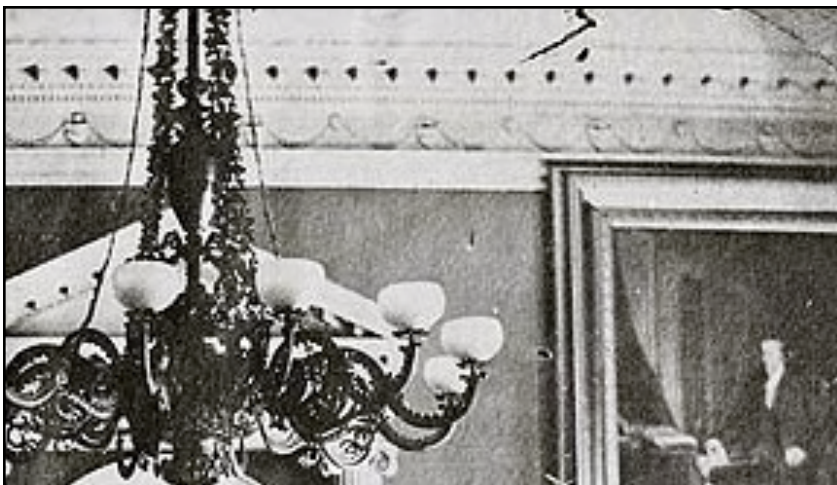
1868 view: Urns are much stouter and very rounded swags touch the bottom of band before rising to mid-point on urns.

Annotation: Details are not consistent from one era of cornice reconstruction to the next.

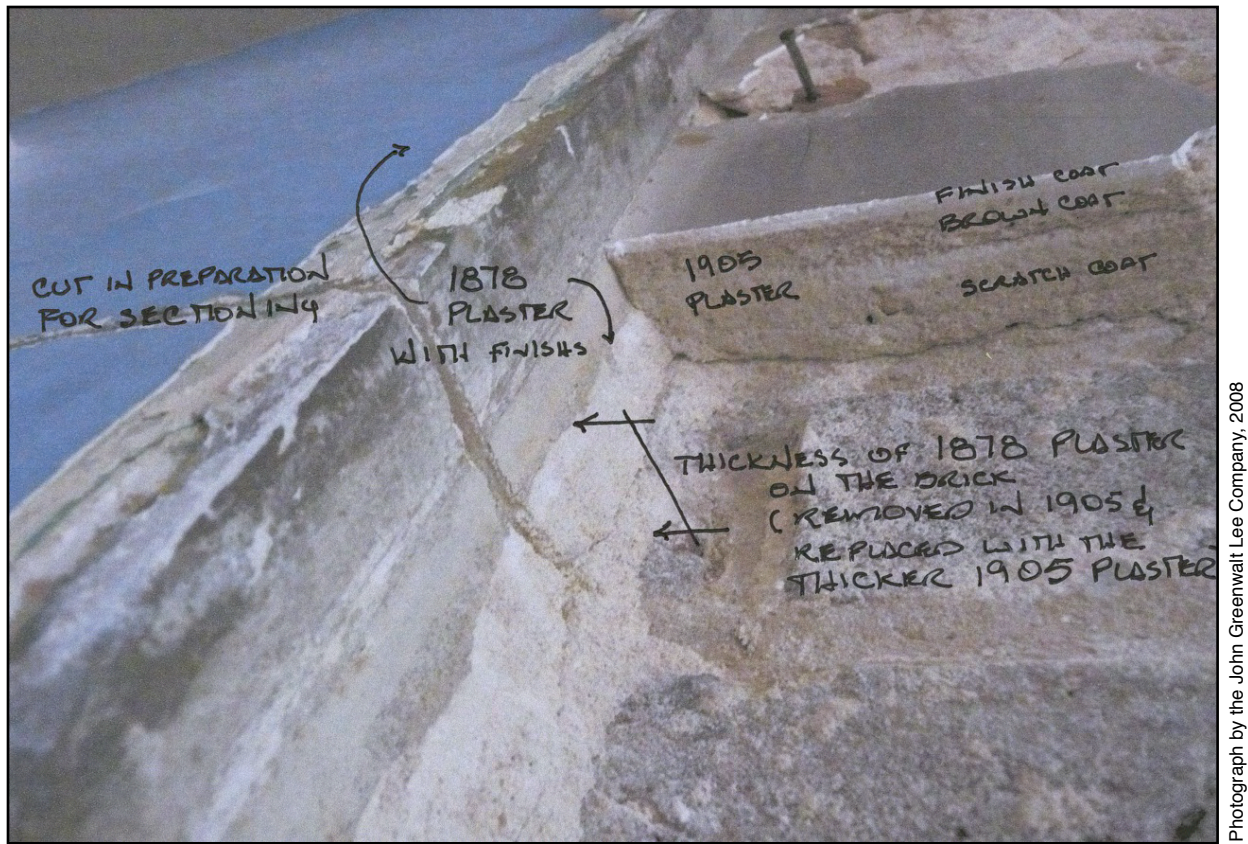
The right edge of the niche revealed in section showing the original construction with the lath running behind wooden pilasters.

The right edge of the niche with 1878 plaster sectioned and partially removed up to the original 1770's plaster of the arched architrave.

Looking up at the intersection between the 1878 plaster in the spandrel over the niche with adjacent 1905 plaster directly on the brick. This area of the niche provides good examples of each of the types and qualities of plaster used during each era of alteration. The high-quality lime plaster used in the construction of the niche remains as a guide for the type of plaster that should be replicated for any future plastering in the room.

Careful removal of the paint on the edge of the woodwork here may provide additional information about the original thickness of the plaster adjoining the niche and the paint treatment on the woodwork.

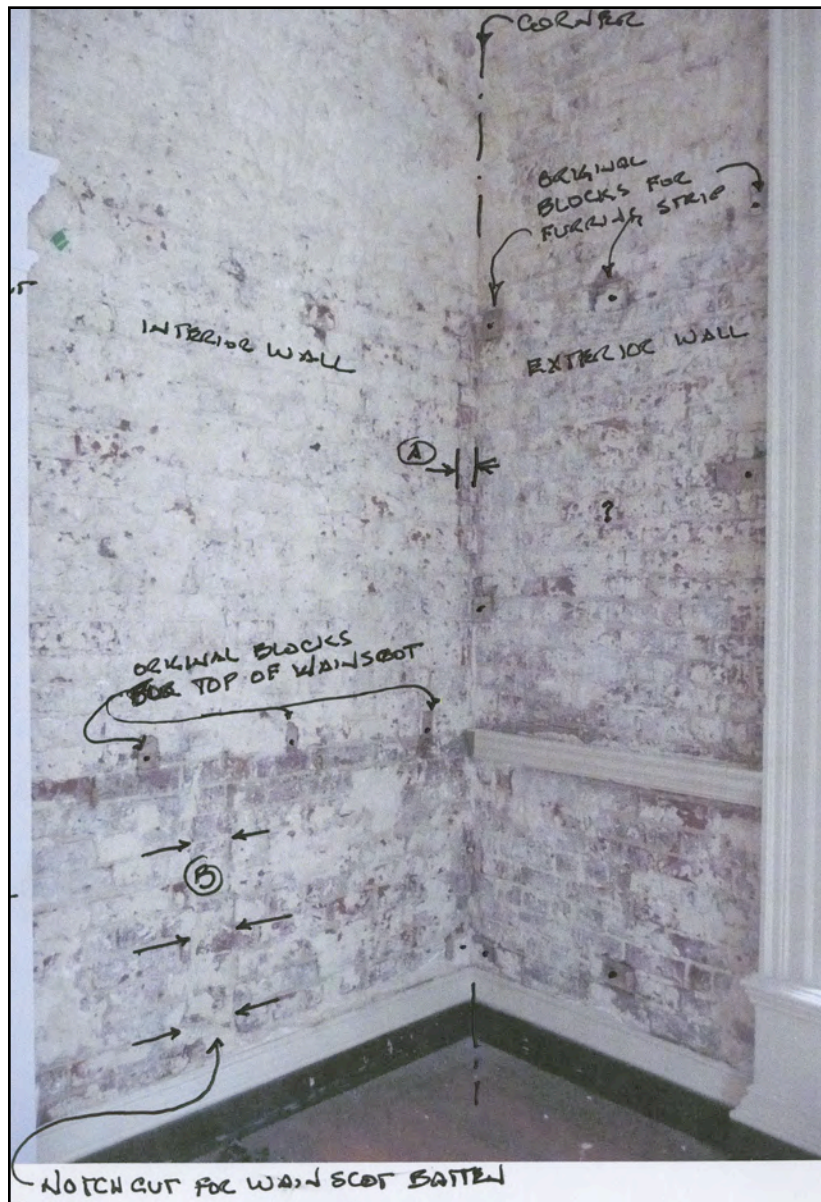
Since the wall plaster on exterior walls was not in contact with the brick and the wainscot was made of wood, there was no plaster contact either above or below chair rail height and the basic background color (below the 1878 and 1905 plaster haze) is the same shade.

Note that the walls above arms reach have not been as well cleaned as below at the time of this picture and are much whiter with plaster haze from the weak 1905 plaster.

At the corner, a darker vertical stripe (A) on the interior wall was protected from plaster by the adjoining corner furring strip from the exterior wall.

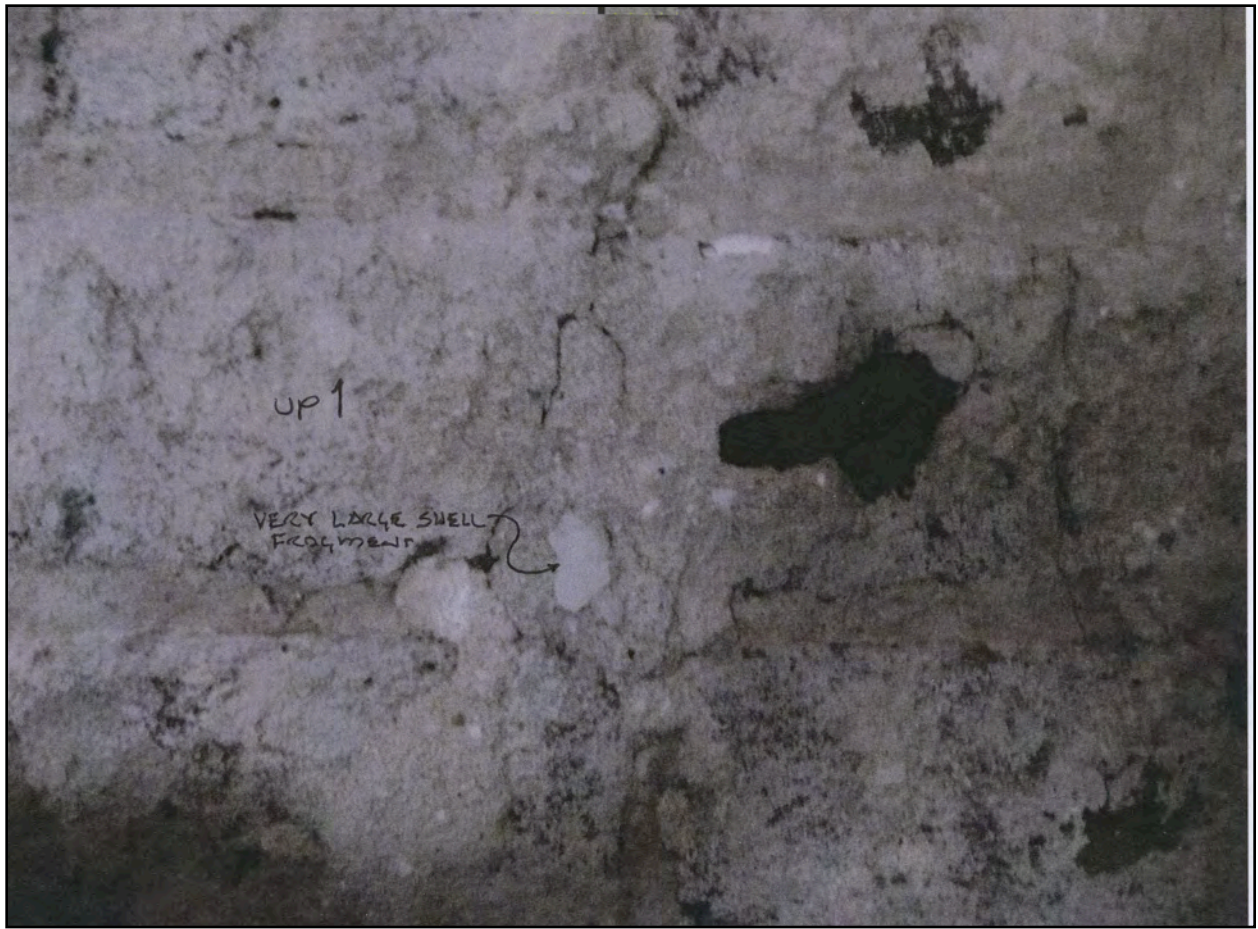
On the interior walls once the 1905 plaster was removed, numerous locations have bits of what appears to be original base coat with sizable chunks of shell flecks remaining. These obviously do not occur on the exterior furred out walls.

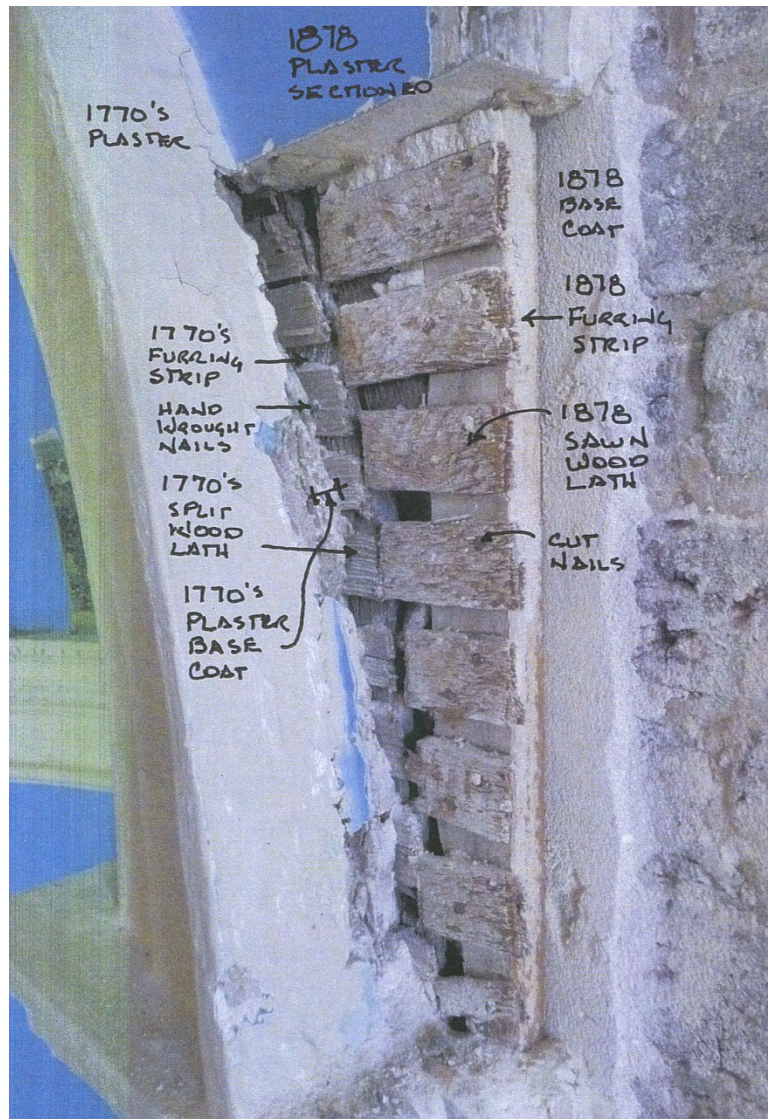
The 1905 and 1878 wall plasters on this exterior wall were applied directly on the brickwork. The 1878 plaster was furred out only at the spandrels of the niche.

All of the 1770's plaster was furred out on the exterior walls. Thus the furring strip, lath, and base coat of the 1770's plaster at the niche is indicative of the wall plaster used for the room originally - it just happened to be protected by the decorative plaster of the architrave at the niche which was not removed in 1878.

Where decorative plaster elements were added, they would most likely have occurred on top of the standard base (or scratch) coat of plaster with adjoining brown and finish coats of wall plaster abutting the decorative work. This means it is unlikely there will be any trace of the decorative plaster elements both on the furred walls and those that were directly plastered.

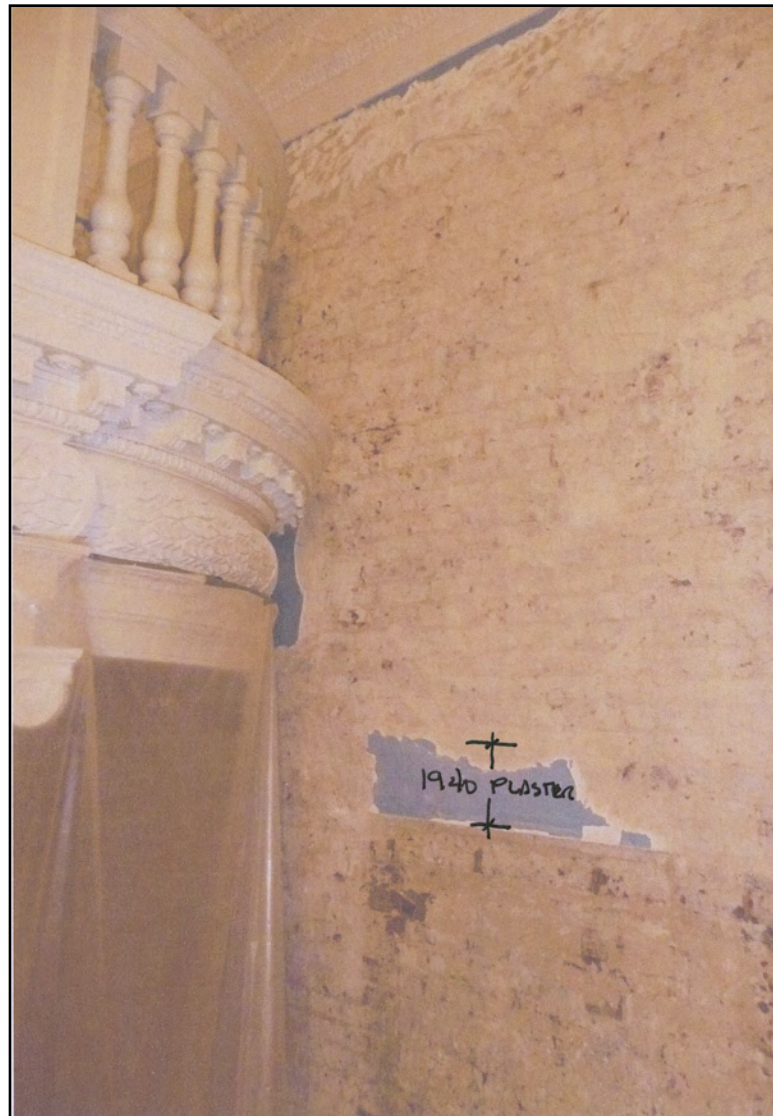
Infill plaster from the 1940s above the false door indicates removal of the 1905 overdoor. Because the design of the 1905 overdoor was not balanced by wider trim (or pilasters) below, it appeared top-heavy and so was removed in the 1940s as part of a reinterpretation of the restoration.

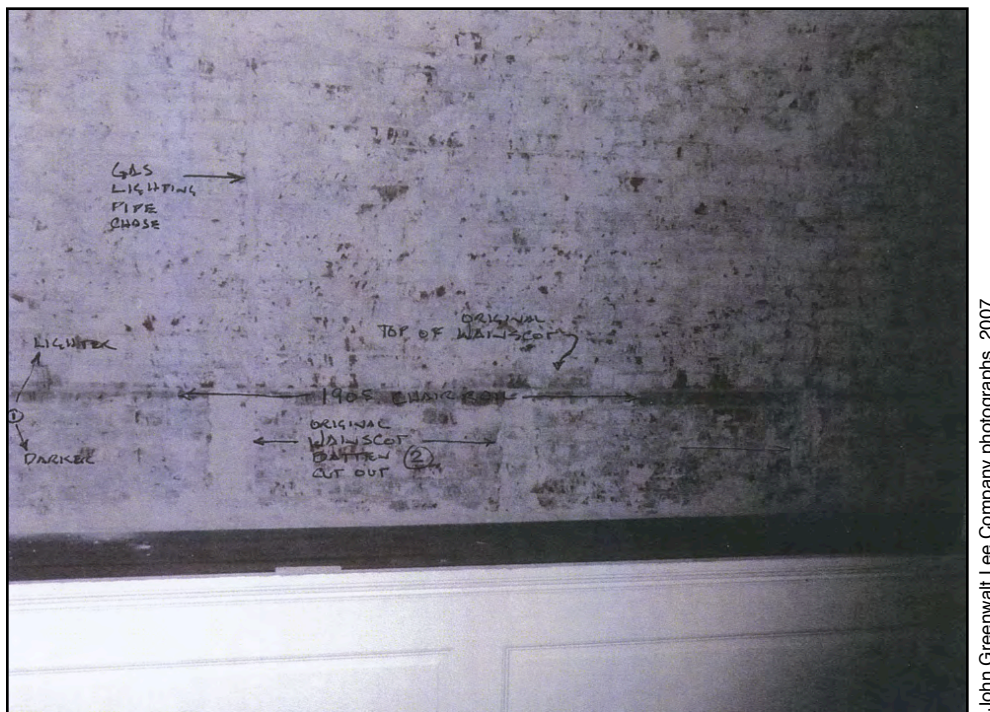
With the pre-1878 treatment of the room having plaster directly on the interior walls and wood wainscot below, the area below the original chair rail height is still markedly darker - in spite of the lime haze from the 1905 plaster coating everything. Note the difference in wainscot height down several inches with the 1905 restoration from its taller 1770s arrangement when the panels of the “plain dado” wainscot were originally attached with battens on the backside. The battens were chopped into the brickwork (see filled patches) to keep the face of the wainscot in the same plane as the plastered wall above.

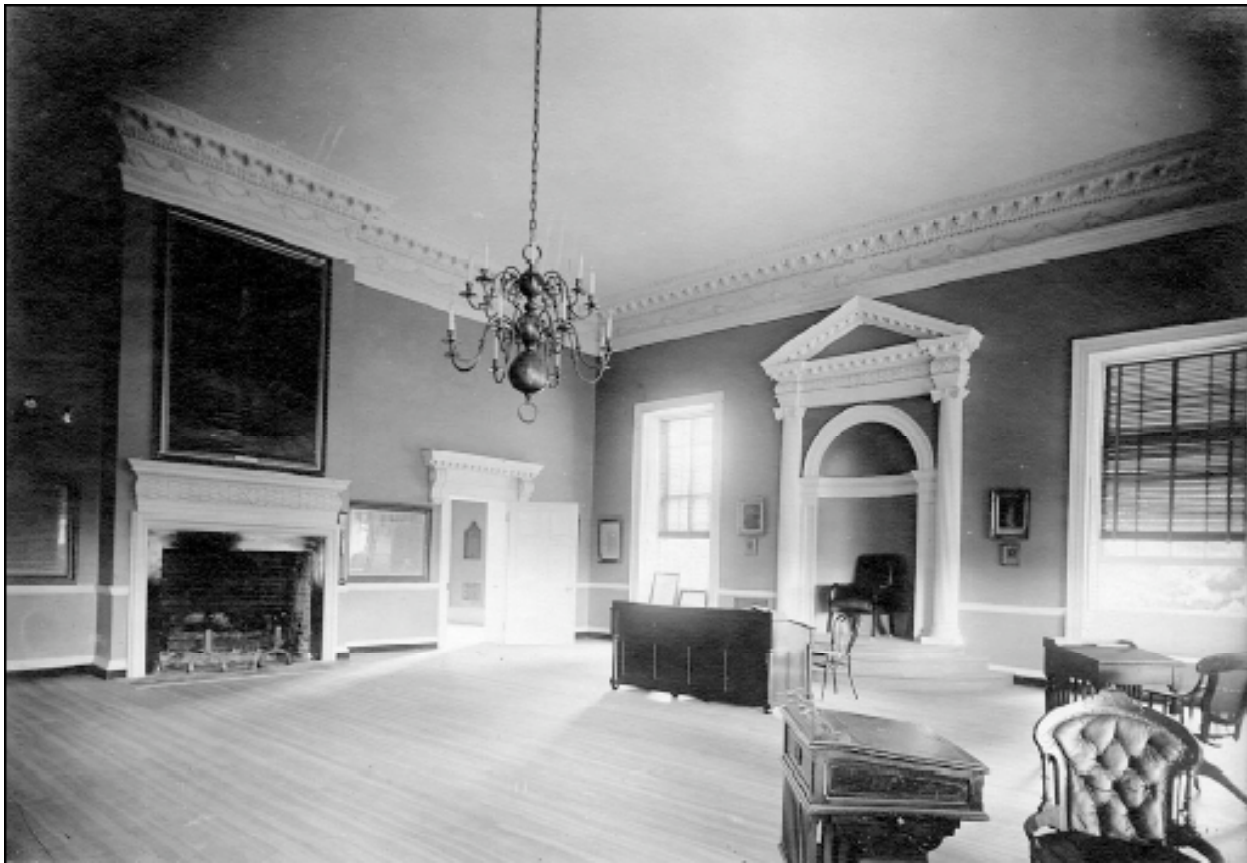
With the 1905 restoration, the doorway to the Committee Room been narrowed by four inches to a single-leaf, or single door of 44-inches wide.

The restored overdoor was based on Trumbull's painting at the U.S. Capitol. However, the console brackets are misproportioned both relative to the painting and other period examples. The final result may have been determined by the available architectural pieces being stocked in 1905.

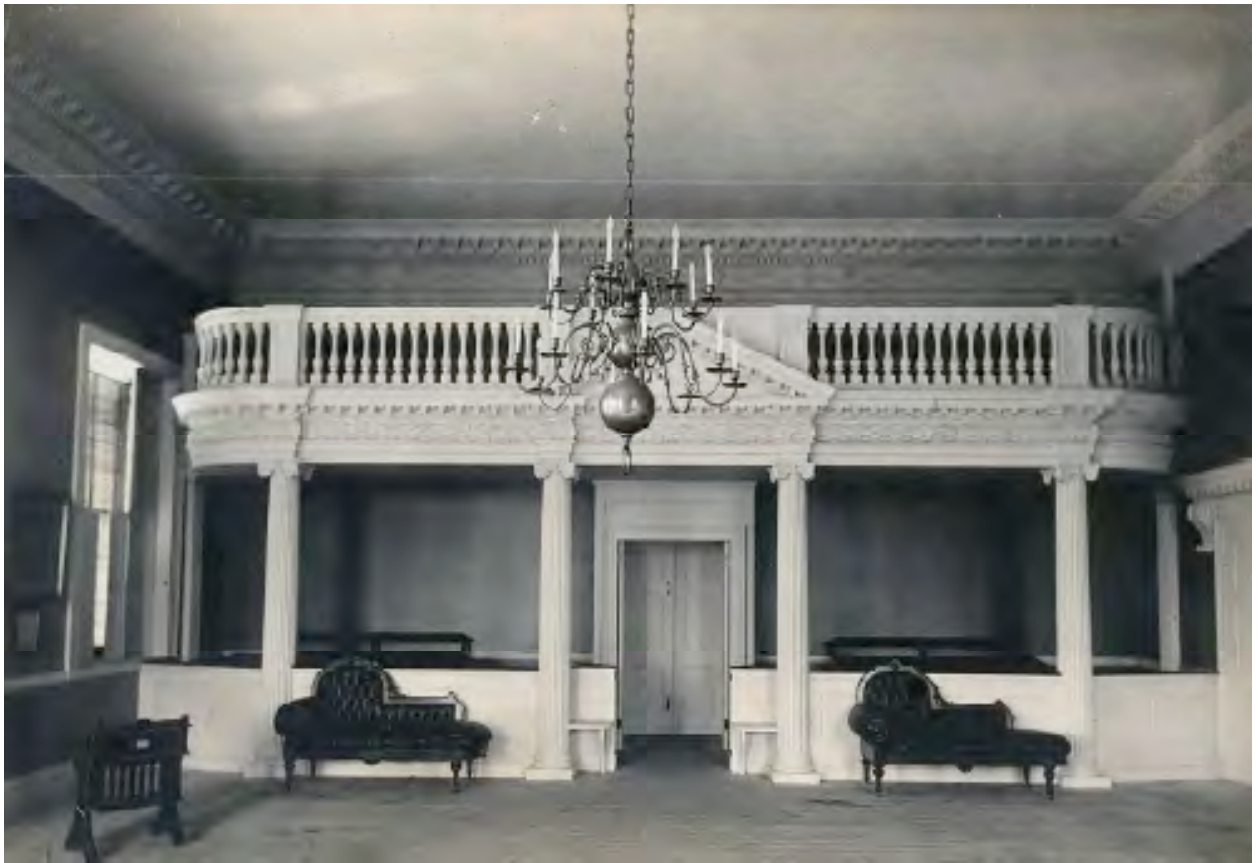
- The vestibule doorway was recreated based on the 1869 photograph.
- The door partially visible at the far right of the photograph is the false door as replicated from Trumbull's paintings and located by an 1858 floor plan drawn by engineers during installation of the central heating system.
- The console brackets are noticeably misproportioned relative to the Trumbull painting producing a design atypical for overdoors from the period.

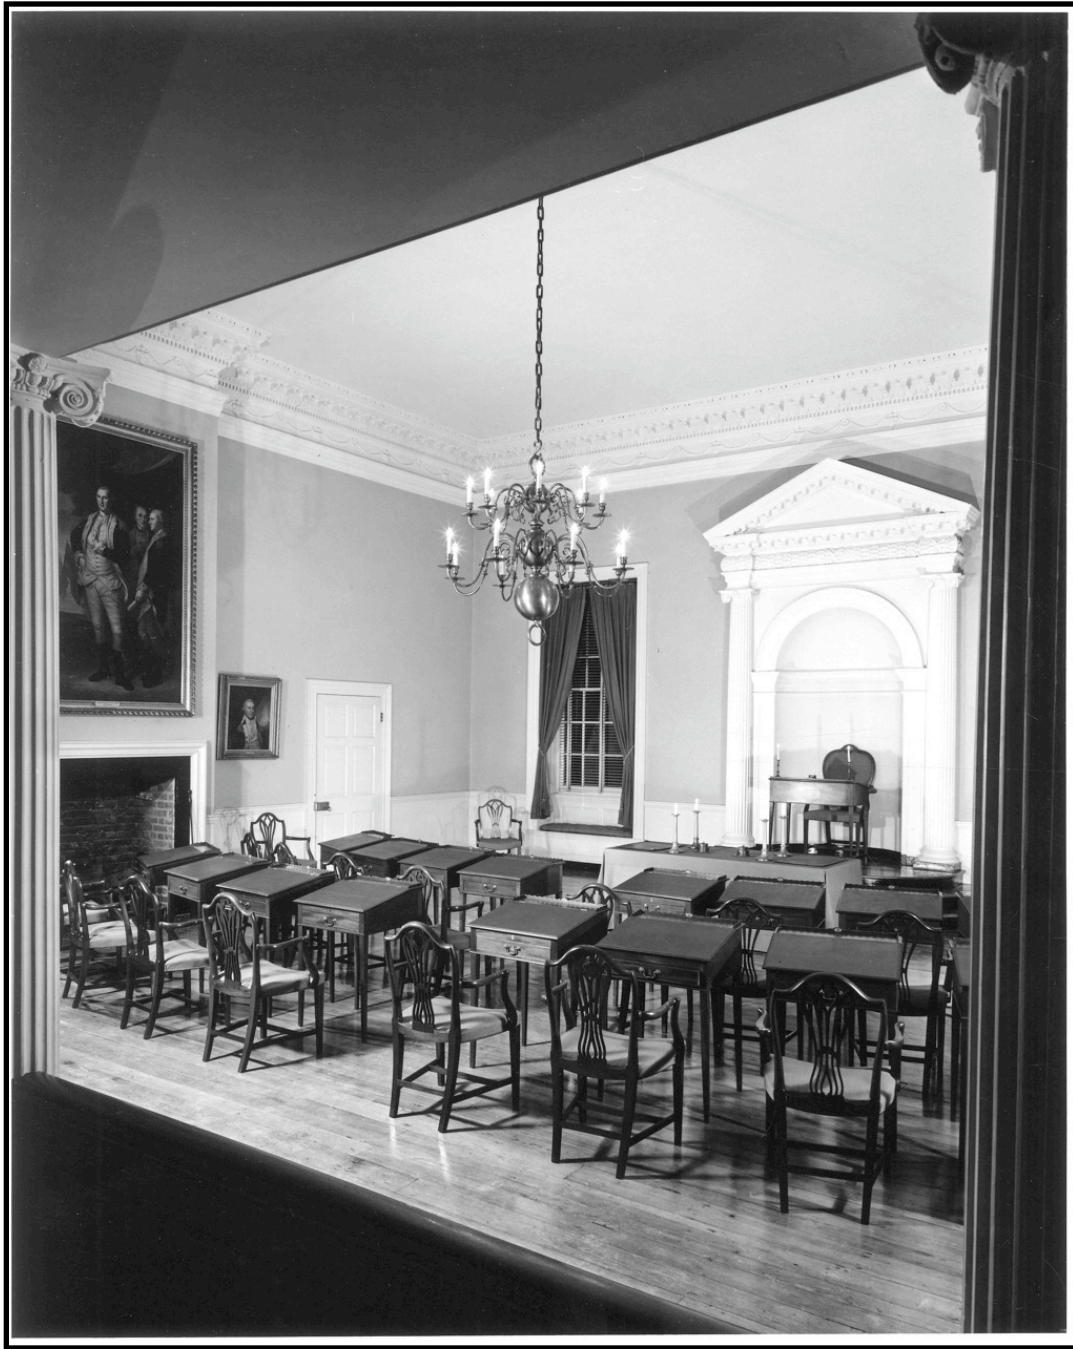
Circa 1947 Photograph of the Old Senate Chamber from the Balcony by M.E. Warren, MSA SC 1890-01-3.

Annotation: The 1905 overdoors to the Committee Room were removed by 1947.

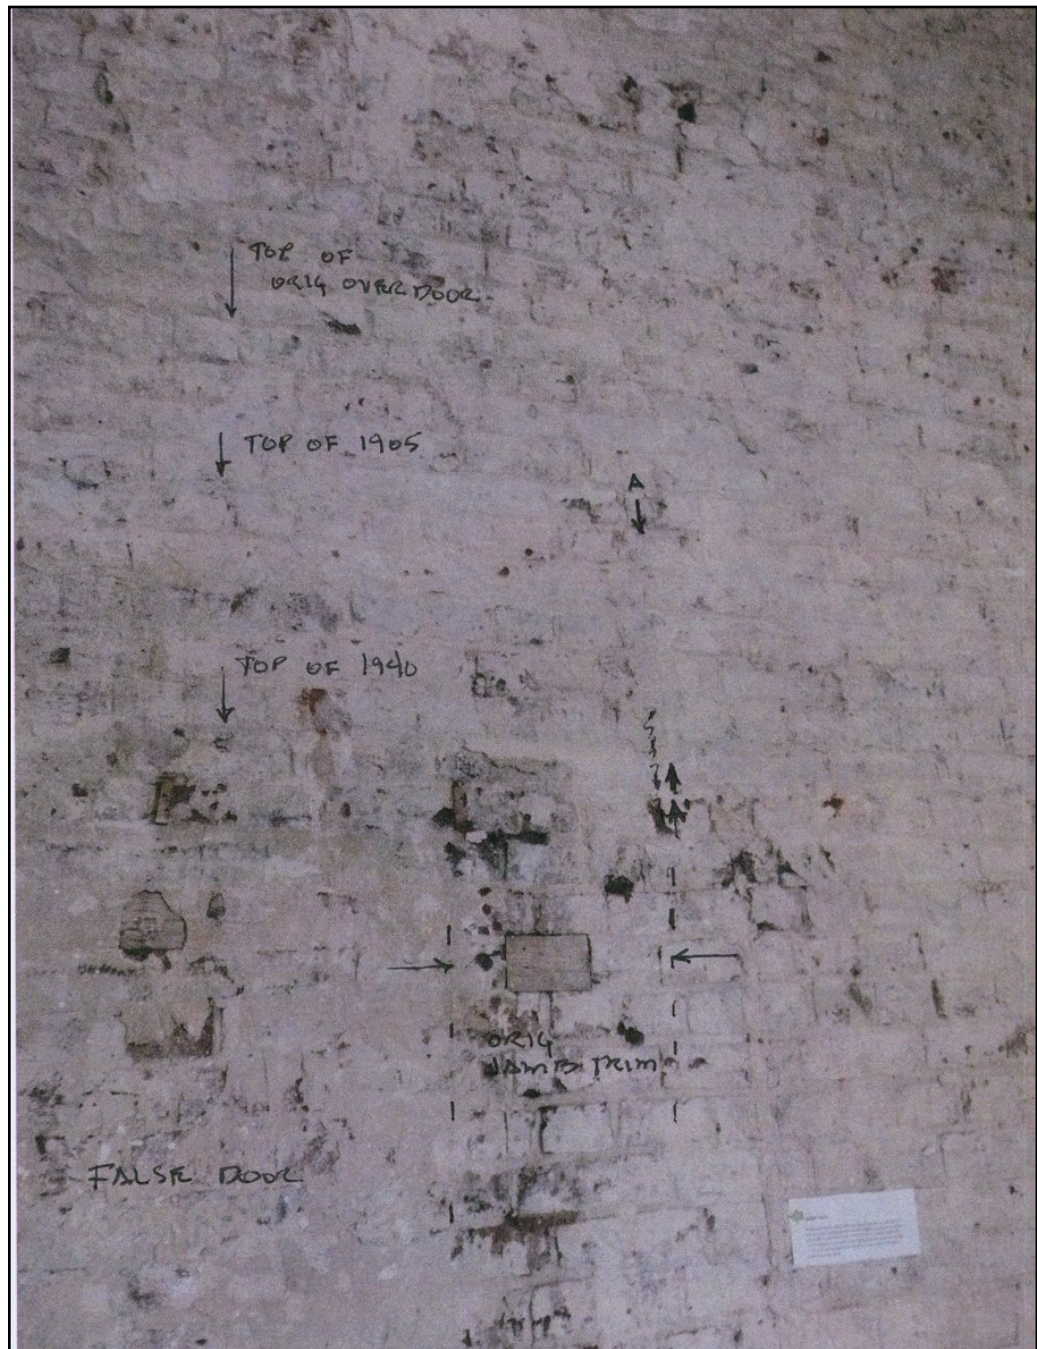
In this photo of the false door, both the 1905 and the 1940 plaster has been removed, along with the 1905 false door and trim (1905 overdoor removed in 1940). The top of the 1940 trim is approximately the top of the original pilaster capital and the top of the 1905 trim is about the top of the original frieze (A-A' is the vertical imprint line for frieze bracket).

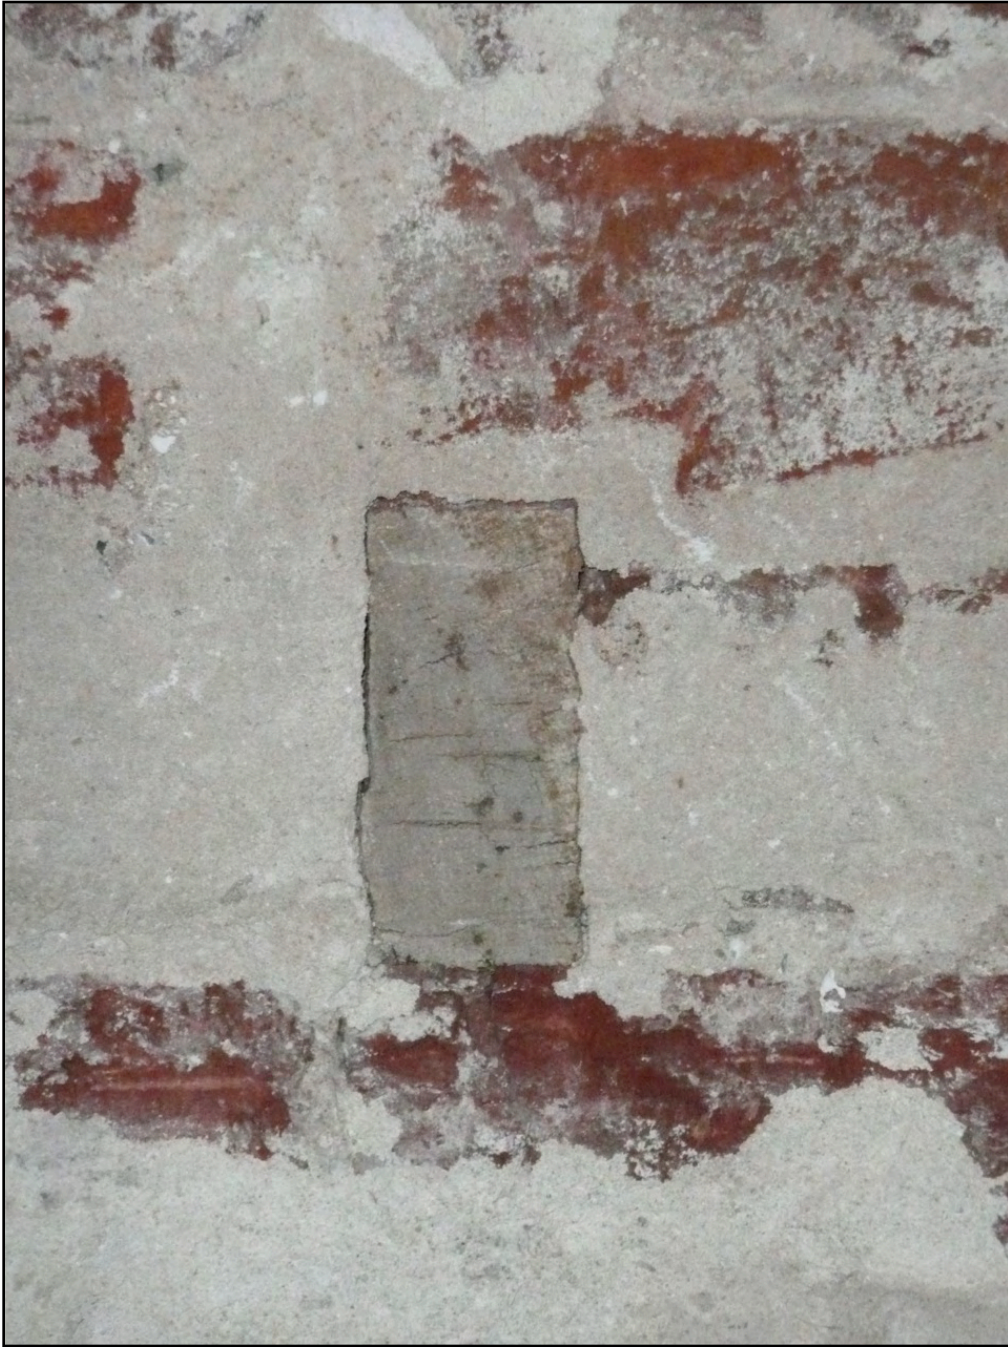
This original chair rail nailing block within the area of the false door has no holes for nails, indicating the false door is an original feature and wainscot was not installed here.

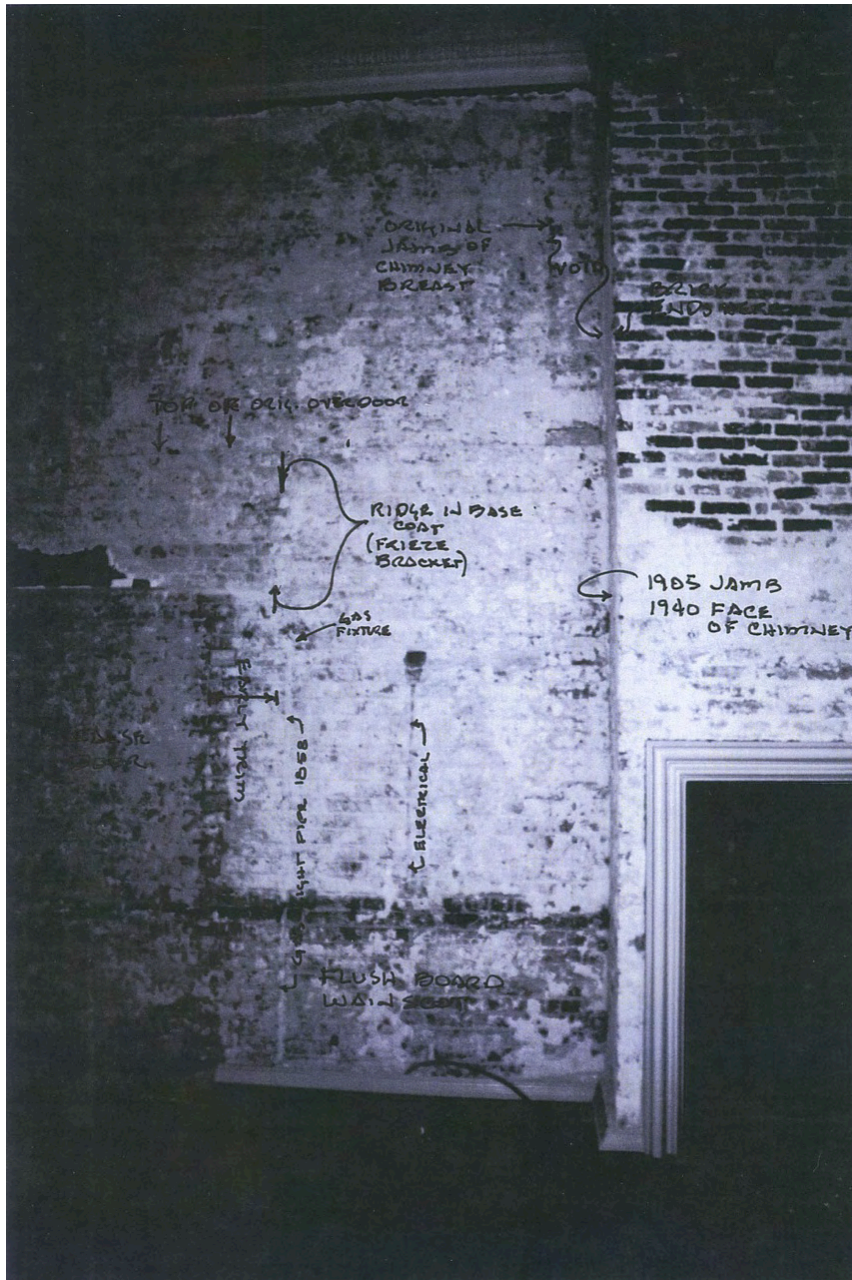
The use of infrared (IR) photography in the 750 nm range hints at what more powerful modern infrared photography might show through the 1905 plaster haze on the wall. Here the area once covered by early wooden flushboard wainscot (and thus not plastered until the 1870s) clearly stands out, as does a stripe down the sides of the false door (where the masonry has not been altered as at the committee room door) that extends as wide as the pilasters at the niche.

Ghosting down the side suggests the reason the 1905 entablature was removed for seeming top-heavy was the lack of balance that would have been provided by wide supports.

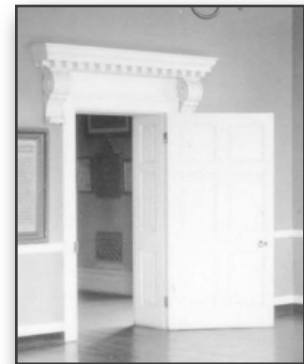
Also noticeable with IR is the edge of ridges in original plaster remaining on the wall at an intersection with the edge of the early entablature. The apparent straight edge at the height of the oak leaf frieze band suggests it was capped with brackets. The use of a bracket is suggested by Trumbull's paintings and sketches, but the configuration he sketches appears to differ with these ghosts.

[If there was not a bracket at the edge, the pulvinated (pillow-shaped) bulge of the frieze would end in curvature where it turns back to wall, not a straight line.]

In other words, with an 11" pilaster on either side of the doors and windows, a repeat of the niche and gallery entablature for overdoors and windows will be properly balanced.

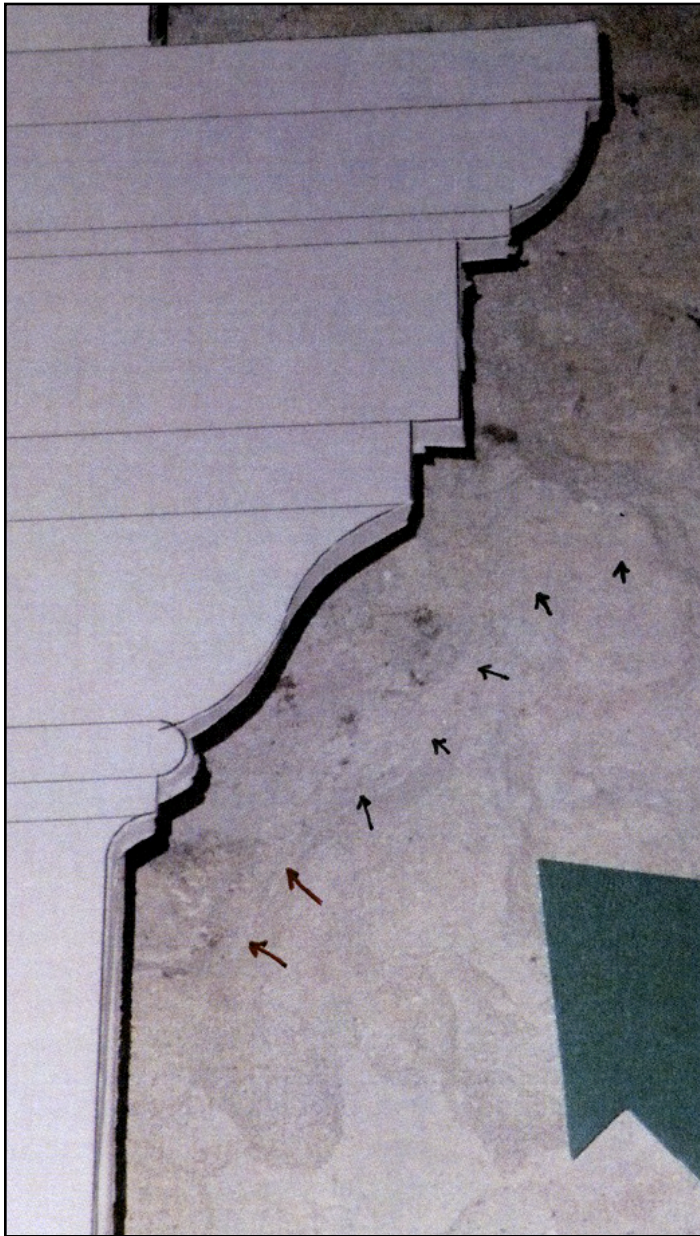
Foamcore mockups assists refinement of the outline of the pilaster and door entablature treatments. These door entablature mockups were created from an outline of the 1905 entablature at the gallery. Although comparisons of 1868 and 1905 photos highlight obvious discrepancies, the use of a cutout provides a reasonable starting point for helping to locate similarities and discrepancies with ghosts and ridges on the early plaster remaining on the chimney elevation wall.

(Looking up from below at a skew angle, the arrows at left highlight ridges in the original plaster that suggest there was once abutting decorative trim.)
