Interim Report on Archival and Architectural Evidence
Old Senate Chamber at the Maryland State House

09/17/2008 *(updated on 11/24/2008)*

Report by the John Greenwalt Lee Company

**Produced for Maryland Department of General Services, Alvin C. Collins, Secretary
Contract Number BA-491-070-203**

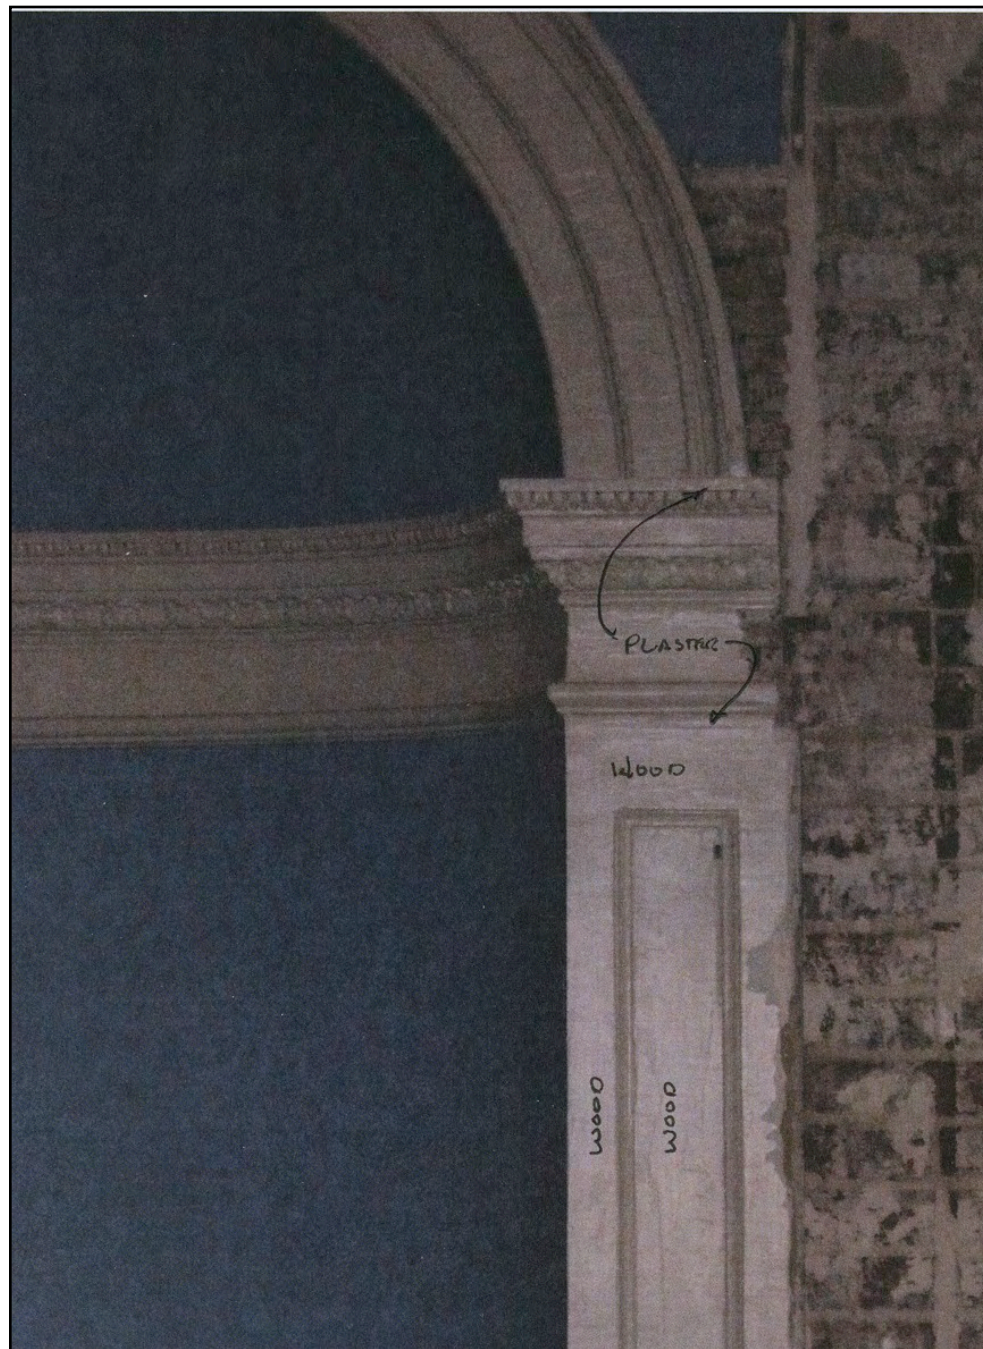
The wooden pilaster with plaster capital at the niche matches very closely with the evidence for the door trim (seen with IR photography, plaster ridges, and ghosting).

Again, with the addition of brackets centered over the pilaster capital, the overdoor can have Trumbull's brackets while creating the straight vertical line at the edge of the frieze band that the ghosting suggests.

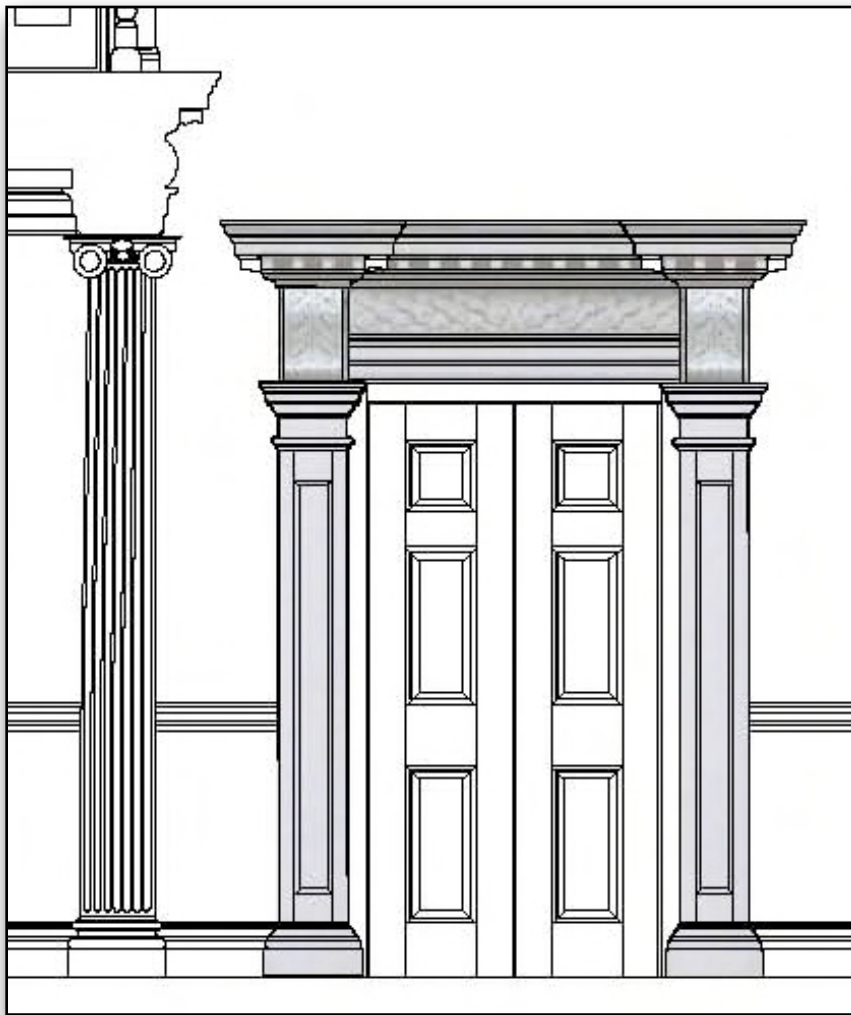
The evidence for doorways in the Old Senate Chamber indicates a wooden element about 14+ inches wide at the jambs. On the wall there is still the imprint of a molded element 90 inches from the floor that corresponds to the capital over the niche pilaster .

If the paneled pilaster of the niche that is 11 inches wide were also at the doors and a 3" backband was added on the inside edge (to allow doors to open wide in spite of the capital), then this would achieve 14" wide trim.

At the false door there is a clear outline of straight line rising vertically above the capital aligned with the outside edge of the pilaster shaft. The plaster area tends to then move horizontally a few inches then generally out at a 45 degree angle implying a plaster overdoor entablature at rests on brackets sitting atop the pilaster capitals.

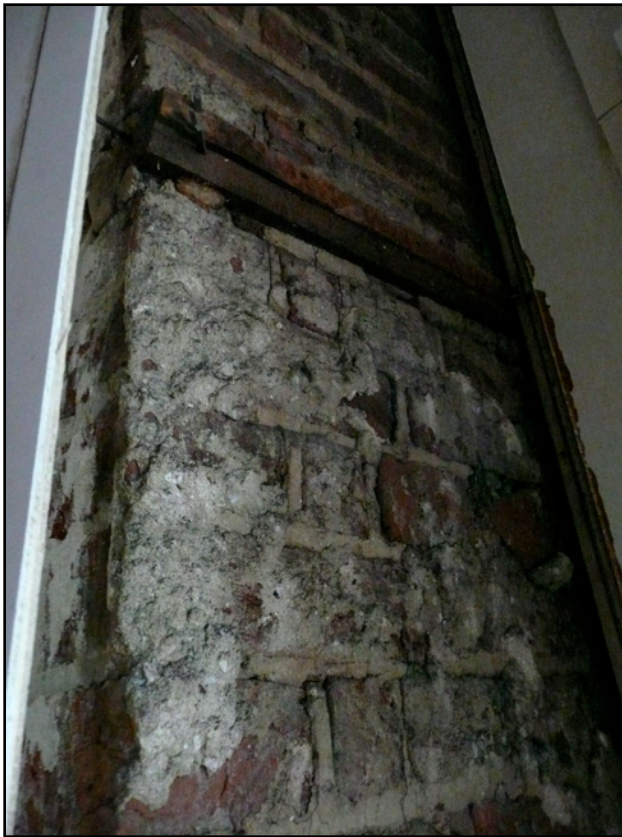
Annotation: Back shutters are the leaves of interior shutters that fold out of sight into a shutter pocket. This item together with the “painting of the room and blinds” implies that the windows had jambs without shutters and some form of blinds prior to 1792. The brick jambs of the window recesses have remains of a shell lime plaster on the lower half only. The plaster appears to be different from the remains of the early shell lime plaster on the interior walls which implies a different construction campaign and may well relate to this 1792 reference. The curious aspect is having shutters on the lower half only.

Benches probably relate in some manner to window seats. Having the flooring extend into the window recesses is a pretty good indication that the room did not start life with window seats and likely did not acquire them until 1792.

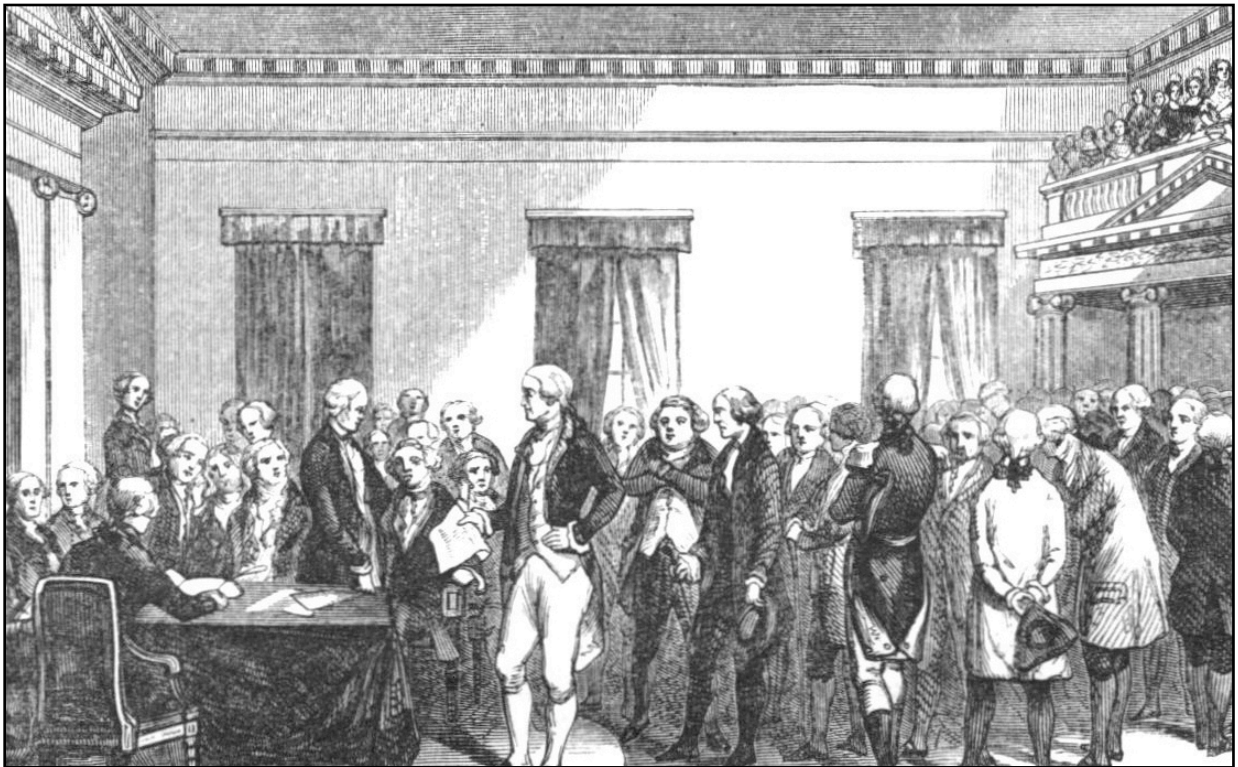
Annotation: Benjamin Lossing chided Trumbull for not showing the windows properly, but where is the fourth window on the wall? Here, Lossing depicted only three on the East wall.

By this point, the windows to either side of the niche had likely been covered by paintings (see ca. 1868 photo of niche). The architectural trim of the windows has also been covered by draperies and an upholstered valence.

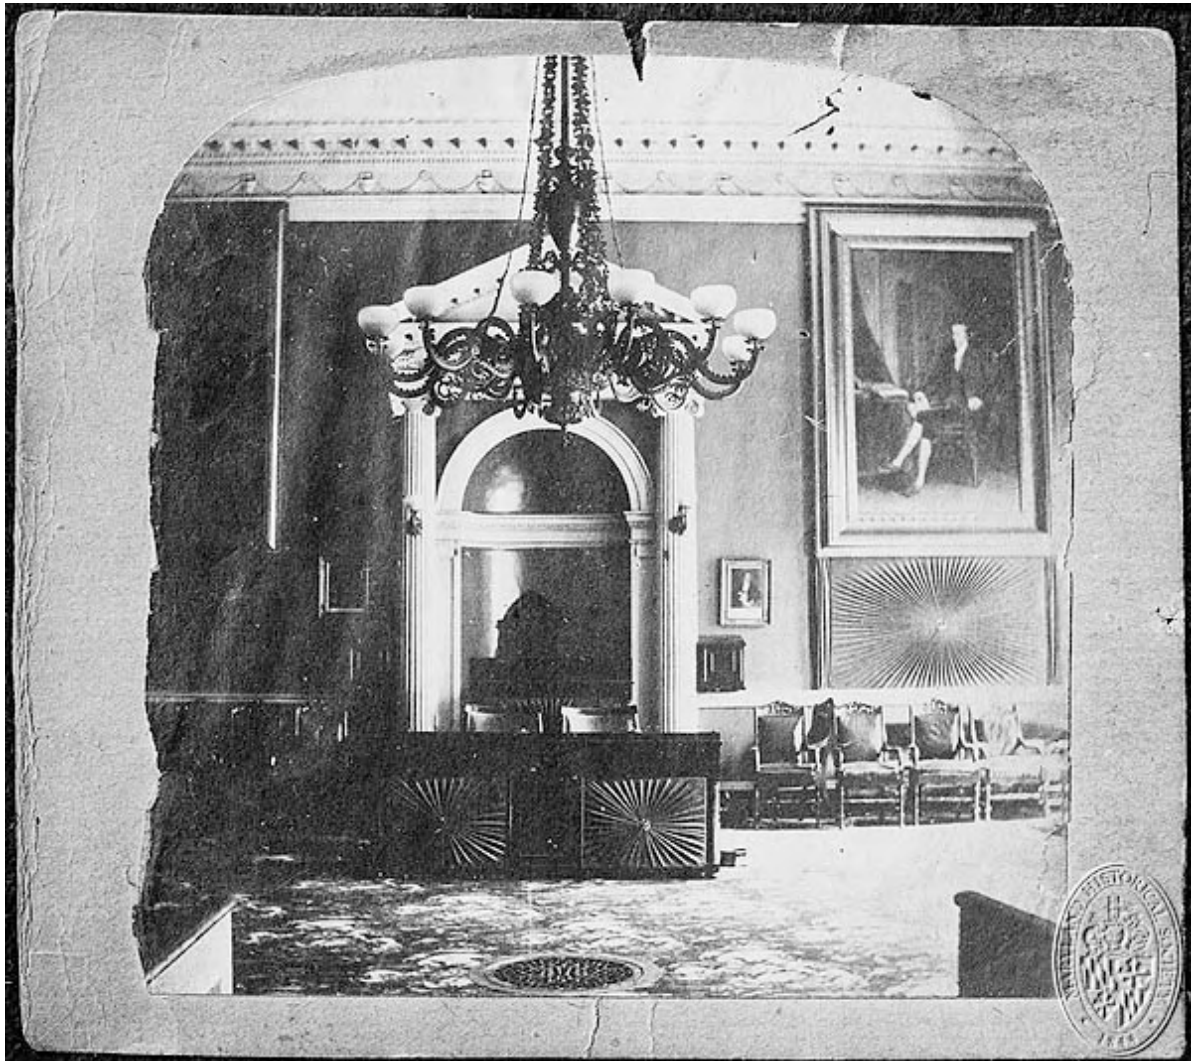
Annotation: The windows on either side of the niche are completely reworked with the space covered by large paintings. The chair rail appears to run through, eliminating the recess below the window sill. With the way the painting and fabric panel below are hung, there is no room for any trim to remain on the window. This arrangement was likely in place by 1851 as Lossing shows no windows on this wall.

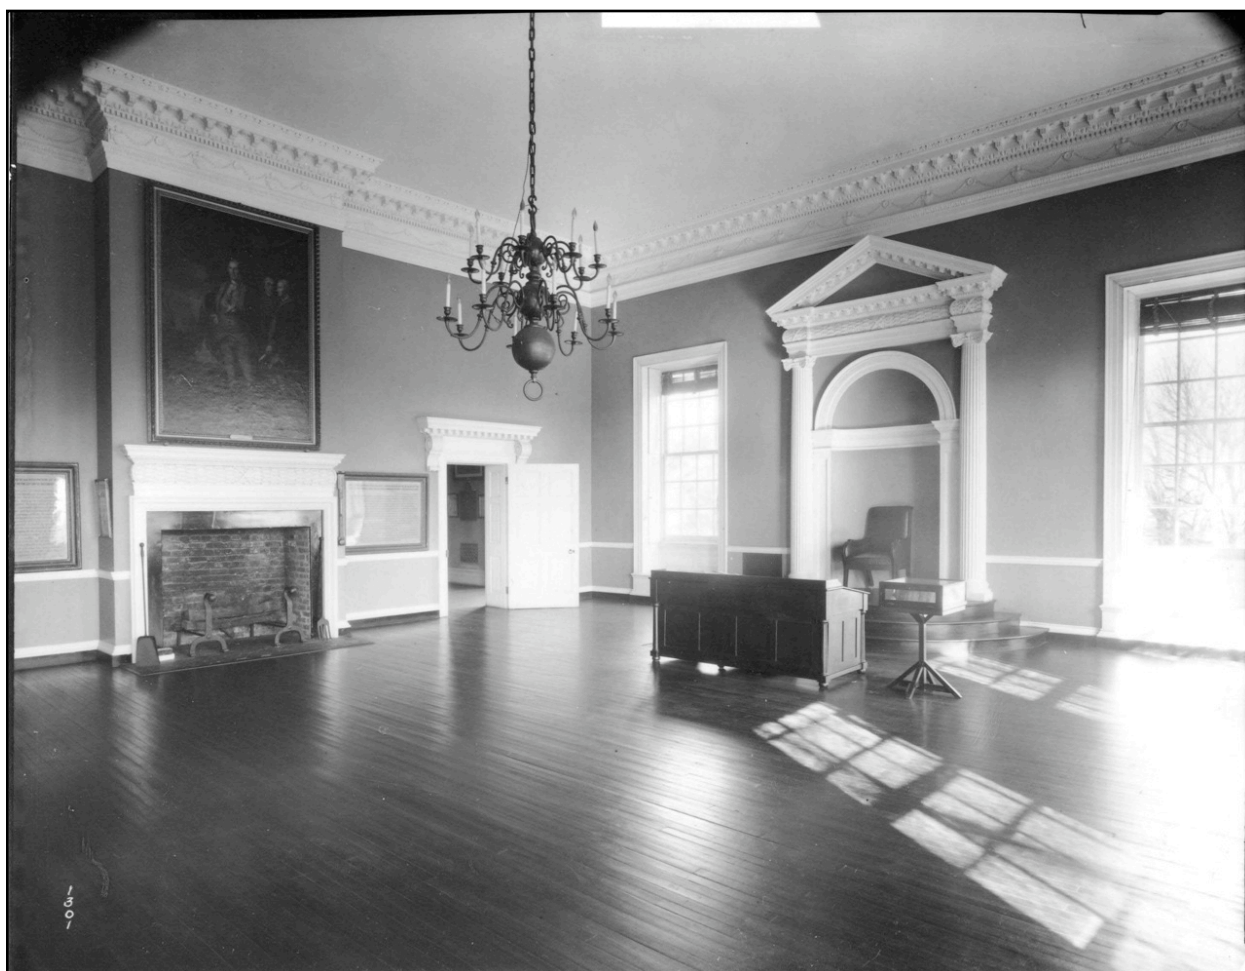
As with most early Colonial Revival “restorations”, Georgian, Federal, Neo-Classical, and even Greek Revival styles get blended into “Colonial”. The window trim, especially the casing architraves and the shutters, are now very delicate and definitely not the bold Georgian of the original architrave over the niche.

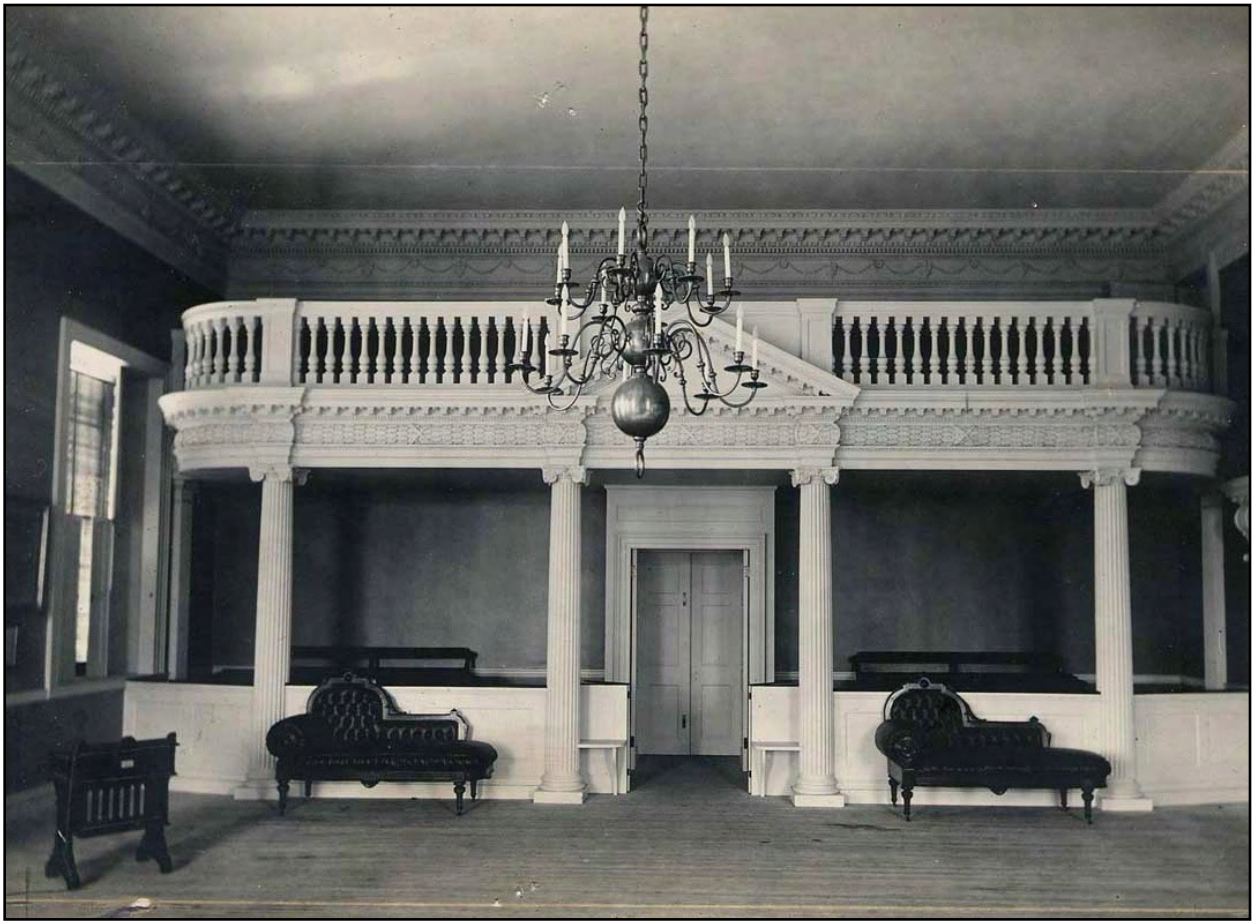
With the exception of having a chair rail high sill, the window at the far left is typical of a 1905 restored window. It appears to have had a recess to the floor, like the other windows in 1878 and earlier, which was bricked up in 1905 as suggested by a card signed and dated by the workmen. This appears to only accommodate the screen between the columns that according to Mr. Brooks “miters with the chair rail”.

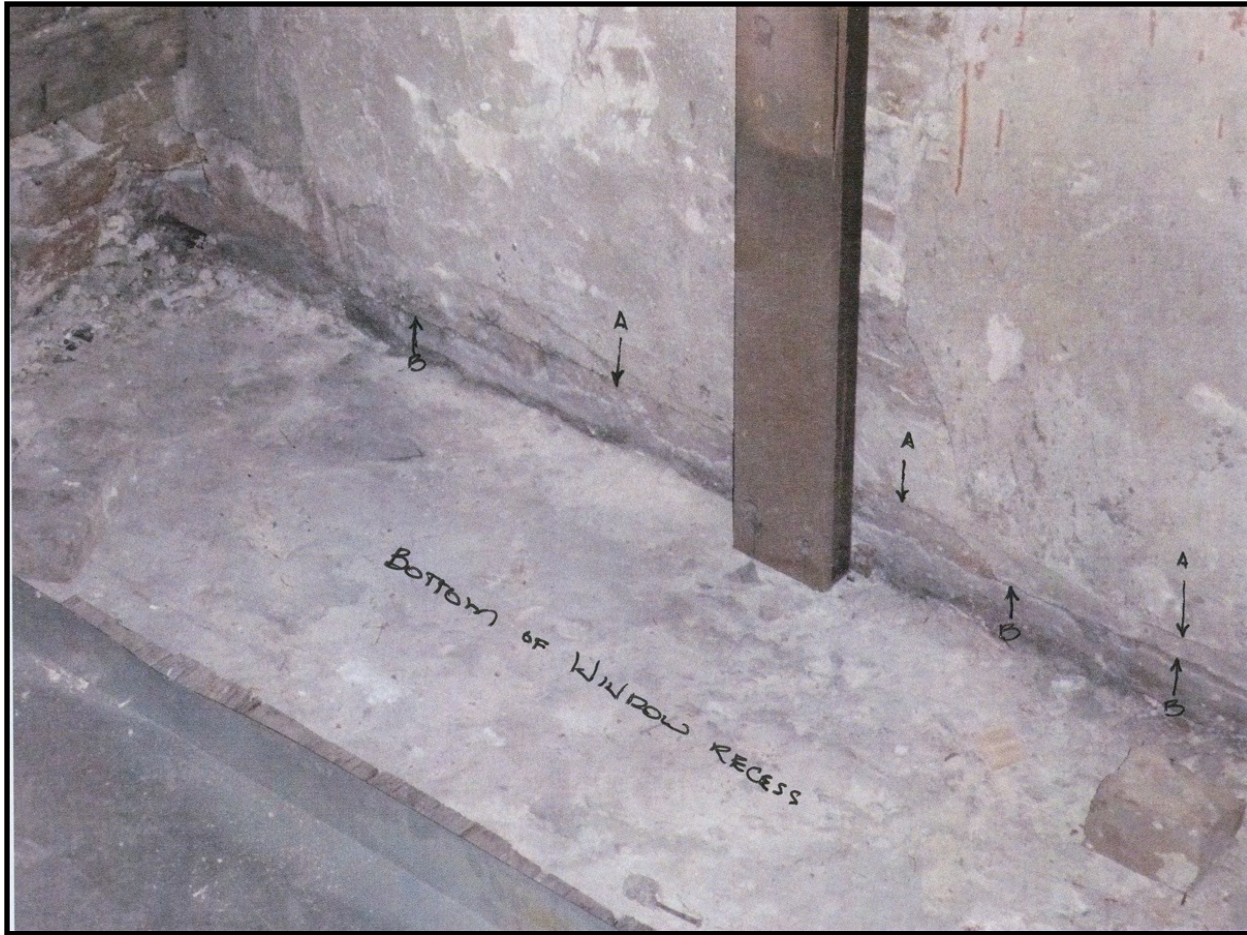
Evidence uncovered within window recesses with 1905 window seat removed:

This fragment of plaster found in the space beneath the window recess closed up in 1905 where the gallery wainscot intersects the fourth window. It appears to be mortar that was dropped during plastering of the room onto a window muntin where it cured before being swept away.

It does not match the current window profile.

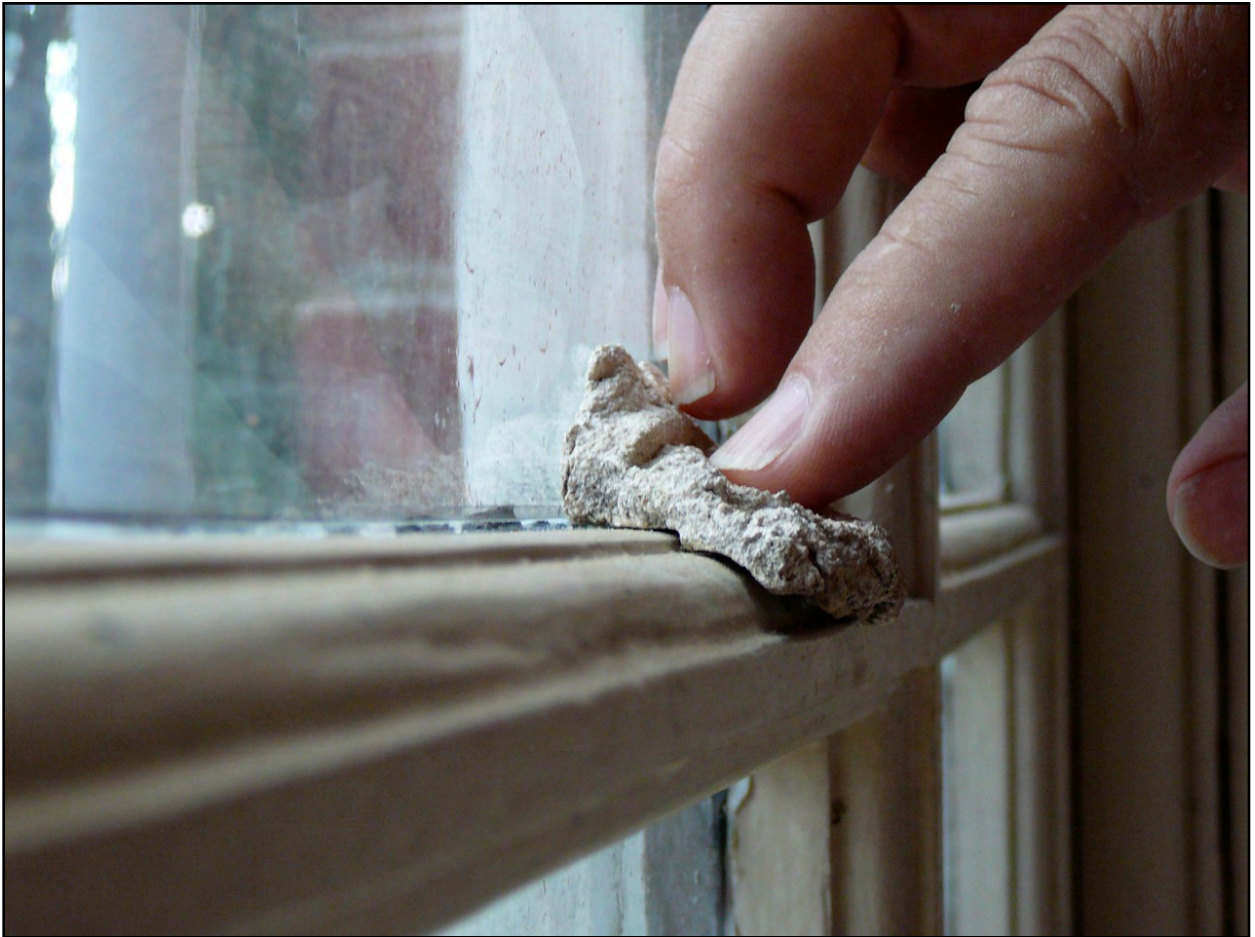
This plaster does not appear to match the original, nor the 1878 or 1905 plasters. Maybe it is from the 1798 or 1826 ceiling.

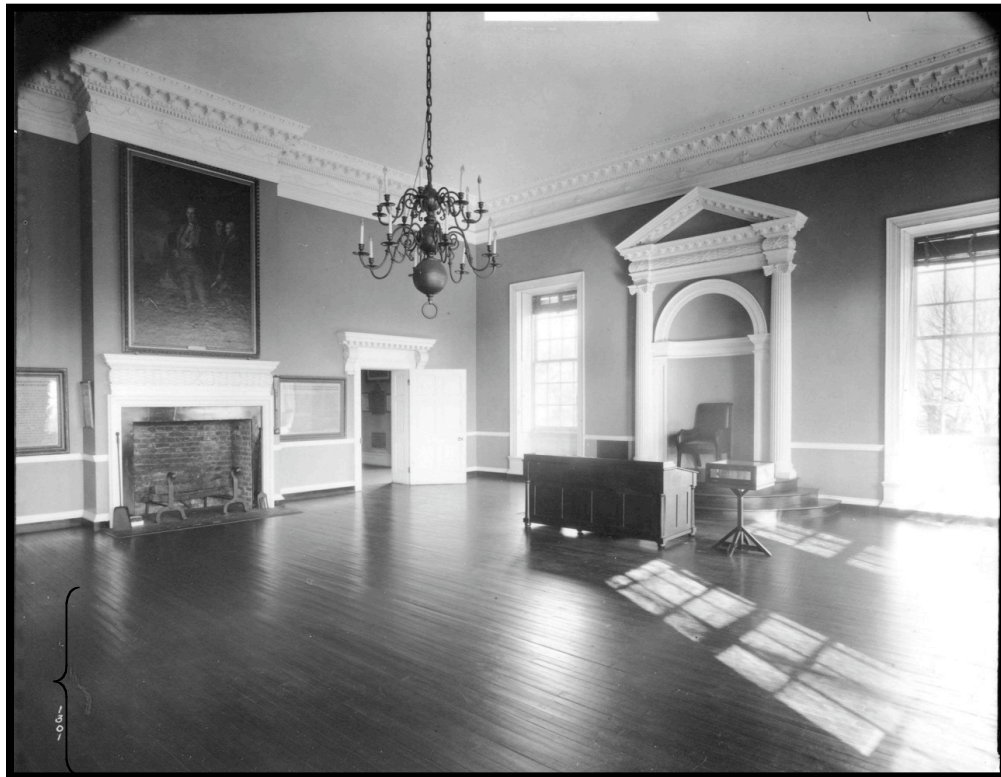
- **Dais with three steps per *Columbian Magazine* of 1789;**
- **Engaged columns and pediment as per circa 1868 photograph;**
- **1878 plaster between columns and outside of niche architrave;**
- **1770s niche, niche architrave, necking band in plaster & paneled pilasters in wood.**

Physical evidence shows the dais was only two steps high and a foot larger in radius. The 1905 engaged columns and pediment are anemic and do not project sufficiently out of the wall. The columns should start out a step lower and be almost full round and just touching the wall. The cornice of the pediment should not break forward at the columns (continuing fully projected forward the full length as in the 1868 photograph) and the leaves should be oak in an overlapping or wave pattern as opposed to bay leaves laid one-dimensionally.

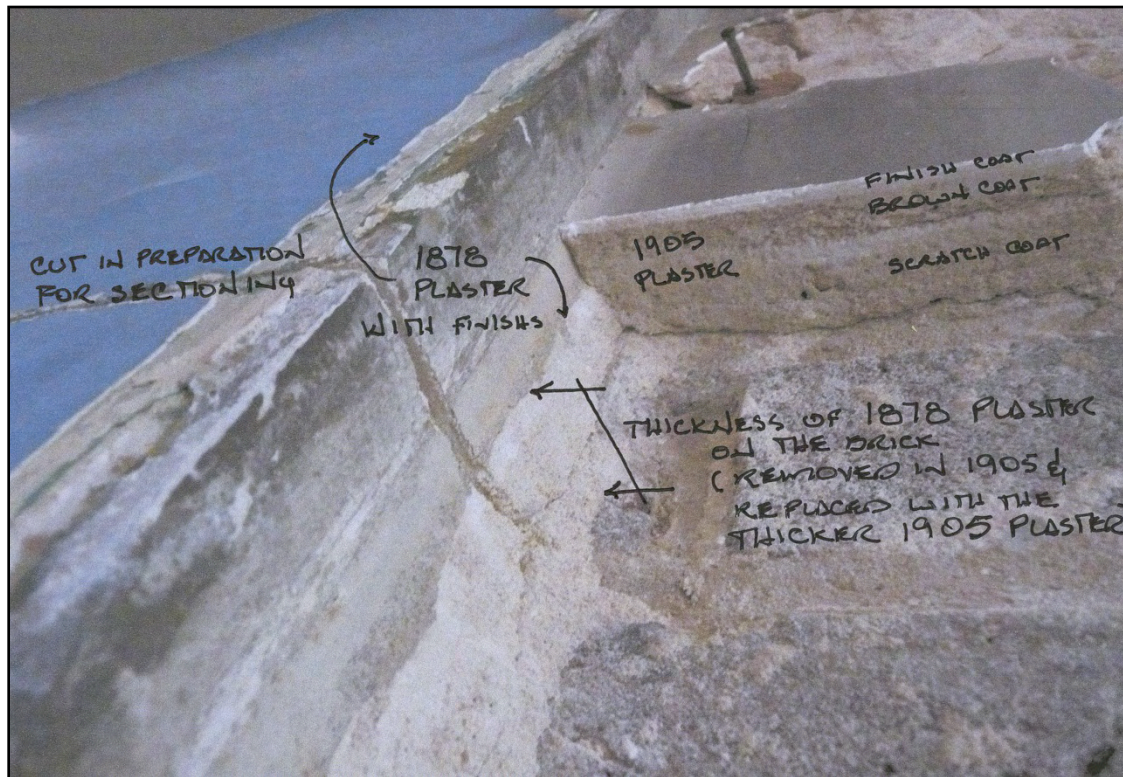
Looking up at the intersection between 1878 plaster in the spandrel over the niche with the 1905 plaster directly on the adjacent brick wall. The blue-painted area was generally exposed while the rest of the photograph to the right was covered by the engaged column. These plasters are typical of the wall plasters used during their respective periods.

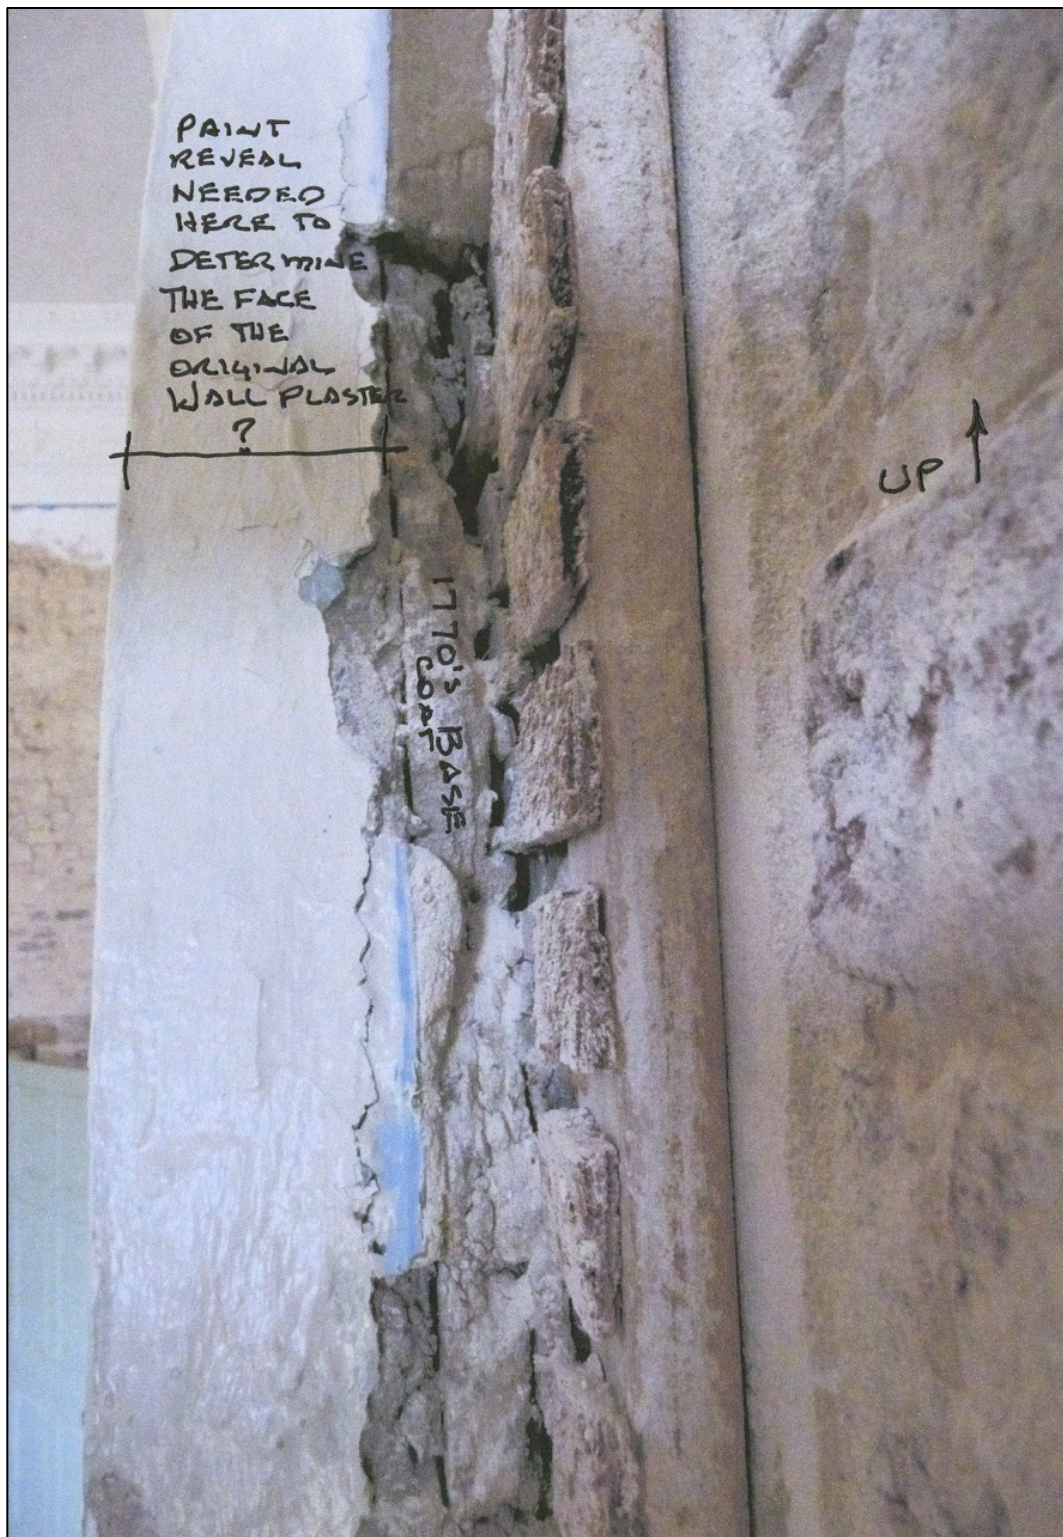
Right edge of niche detail

The 1878 lath almost obscures the original lath. The line between the 1770s original basecoat is clear. Not only is the thickness of the original plaster of interest, but often wall paints lap over onto the edges of projecting decorative work. The spandrel may not be treated the same as the field of the wall, but it may have been. Either way, knowing what interleaves the trim finishes will be of great interest.

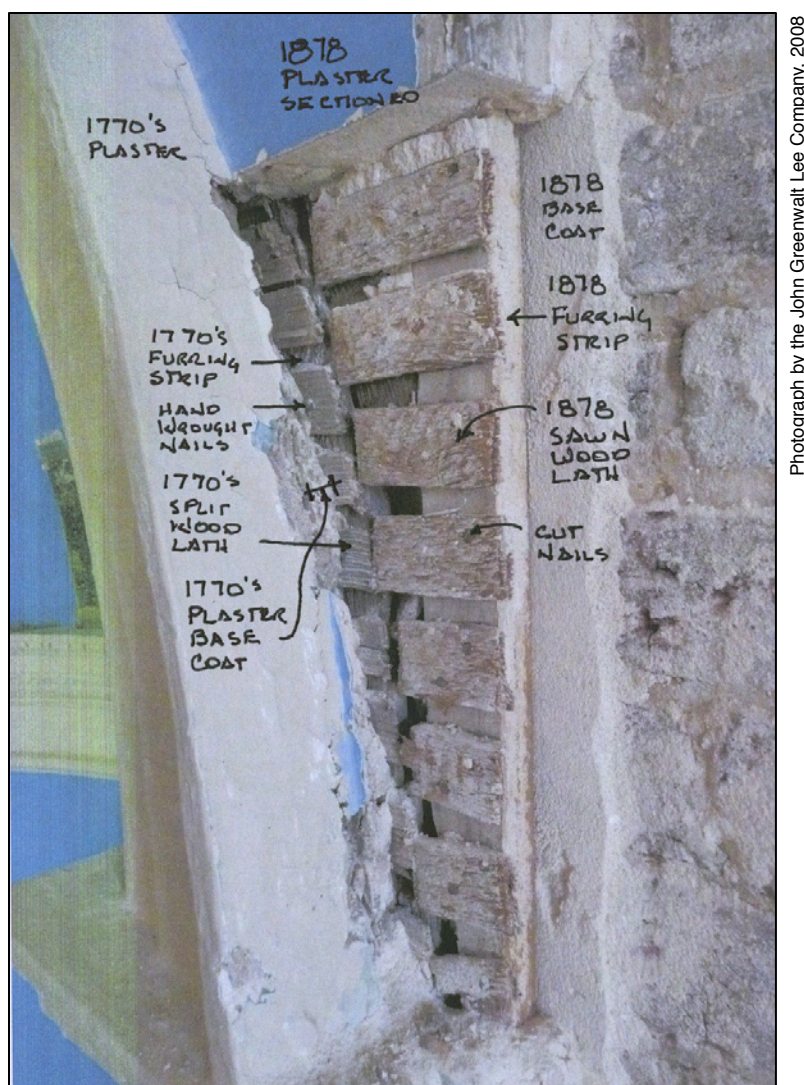
Right edge of niche with 1878 plaster sectioned and partially removed up to the original 1770s plaster of the niche's arched architrave.

The 1905 and 1878 wall plasters were directly on the brickwork. The 1878 plaster was furred out only at the spandrels of the niche.

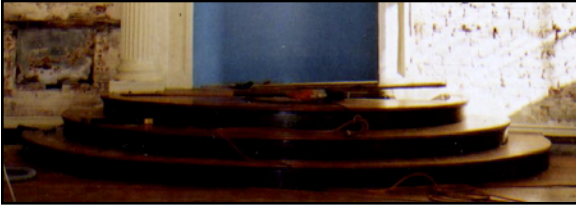
from three to two risers

The top of the 1905 dais has now been lowered by one riser to approximate the original dais height. The unplastered space above the new landing implies a baseboard of approximately that height. There should be a paint line to correspond with the actual top edge of the base.

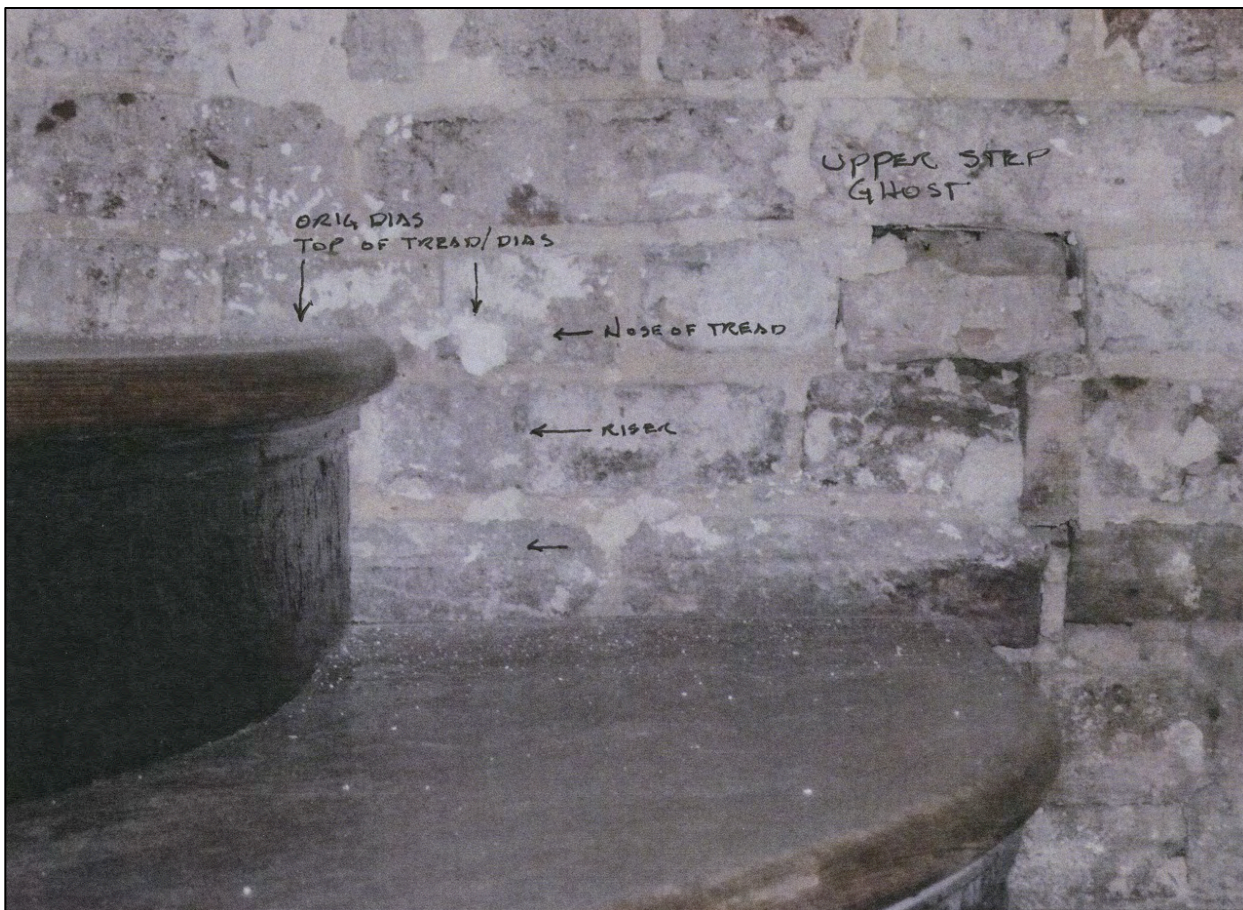
With 1905 plaster removed and the 1905 dais bottom two risers returned to their 1905 position, the original top riser location is most readily seen.

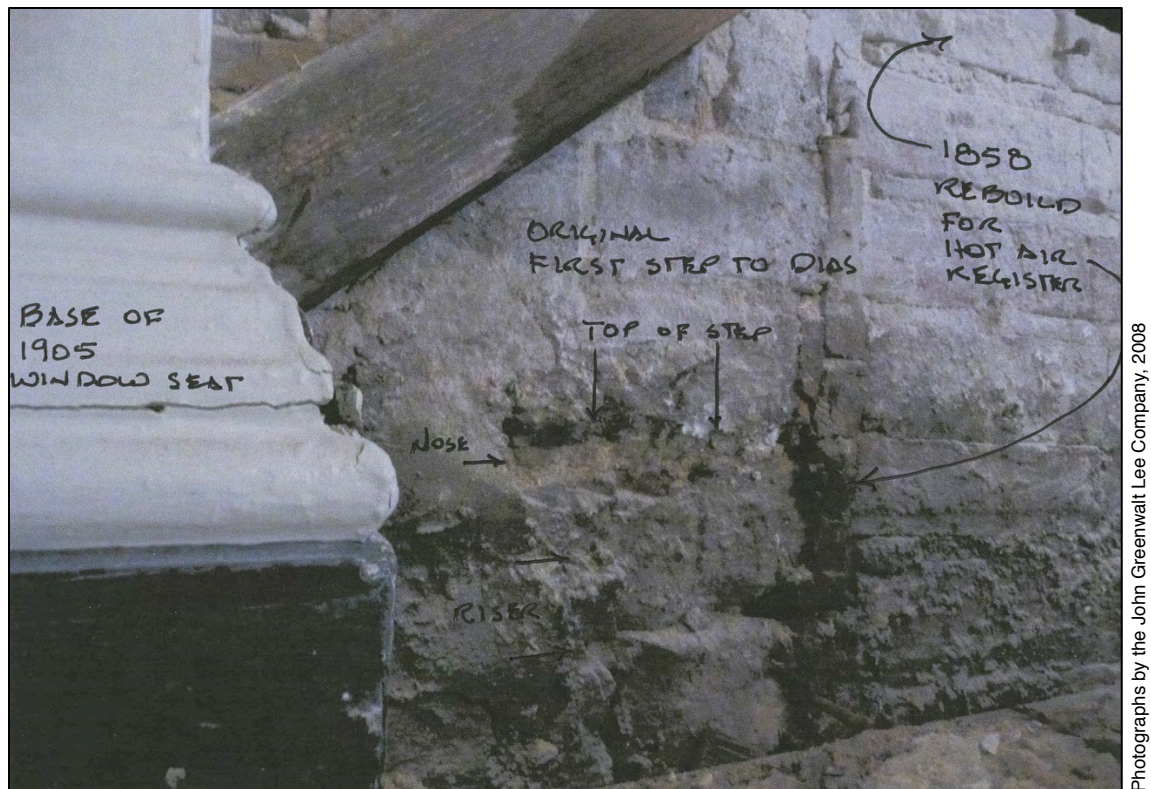
The position of the ghosts for the original first or bottom step makes a broad base (about 24") to the two-riser dais. This would allow those speaking to rise up one step from the floor, but not occupy the top of the dais that was reserved for the Senate President.

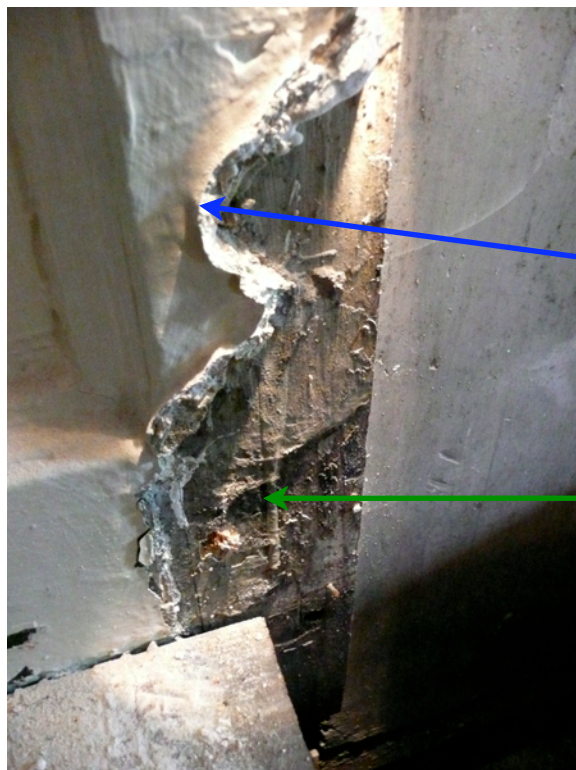
While the pilaster was stripped in 1905 after the column was installed, it retains early finishes beneath the 1905 column base.

Paint line of the 1905 base to the engaged column

Paint line of the original base to the free-standing column that only touched the pilaster at the base

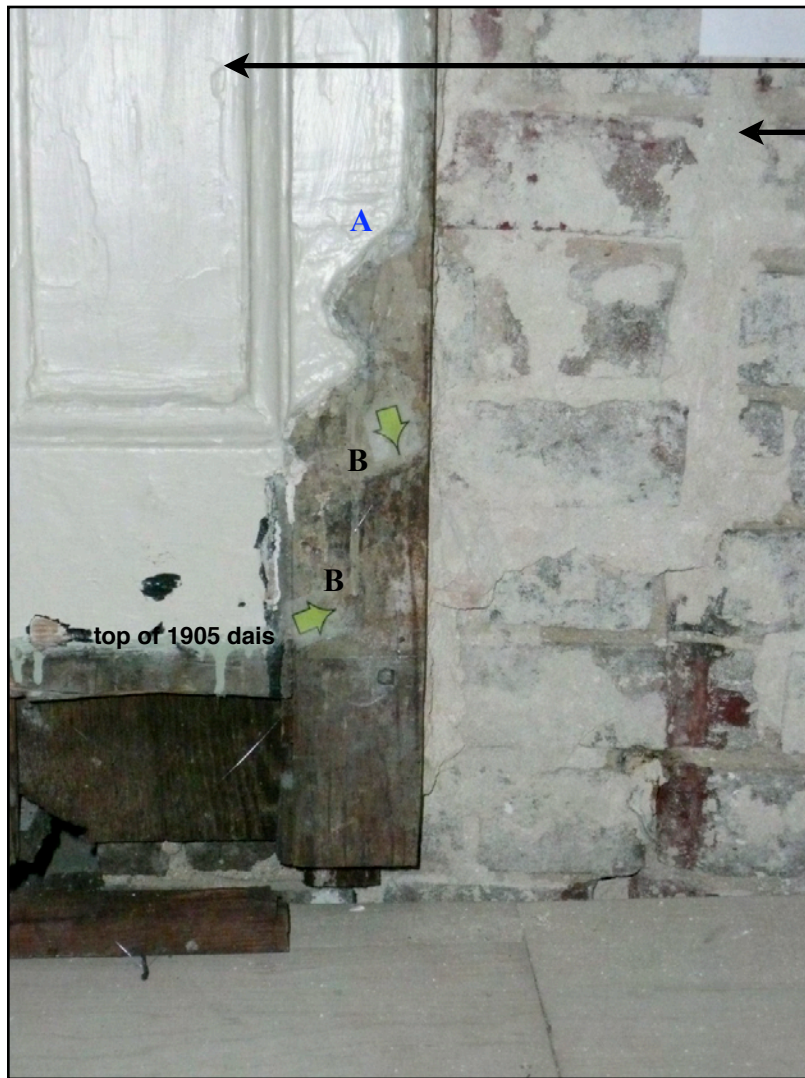
After the top 1905 step had been removed lowering the dais

Original paneled pilaster at right of niche

Gas lighting pipe chase from 1858

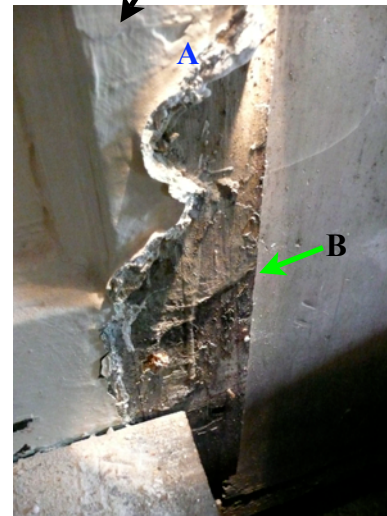
Before dais lowering

A = Paint line of 1905 engaged column base (column and base connected with wall)

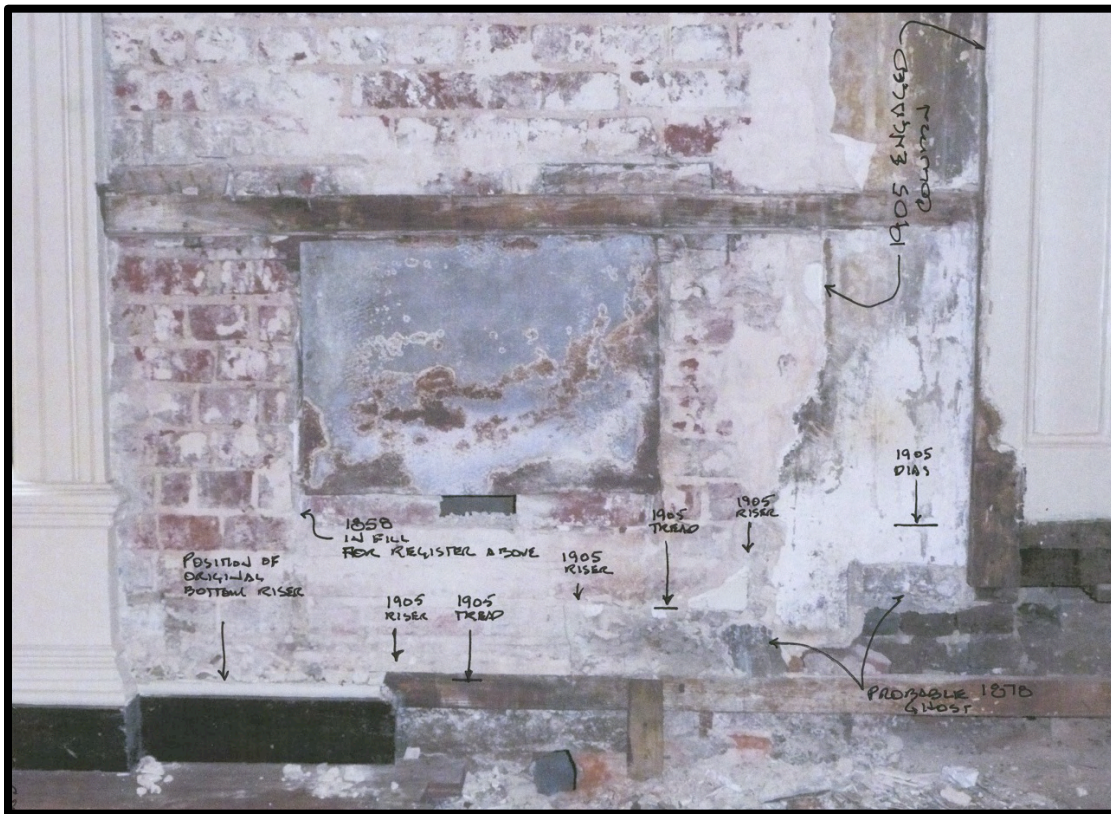
Reused pieces of 1878 trim functioned as grounds for the 1905 baseboard, providing an example of the two-toned graining used throughout the building in 1878 (and remaining under paint in many chambers to this day.)

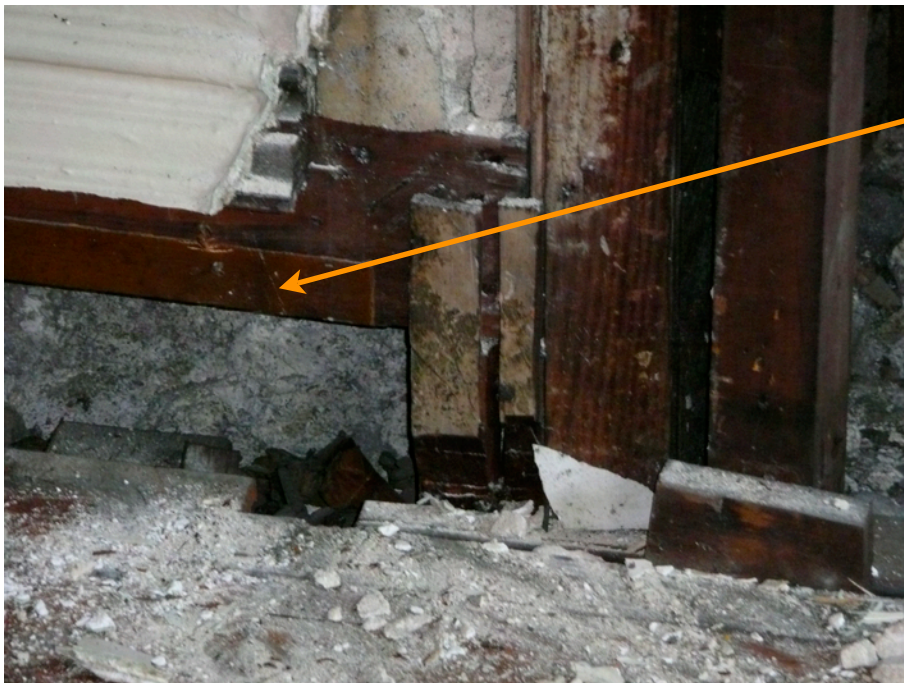
Reused board exhibiting
1878 maple graining

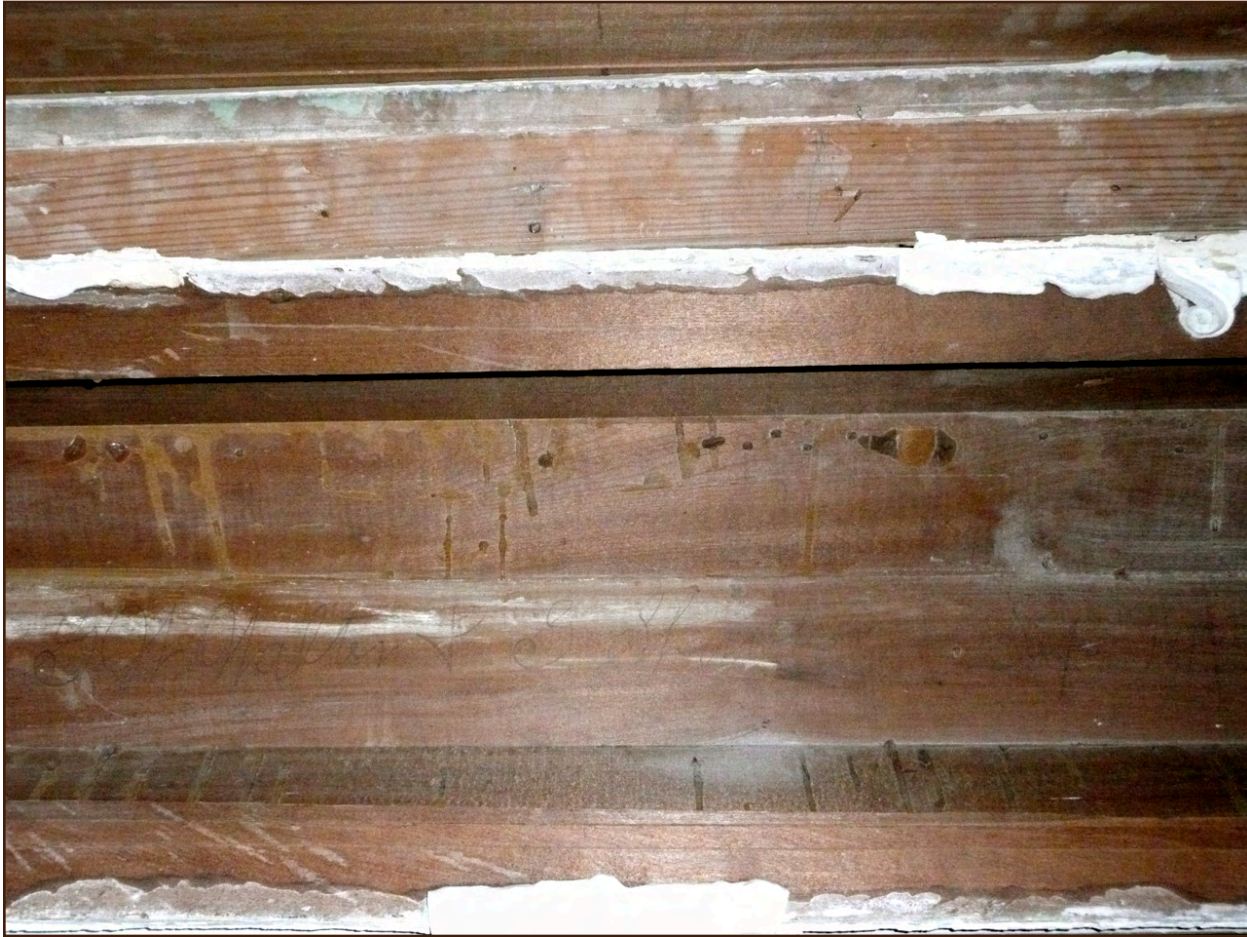
Signed and dated interior of right hand engaged column at niche: Sept 14th 1905.

Although the curved plaster of the niche, the banding, and the pilasters appear to be original, the rest of the surrounding details of the niche are 1905 recreations. This was further confirmed with discovery of the signature and 1905 dating found inside the right-hand column. It is interesting to note that the September date of installation is less than a month after the Restoration Committee began a statewide appeal for more information and photographs that might guide their restoration efforts.
