Interim Report on Archival and Architectural Evidence
Old Senate Chamber at the Maryland State House

09/17/2008 *(updated on 11/24/2008)*

Report by the John Greenwalt Lee Company

**Produced for Maryland Department of General Services, Alvin C. Collins, Secretary
Contract Number BA-491-070-203**

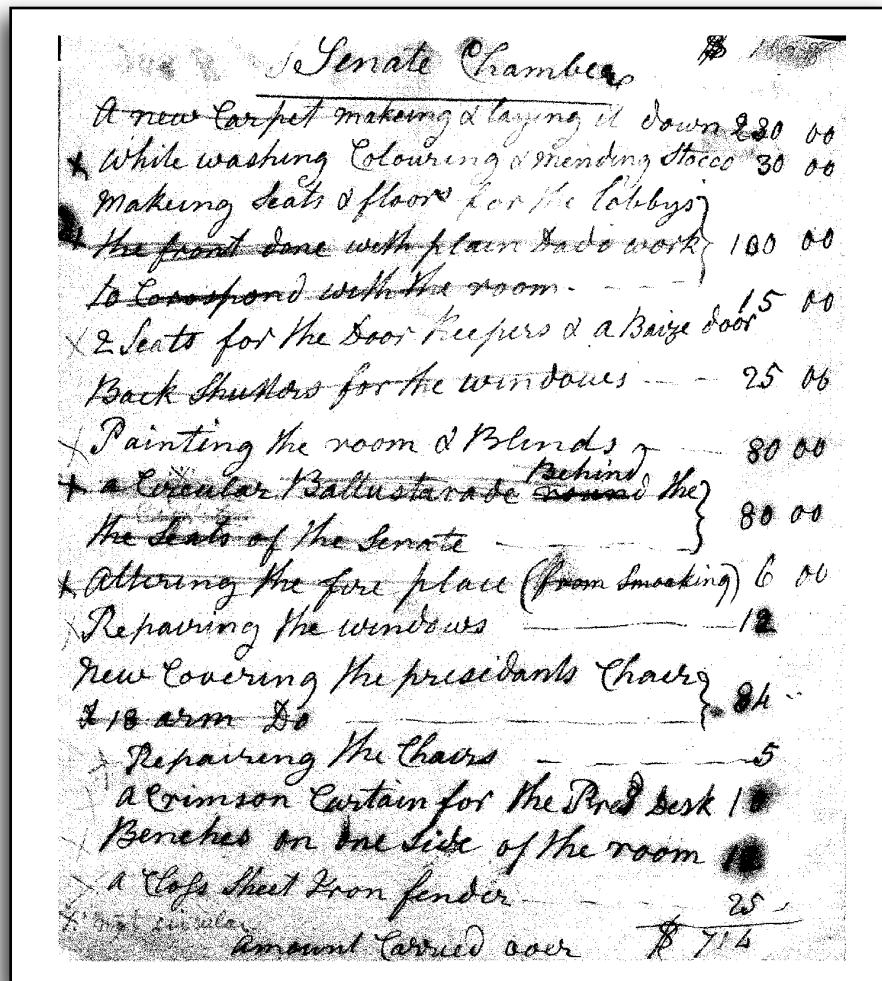
1792 Gallery Changes and Additions:

- **“Making seats & floors for the lobbys”**
(a lobby created under the gallery with pews and risers)
- **“The front done with plain dado work to correspond with the room”**
(flushboard wainscot running between the columns and connecting to the wainscot around the walls to separate the lobby from the rest of the room)
- **“2 seats for the Door Keepers and ...**
- **“a Baize door”**
(in this context the sound-dampening door would be associated with the entry vestibule between the doorkeeper’s seats).

Primarily this is a list of items added in 1792 and thus not present in 1783. The implication is that when George Washington resigned his military commission, the gallery below consisted of unobstructed floor running past the column to the back wall.

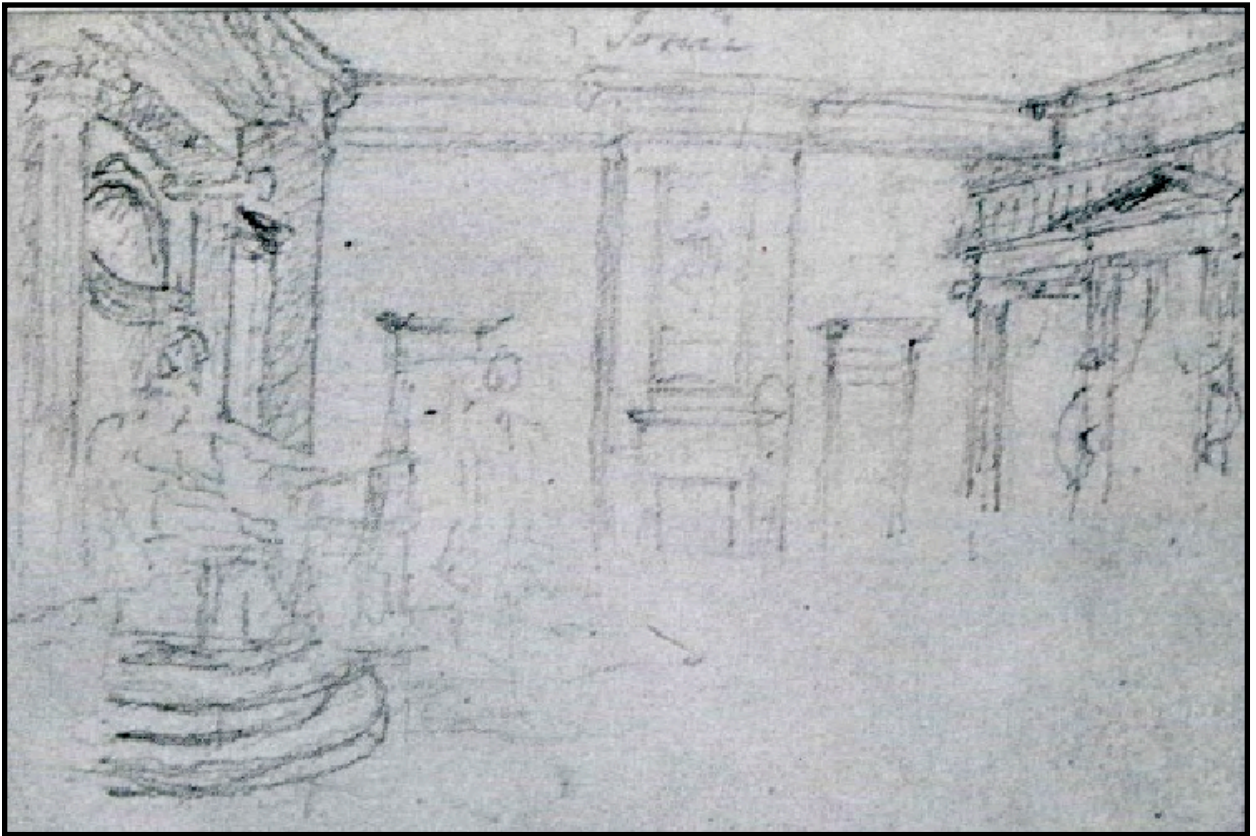
Annotation: In Trumbull's 1822 sketch of the Old Senate Chamber, the gallery recedes between the outermost column and the wall, sufficiently to not be seen, although the beam from the back wall to the column is visible beneath the entablature. Breaks in the entablature are indicated to the outside of each column – this one-sided rendering may just be demarcating the strong shadows.

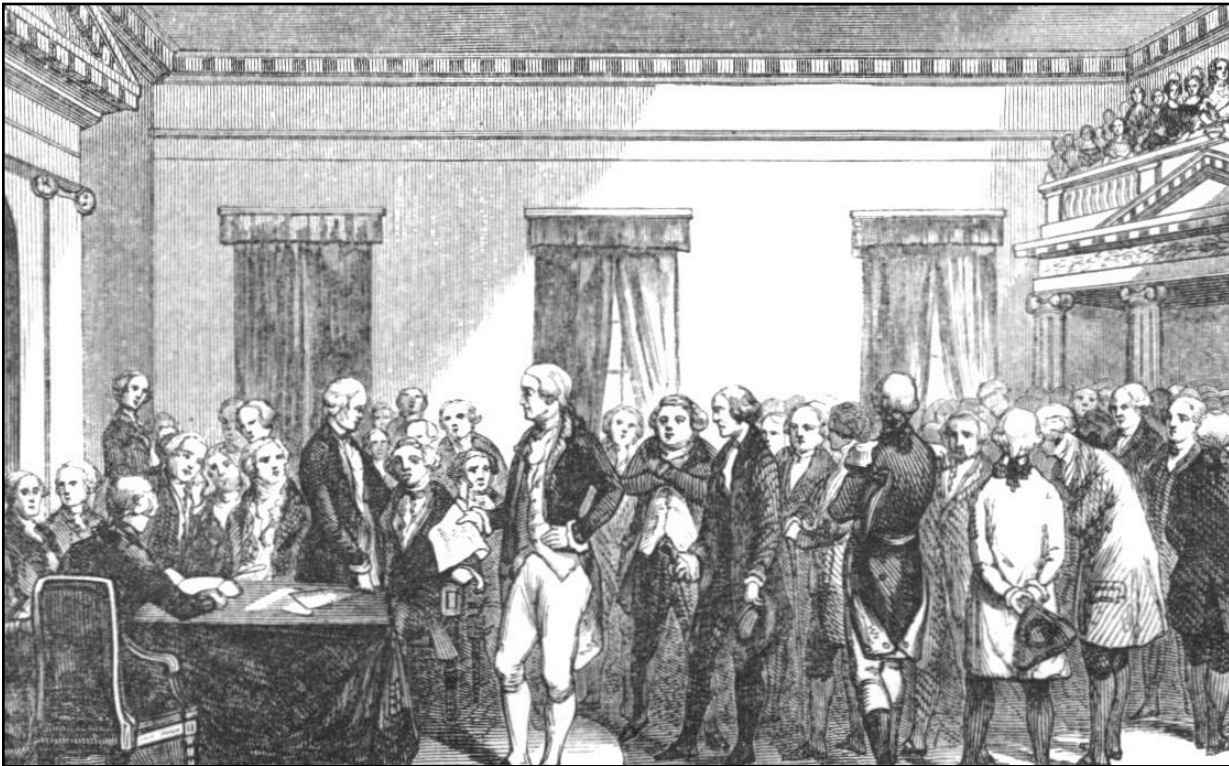
Annotation: As in every rendering, the gallery appears to end at the outside column with a beam connecting the back wall to the column (creating a recessed ceiling for the lobby).

Physical evidence suggests that something connected at the corner of the room. It is not yet clear whether the two ends matched and how far out from the back wall the row of columns was aligned, much less the intersection (or lack) with the outside wall.

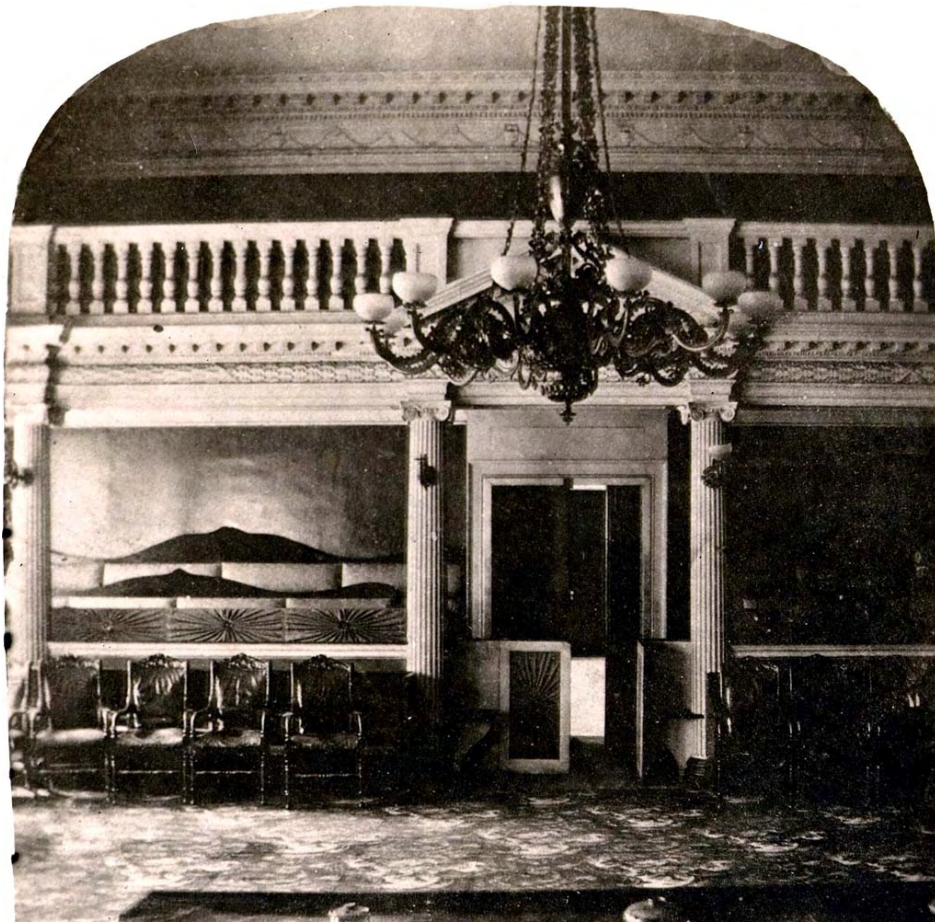
The ceiling and cornice are likely 1826 (having also been replaced in 1798).

The gates are later, maybe 1830s.

The use of complex photogrammetry would allow us to extra much more detail and absolute dimensioning from this photograph and its companion.

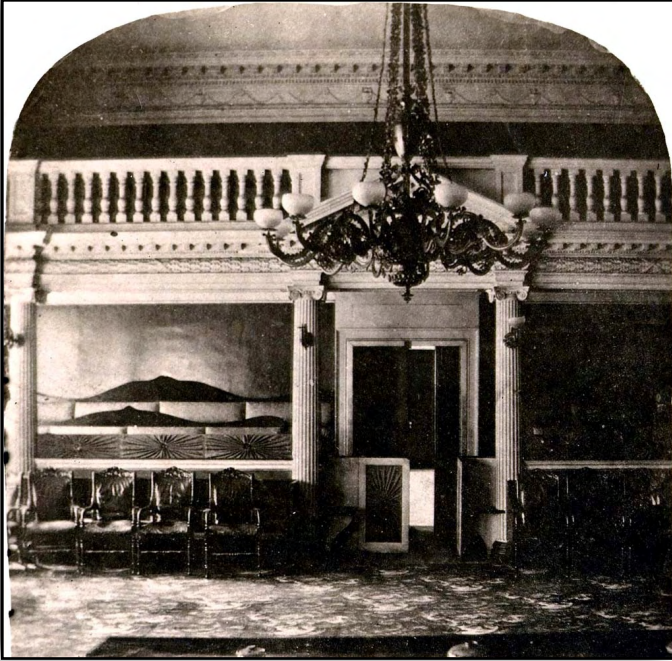
Based on simple photogrammetry performed in Photoshop CS3 Extended, dimensions were extracted from the 1868 photograph. Since the plane of the film was closely aligned parallel to the column line; by knowing a single dimension in the plane of the columns, other dimensions in that plane can be measured as well.

Annotation: The two central columns in place today appear to be early, and thus the height of a column flute is known. The flute to right of center is fully visible.

With this information, the arrangement in 1905 placed the two central columns 4" closer together, while the two outer columns should be a foot further out (closer to side walls), and the balustrade was made 3" too tall, causing the individual balusters to look quite skinny, etc.

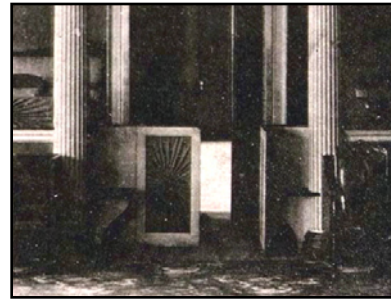
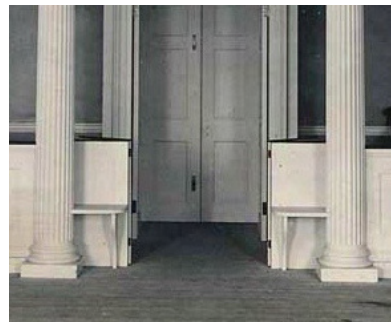
In 1868, the doorkeepers seats consist of a bracket on the column supporting a round seat that wraps to the front of each column.

The 1905 seats were built against the partition to just touch the columns.

Annotation: Details associated with the 1905 gallery recreation were based on the 1868 photograph and supposedly "reproduced as accurately as a minute examination of the photograph admitted." Based on inaccuracies between the doorkeeper's seats today compared with the 1868 photograph, this claim must be questioned.

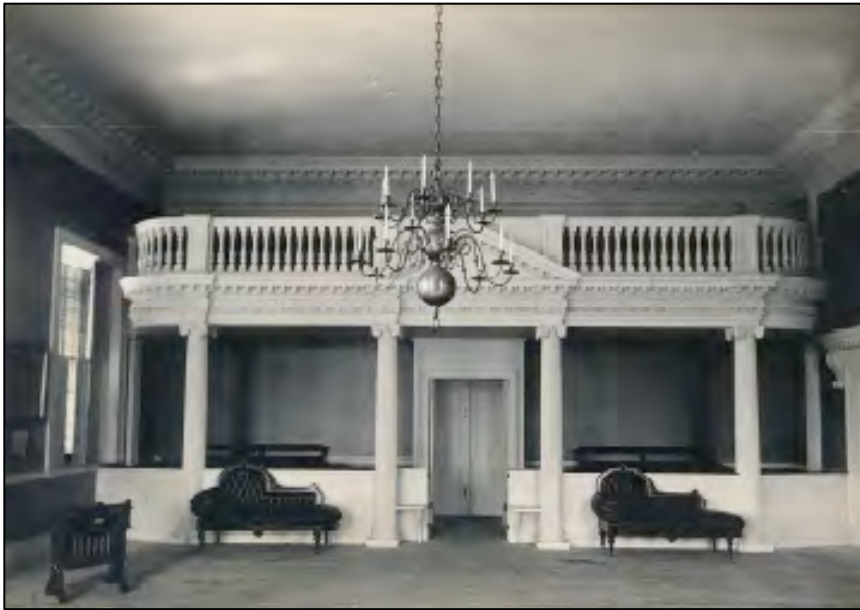
The pilasters, purported to have been found in the State House cellar, are 1905 workmanship in a Colonial Revival replication. Their original location is said to have been based on finding wood blocks. The 2008 investigations however uncovered the blocks and a crisp ghost across the masonry of a very different pilaster – one that has entasis and was 4” closer to the back corner than where it was placed in this 1905 arrangement.

Although plaster was removed from one pilaster location, the pilaster in place in 2007 was the wrong shape (lacking entasis) and 4" out of position. Plaster was not removed from the walls where the gallery floor and entablature intersected the walls and where the original wooden structure would have pocketed into the masonry, providing much more information about the original structure. Two of the columns remaining today appear to be early, if not original, but their location – based on photogrammetry – appears to be from 2" to 16" out of alignment across the front of the gallery. Opportunities for determining the original depth of the gallery appear to have also been missed in 1905.

A curvature inward versus outward (convex or concave) was never clarified and although the partition at the lobby level was to have been straight, the 1905 team angled it backwards outside the two end columns to accommodate the window and false door that would otherwise be bisected by a straight partition (based on the 1905 location of columns.)

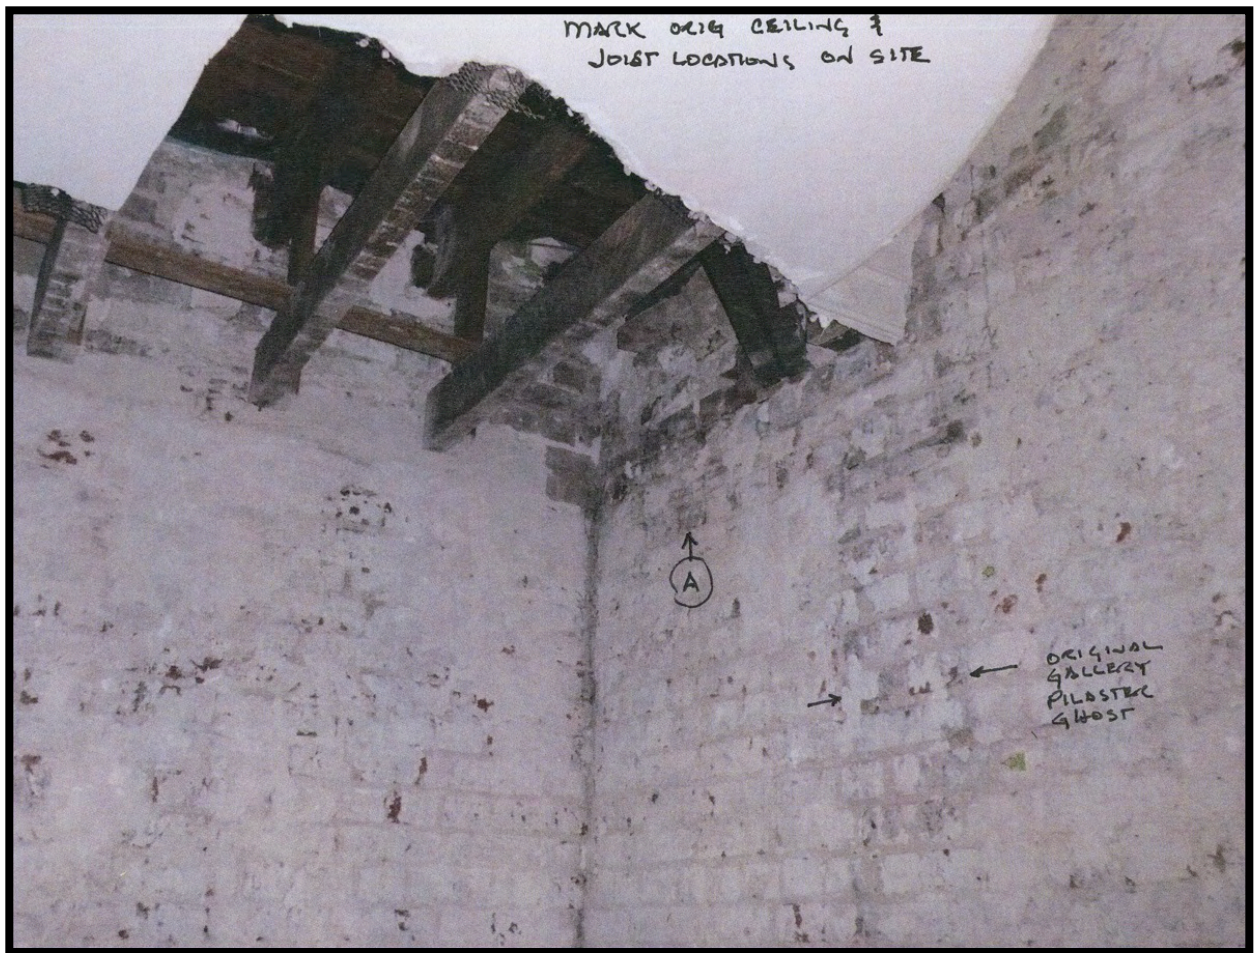
On the underside of the gallery with 1905 wall plaster and pilaster removed, the ghost of the original pilaster (offset from where it was set in 1905) and the edge of original plaster (A) are clearly visible on the end of the chimney wall.

(Note the ceiling material that was removed here was more recent than 1905.)

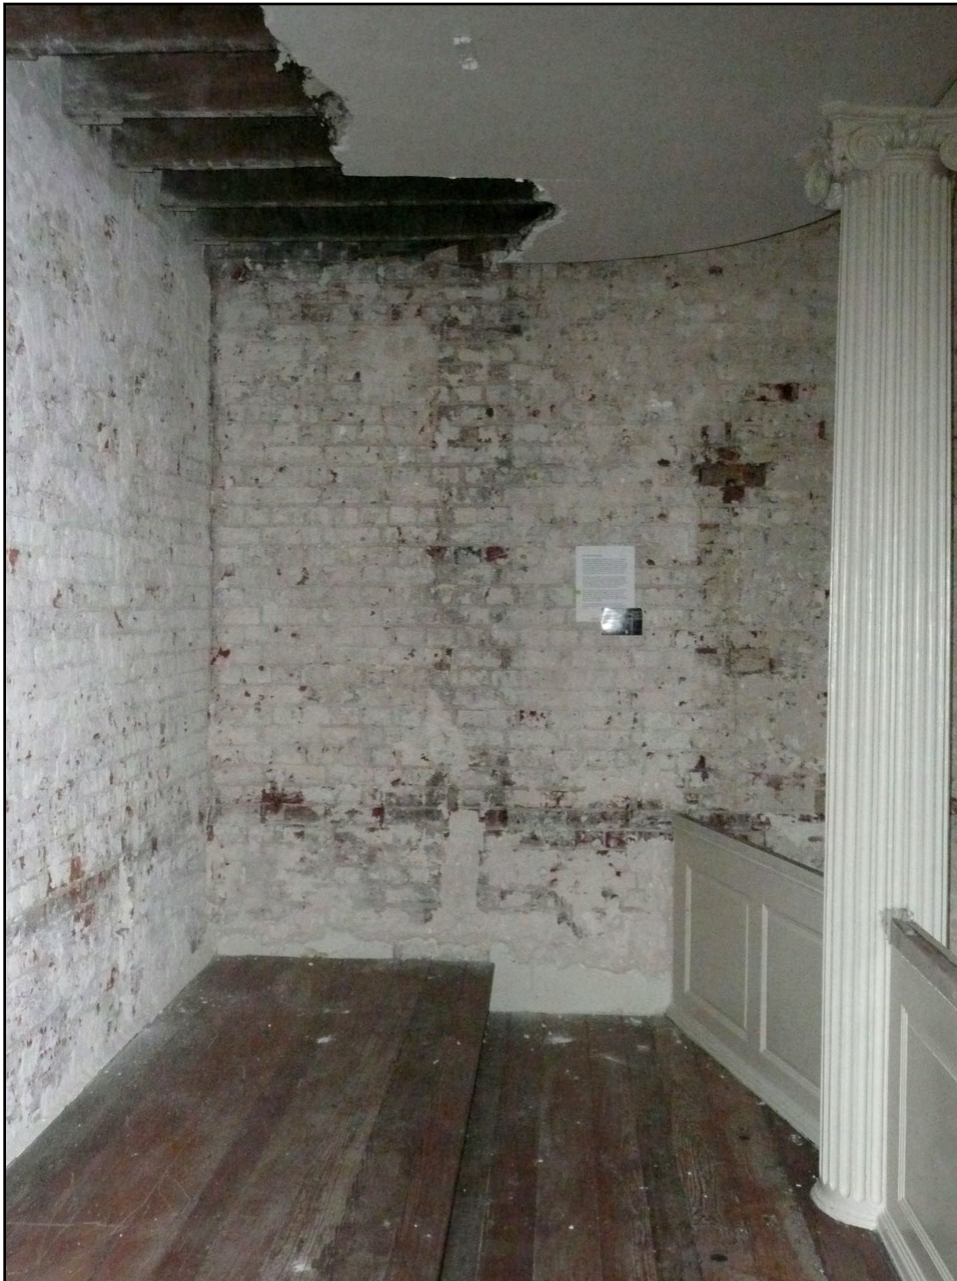
The vertical dark area on the end wall can be cleaned to bring it into sharper focus. Infrared Photography (1500-2000 nanometer range) could also enhance the image.

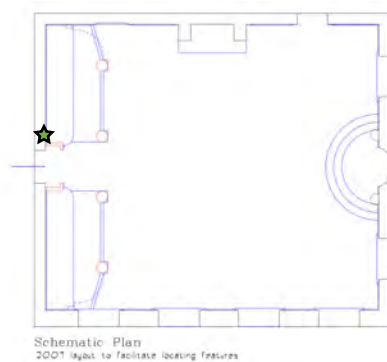
There is a patch of early masonry infill that may be related to the original door to the hall on the back wall approximately aligned with the right-hand column flanking the vestibule.

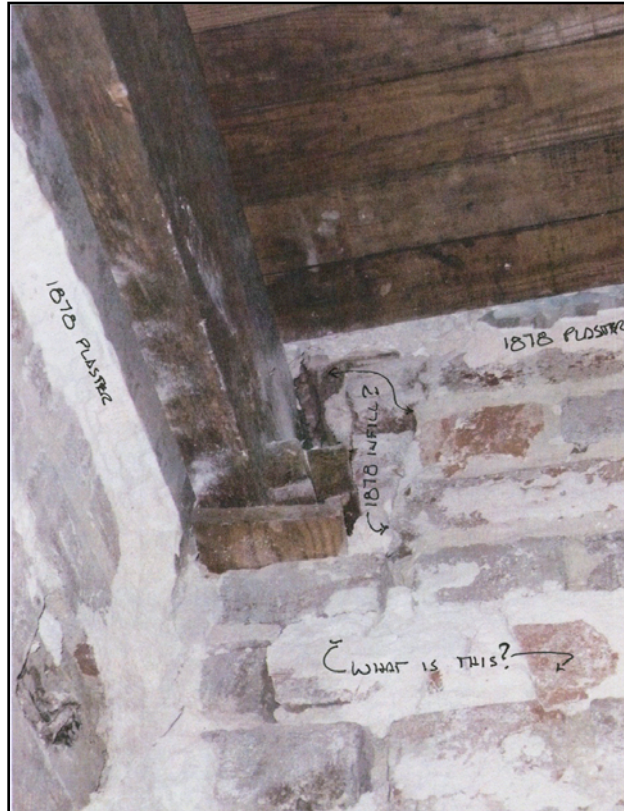
Yet unidentified alterations/patches at the far left end under the gallery at the wall intersection.

Compared with the 1868 photo, it's hard to see the for the justification for the claim that these were “reproduced as accurately as a minute examination of the photograph permitted.”

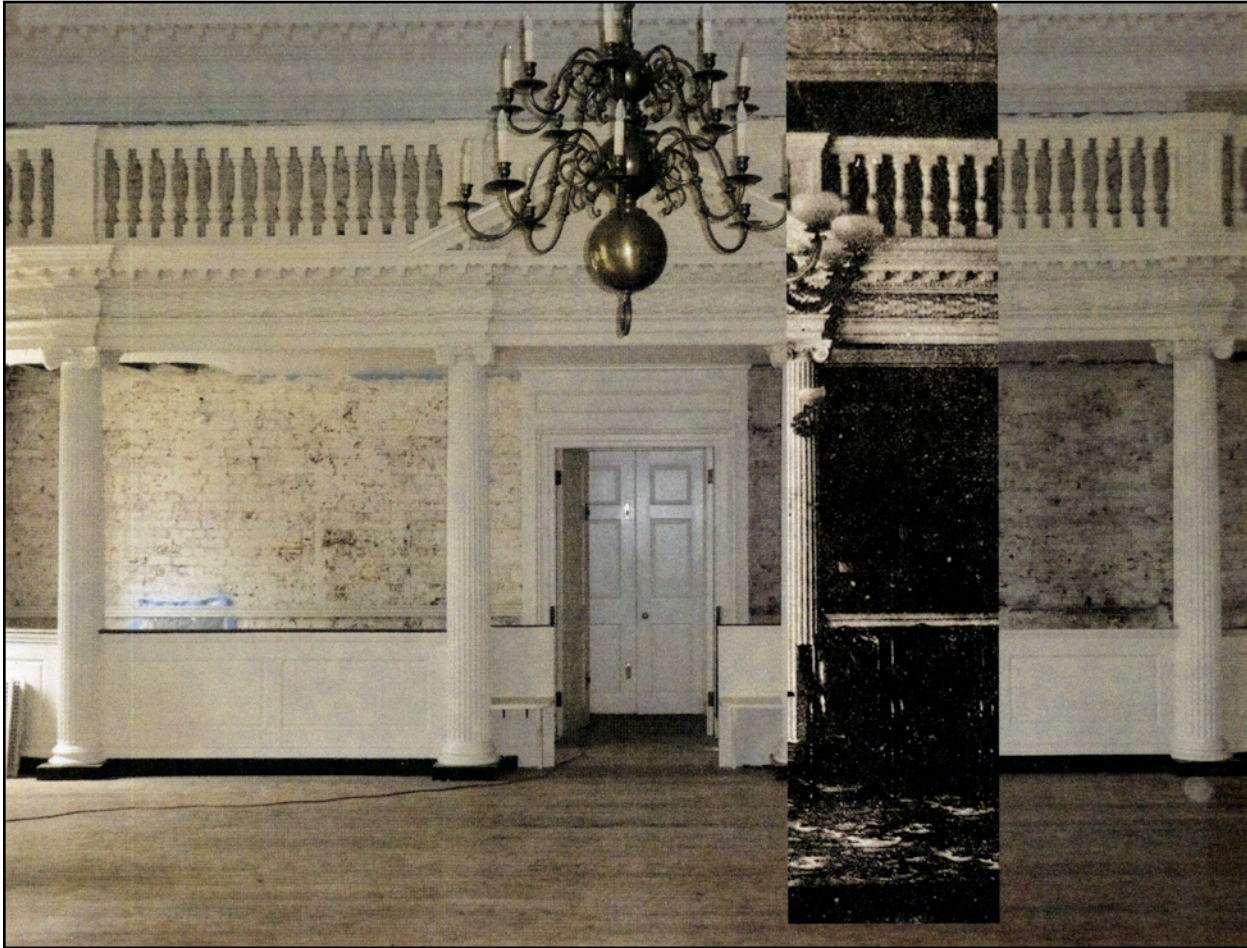
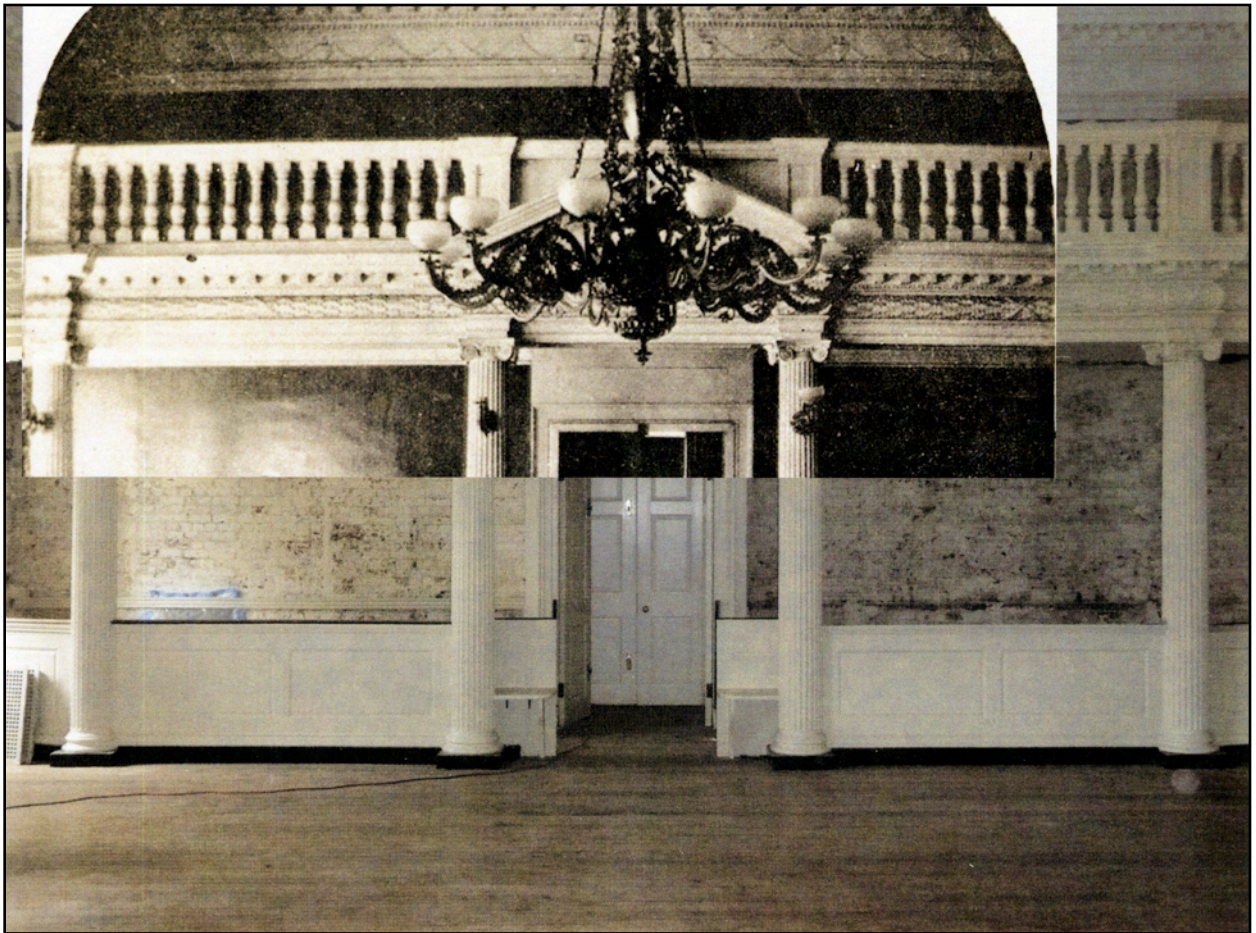
2008 photograph with a circa 1868 vertical overlay

Using crude photogrammetry, the ca. 1868 photo was scaled to match the current photo by scaling both photos to the length of the flute on a column. This is the only readily identifiable element in both photos, as the two original column shafts were used in the 1905 recreation of the gallery. This process only scales elements in the plane of the columns. Highly sophisticated photogrammetry can scale the entire photo.

A narrow vertical slice of the scaled ca. 1868 photo is here overlaid showing a distinct discrepancy in the height of wainscot between columns, proportions of entablature, shape and height of balusters, etc.

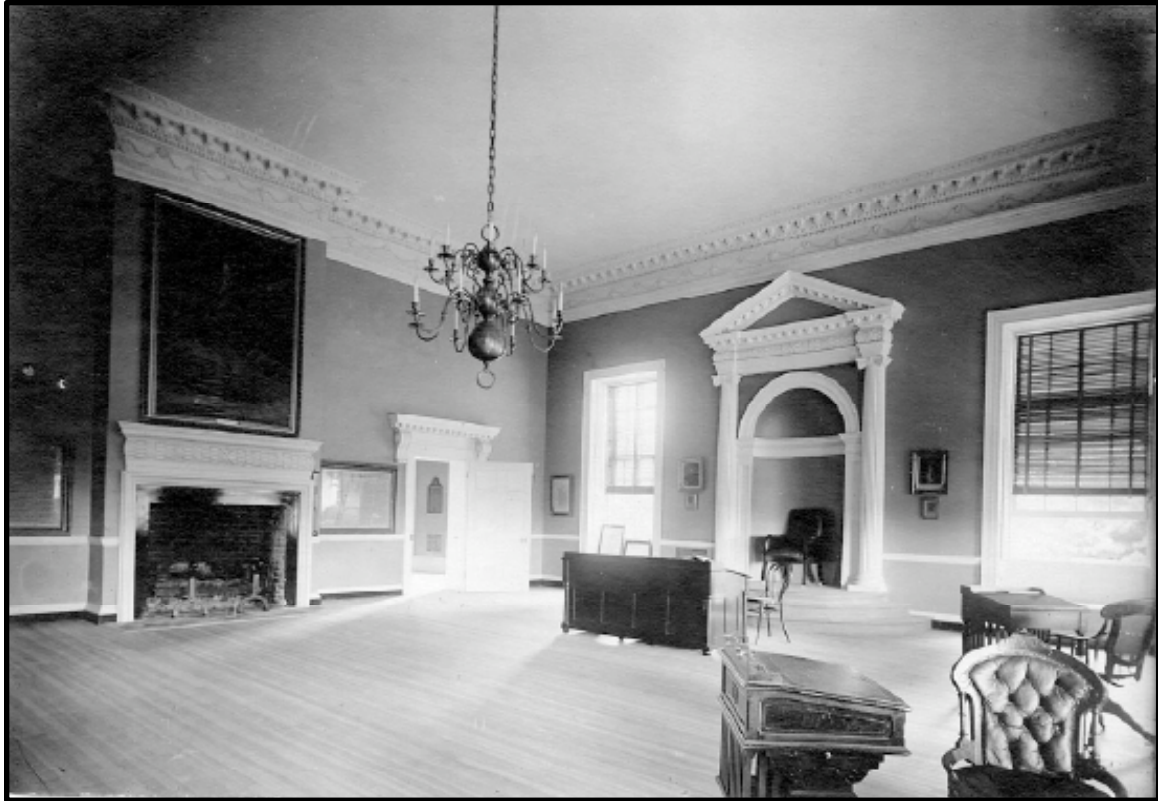
- **This chimneybreast is a complete 1905 fabrication to replicate what had previously been removed.**
- **The mantle was based on period examples and elements from the gallery and niche.**
- **Note the minimal projection from the wall (expanded in the 1940s restoration).**
- **The andirons were custom made based on sketches of recollections from the mid-19th century.**
- **At this time the painting should be Washington, Lafayette and Tilghman by Peale.**

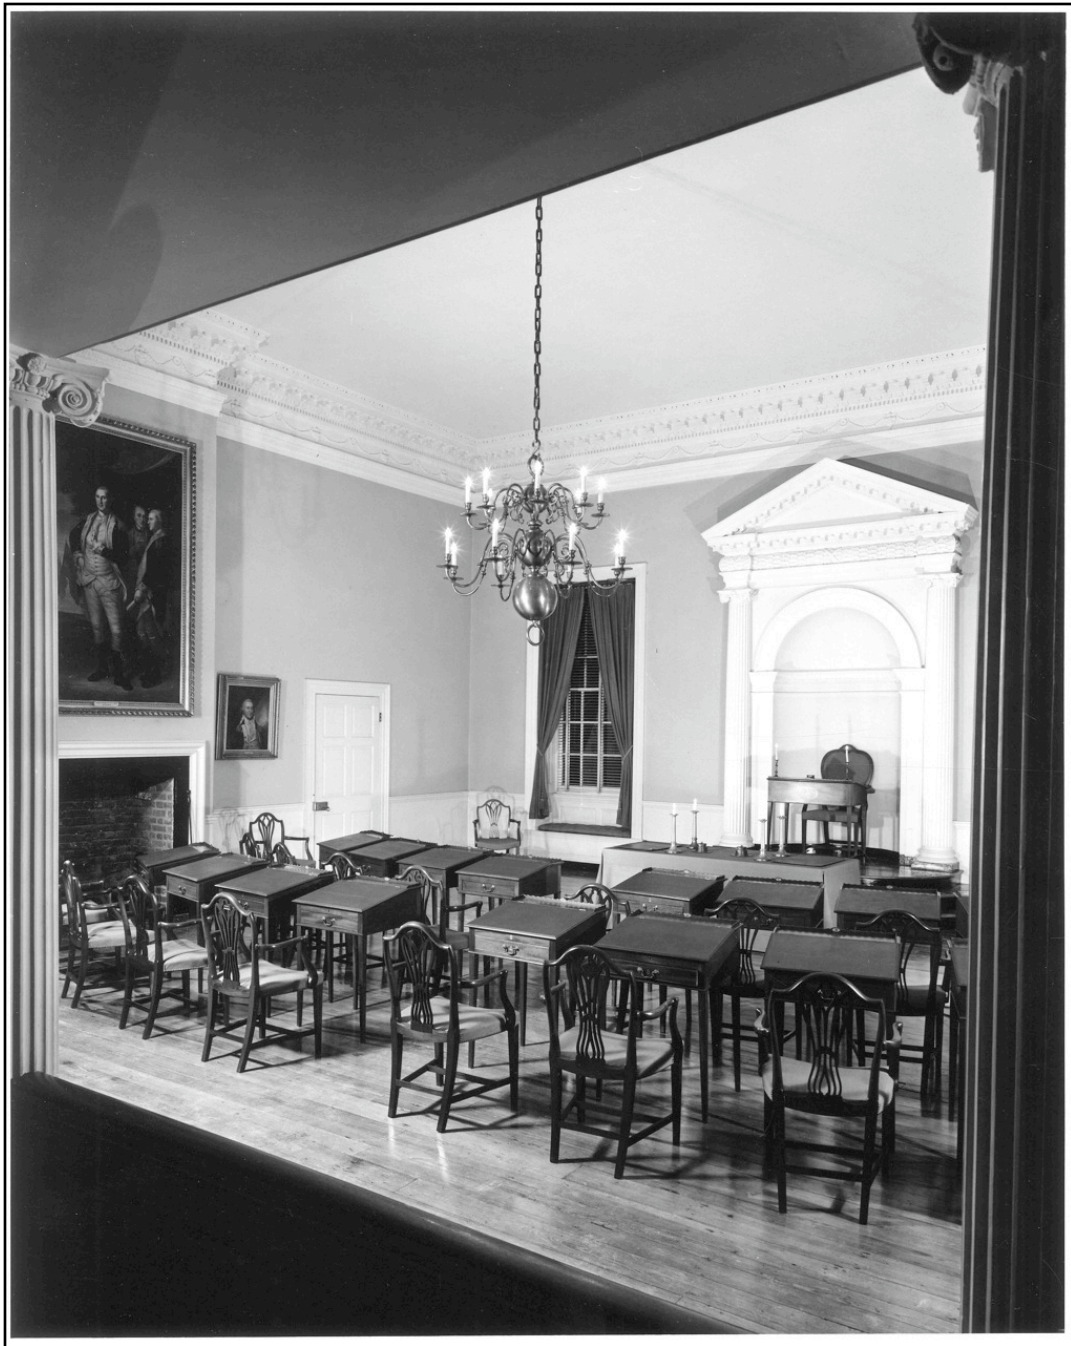
Annotation: They appear to have worked out the width of the masonry for the jambs. The black painted plaster would be correct for post-Civil War era, when imitating the black slate or marble was in vogue. Earlier it would have been whitewashed plaster, possibly with some veins drawn in to simulate marble. The antiquarian impulse to reuse hexagonal pavers from the hall is interesting, and possibly correct, but we cannot recall of other examples of these used in hearths.

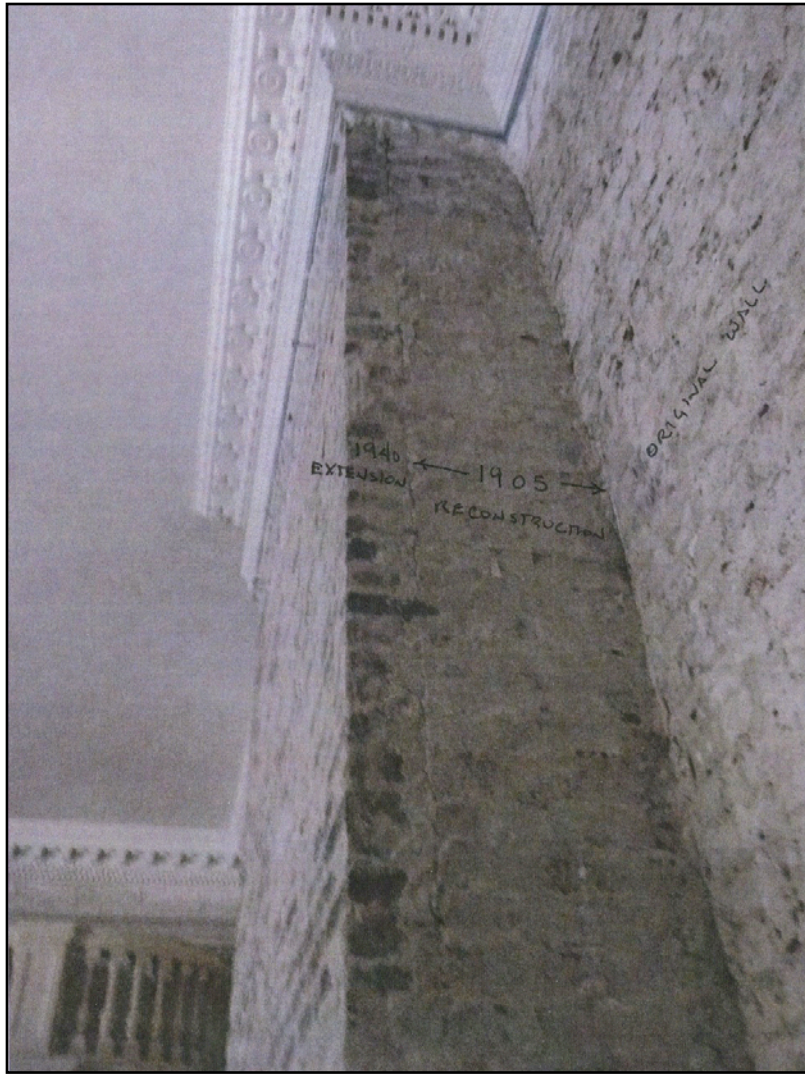
With 1905 and 1940 plaster removed, the 1940s extension to the chimney face is clearly visible. Chimney breast was removed when central heating made it redundant and was reconstructed in 1905 as a very narrow projection from the wall. This was augmented later, probably in the 1940 re-restoration.

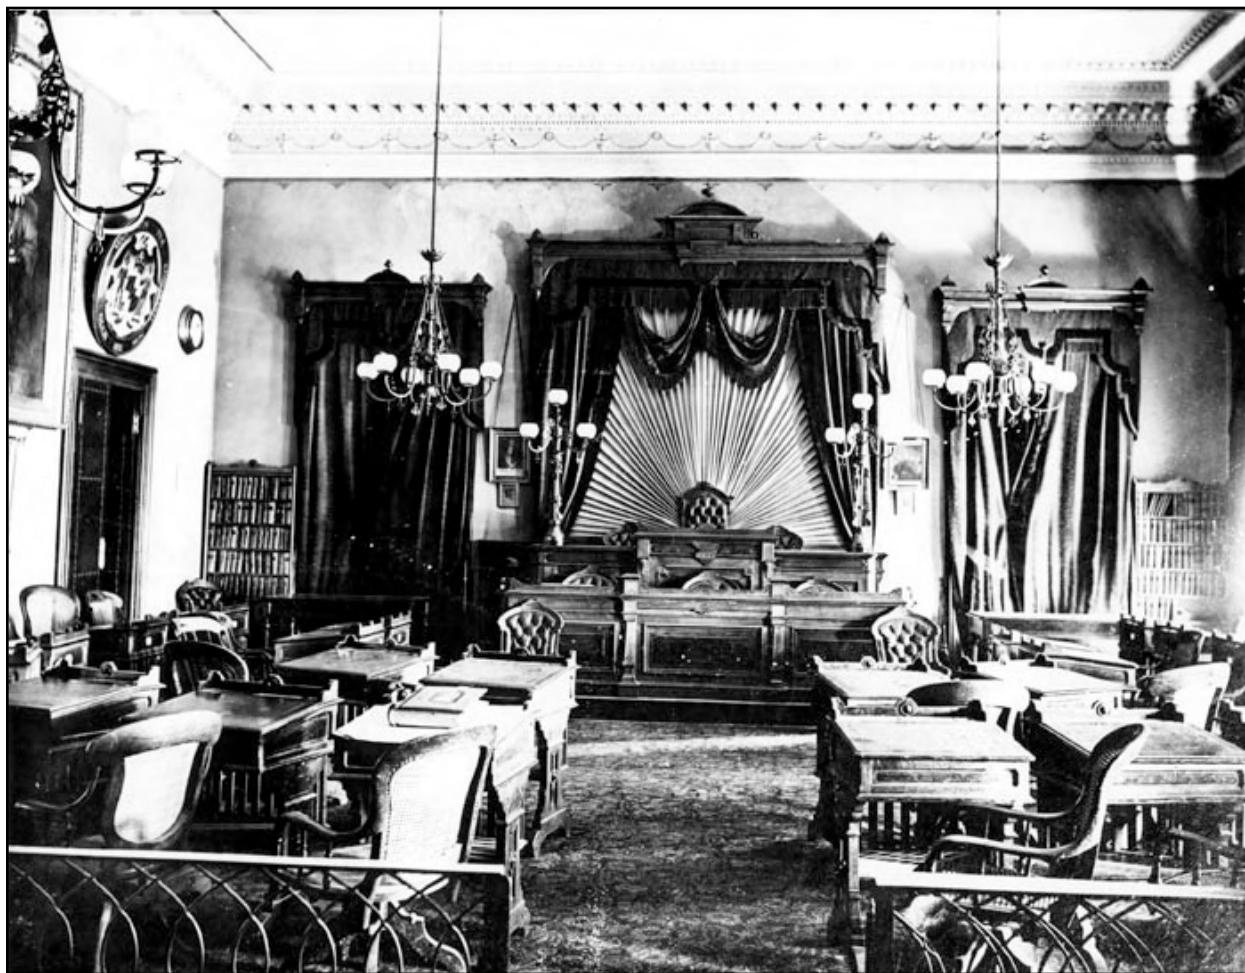
Annotation: Another wall-to-wall carpet in 1878.

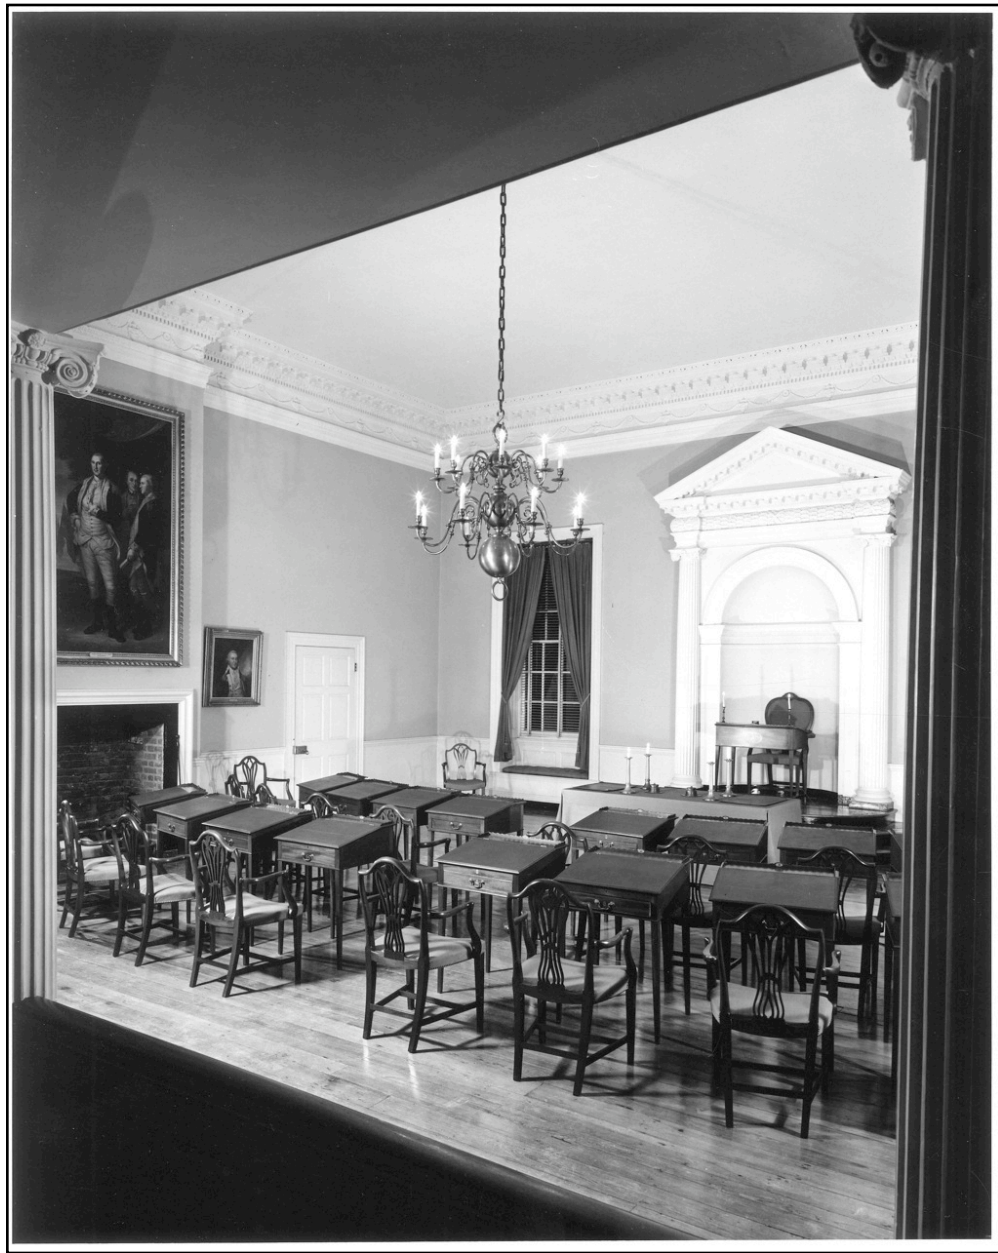
Accession: MSA SC 5287-11-429

Current floor was installed during the 1940 restoration, it is a random-width southern yellow pine salvaged from a source not associated with the State House. It has a nail pattern completely disassociated from its original context and does not relate to an historic floor framing arrangement.

Annotation: Newly-installed salvaged pine floor. (This is still in place in 2008)

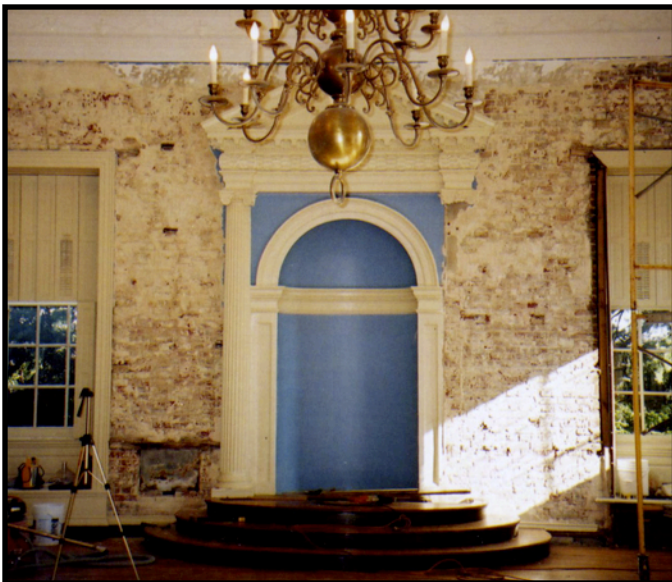
During the archaeological investigation of 2008, the landing of the 1905 dais was removed and the top lowered by one riser to approximate the original dais in height (as shown by physical evidence). The unplastered area at the base of the niche implies a baseboard of approximately that height.

Before: 1905 dais created a diminutive landing

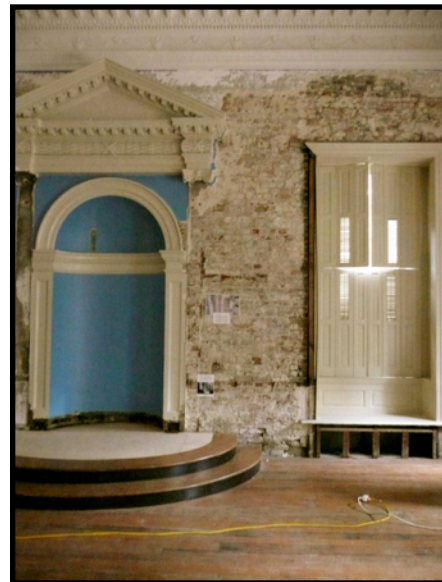
After: 2008 removal of top riser achieves a dais closer to original proportions, including a broader landing

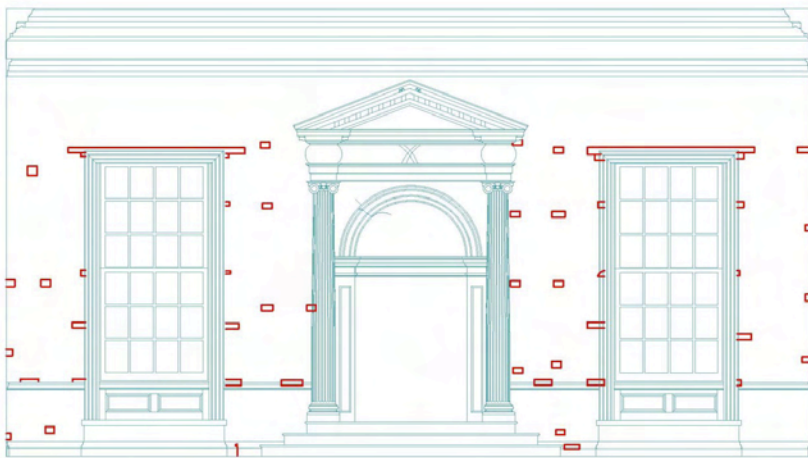
Niche Wall
AS IT APPEARED IN 2007
WITH ORIGINAL EVIDENCE SUPERIMPOSED

2007 appearance with orphaned blocking shown

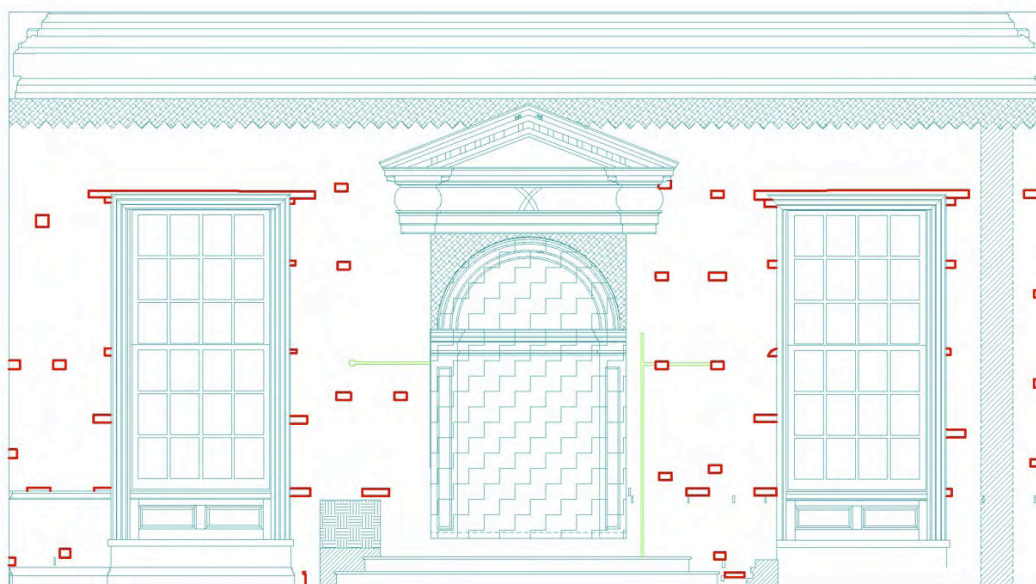
SHOWING EVIDENCE AND AREAS
OPENED FOR INSPECTION

Whereas the blocking does not mate with the 1905 trim:

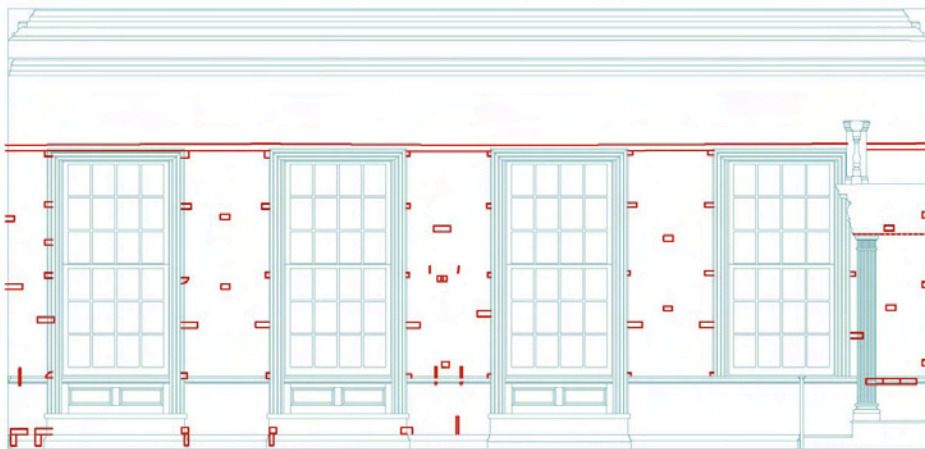
Window Wall
AS IT APPEARED IN 2001
WITH ORIGINAL EVIDENCE SUPERIMPOSED

**Window wall
with exposed
areas and unearthed
blocks**

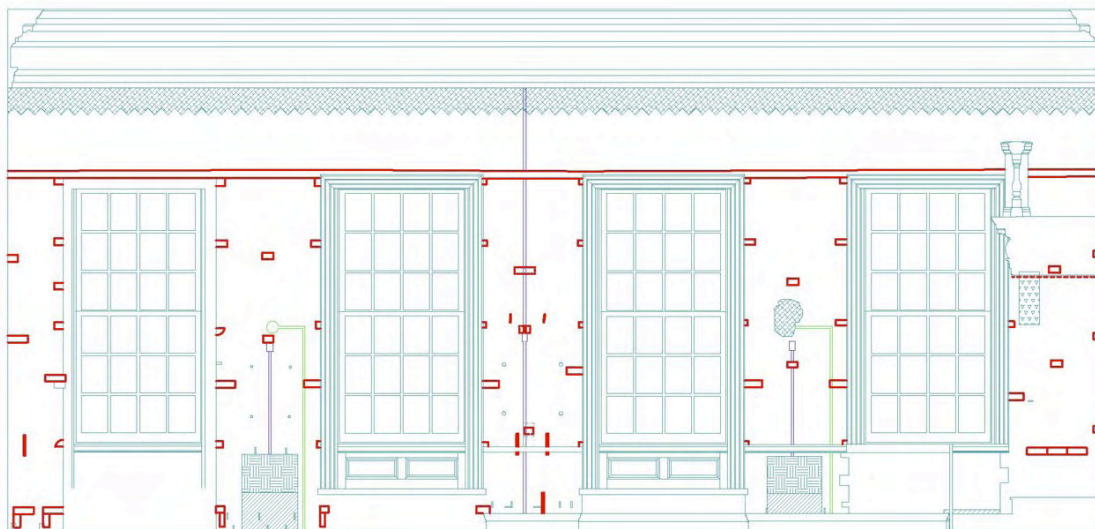
SHOWING EVIDENCE AND AREAS
OPENED FOR INSPECTION

Whereas nailing blocks do not correspond to 1905 restoration:

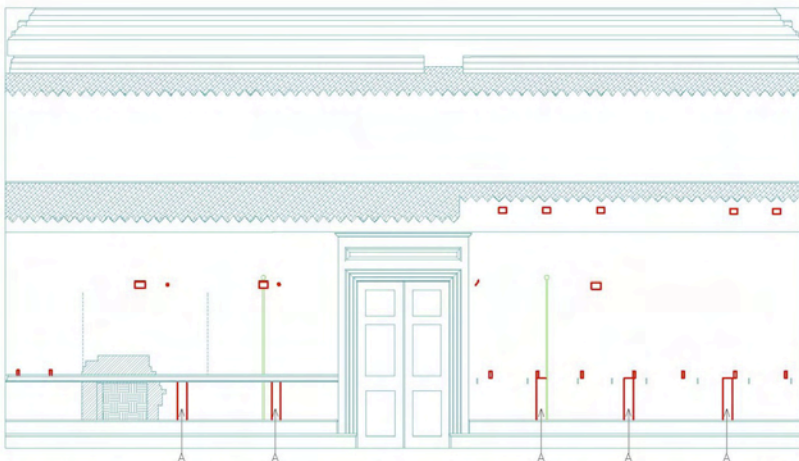
Gallery Wall
SHOWING EVIDENCE AND AREAS
OPENED FOR INSPECTION

**Gallery end wall showing
exposed evidence from
investigations**

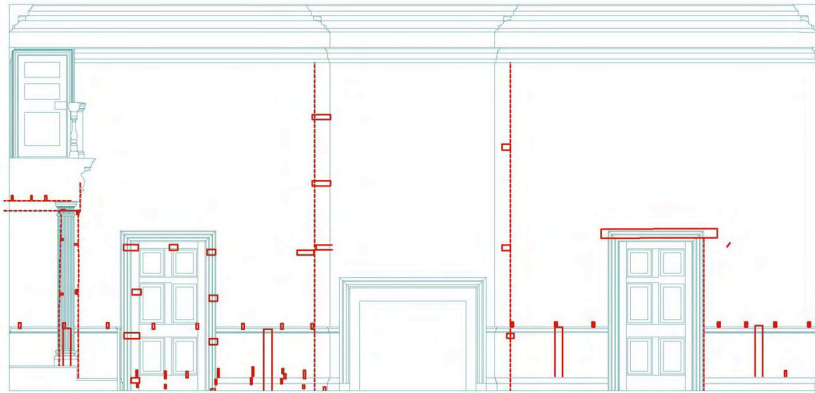
Chimney Wall
AS IT APPEARED IN 2001
WITH ORIGINAL EVIDENCE SUPERIMPOSED

Locations of blocking uncovered in study

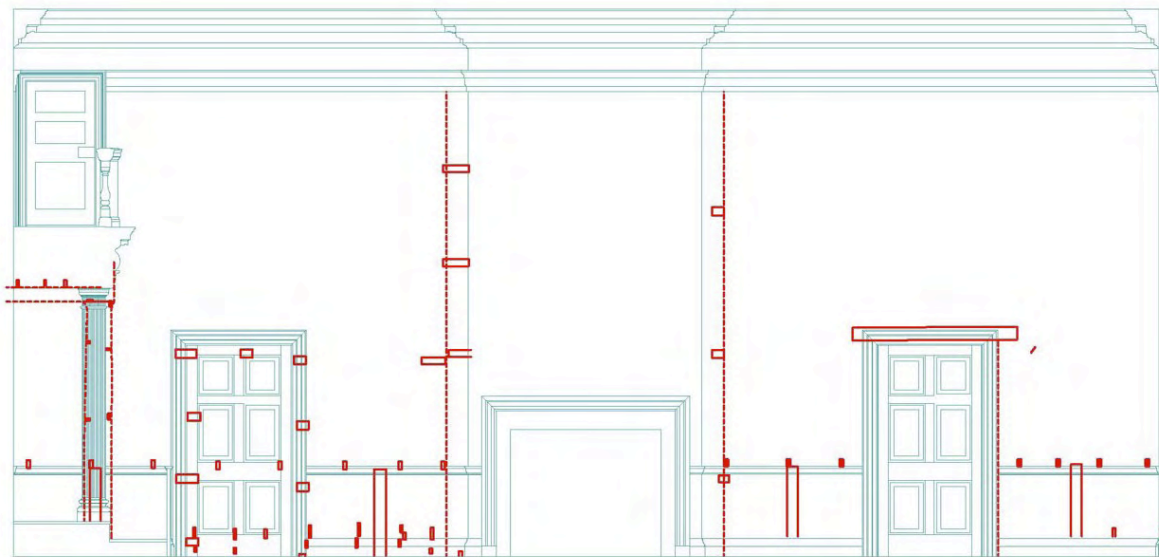
AS IT APPEARED IN 2001
WITH ORIGINAL EVIDENCE SUPERIMPOSED

In contrast, the 1905 restoration left many original blocks orphaned.
